St Peters Close, Rhosrobin

Proposed Housing

Geotechnical Report

SG Estates

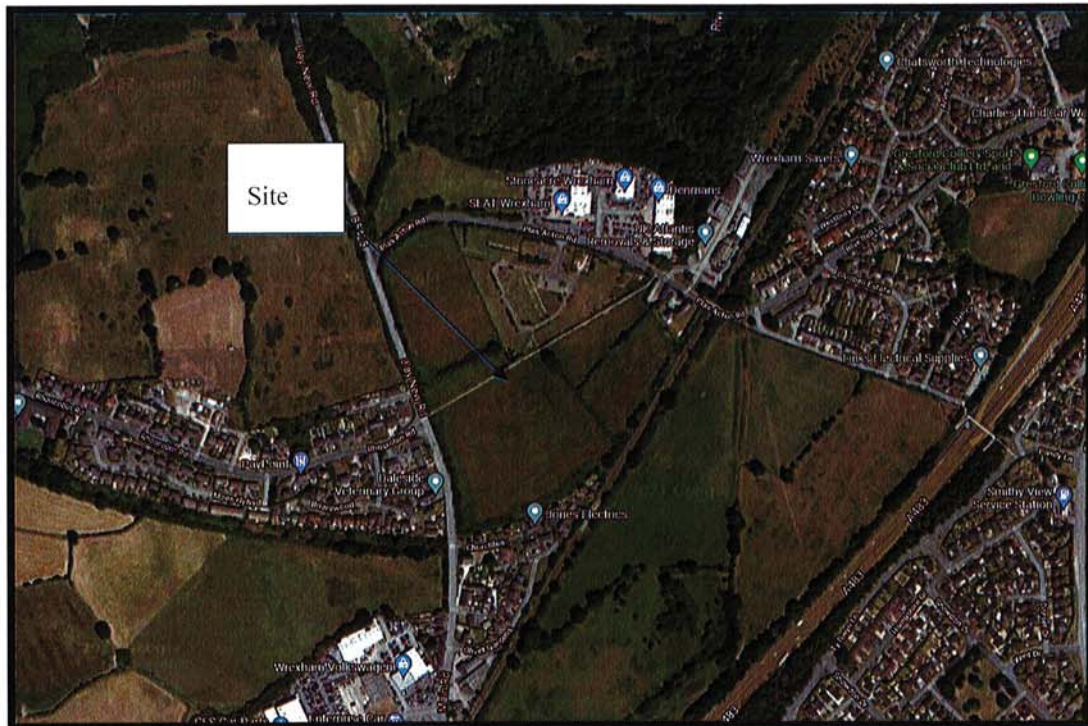
**Recent aerial photograph**

A topographic survey has been provided, which confirms the site to have a gentle fall in elevation in a west to east direction, from around 69mAOD in the west to 65mAOD in the eastern field. A recent aerial photograph is presented below.
