## Bat Roost Survey

The Lodge, Wrexham Road, Overton,  
LL13 0HG (Grid Ref: SJ 368 422)

CLIENT: Rachel Clacher  
SURVEYS: June 2021 – January 2022  
Rev 01: Issued 25<sup>th</sup> January 2022.

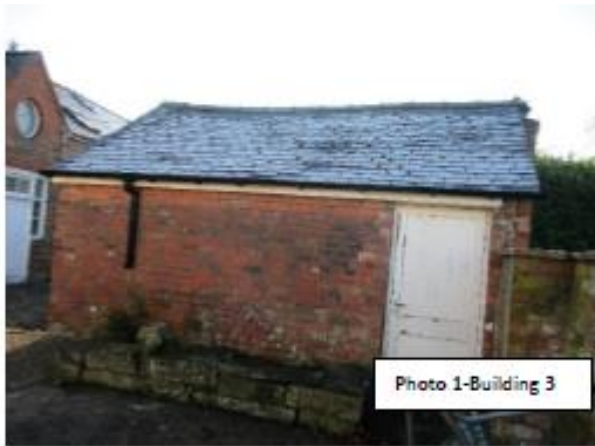
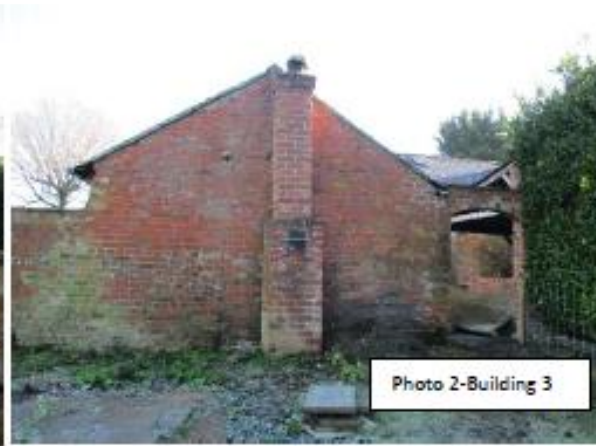
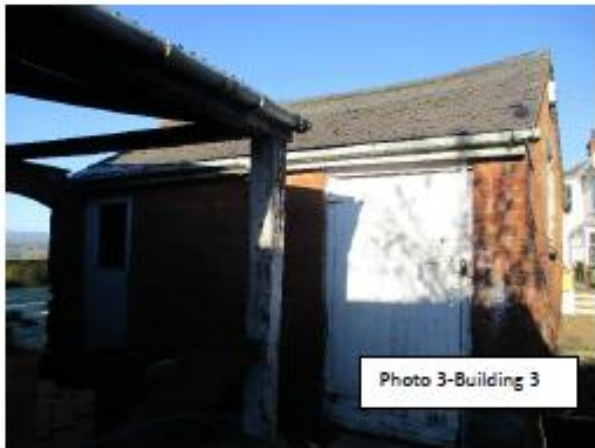
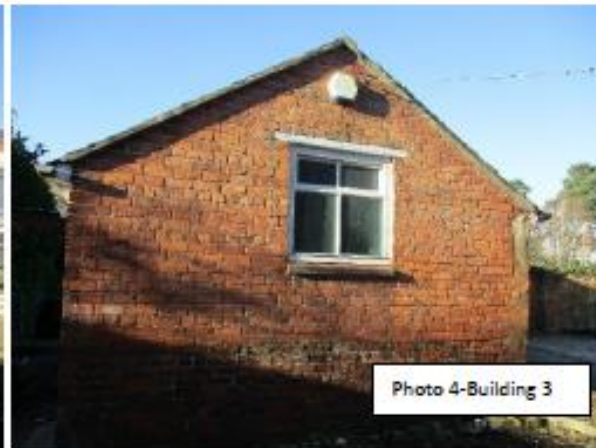
| Building Reference<br>(see Appendix 3) | Description | Suitability for<br>roosting bats |
|---|---|---|
| <b>B3</b> | <p>Brick built single-storey outbuilding currently used for storage. Brick work in moderate condition with some superficial cracks. Some slipped tiles.</p> <p>No Evidence of bat presence noted during physical / endoscope searches.</p> <p>See Photos and Fig 4 below.</p> | <b>High</b> |

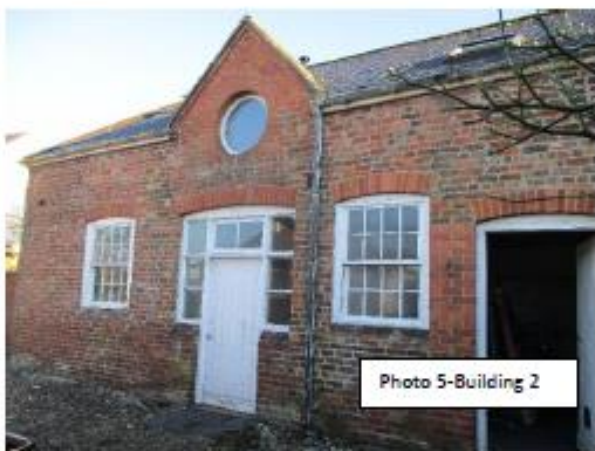
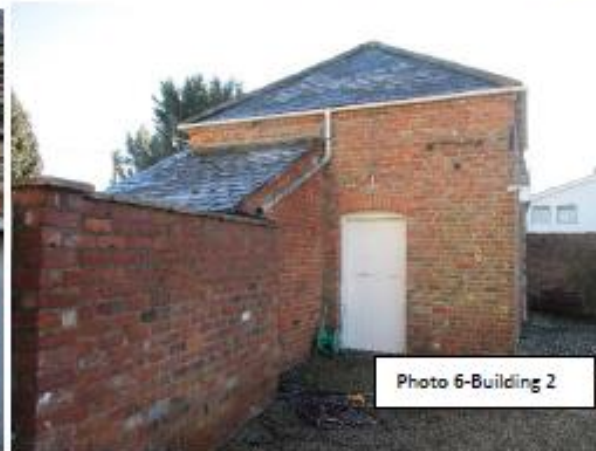
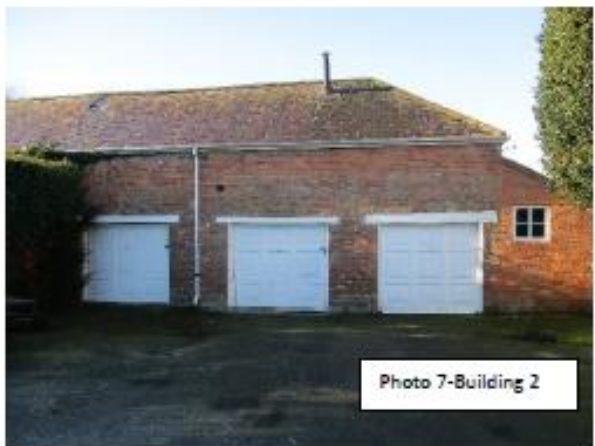
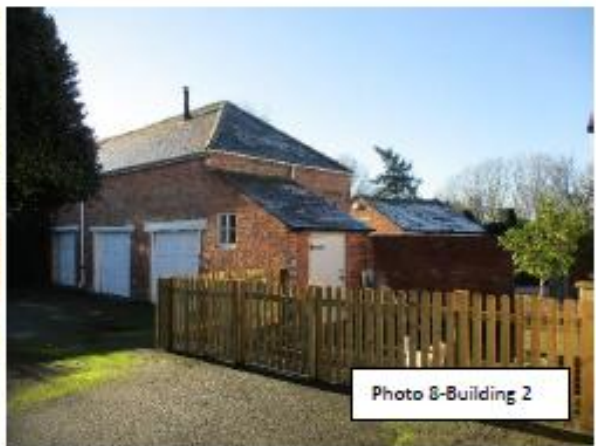
| Building Reference<br>(see Appendix 3) | Description | Suitability for<br>roosting bats |
|---|---|---|
| <b>B2</b> | <p>Brick built two-storey outbuilding currently used for leisure and storage (Semi-detached with southern half in neighboring property). Brick work in good condition with some superficial cracks. Majority of tiles in good condition with the exception of a few slipped tiles.</p> <p>No Evidence of bat presence noted during physical / endoscope searches.</p> <p>See Photos and Fig 4 below.</p> | <b>High</b> |

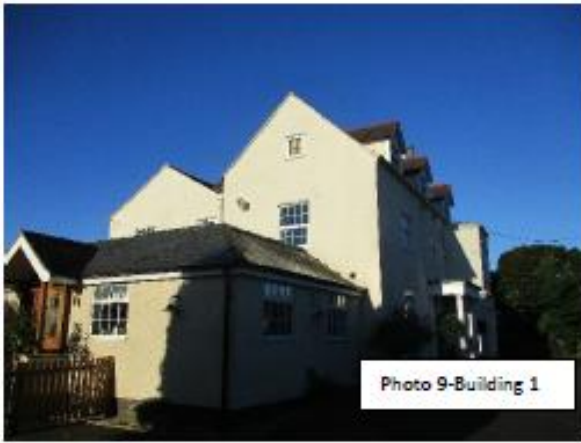
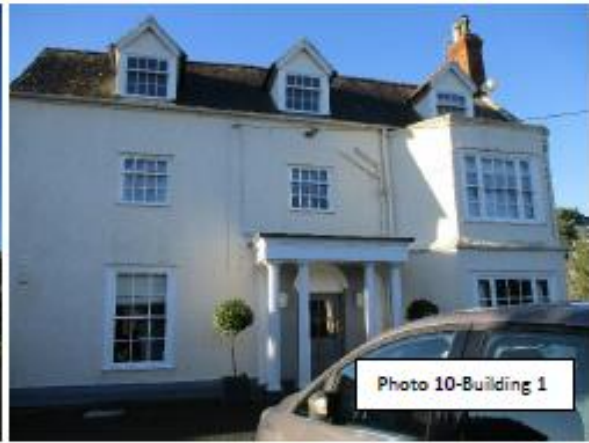
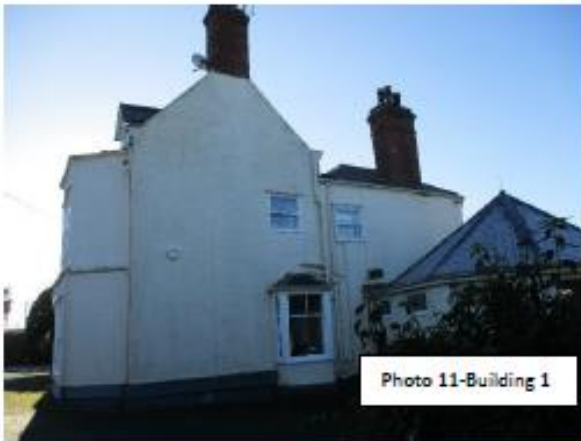
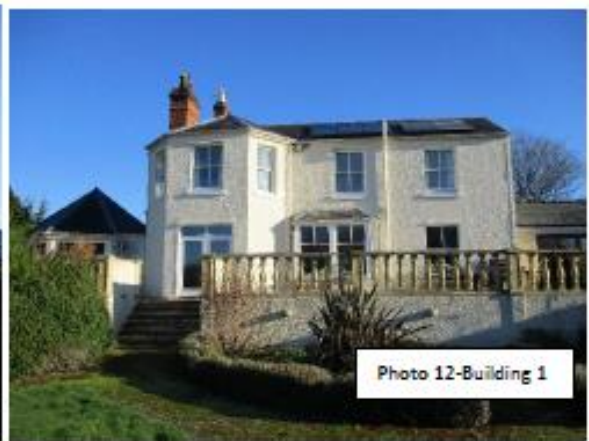
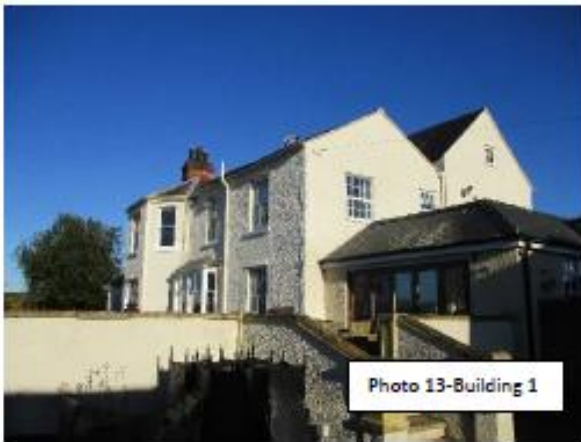
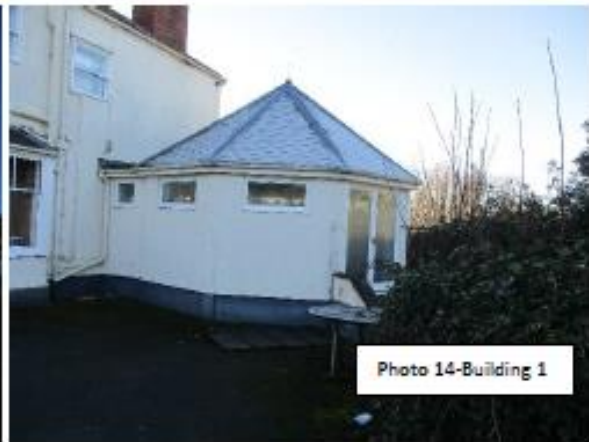
| Building Reference<br>(see Appendix 3) | Description | Suitability for<br>roosting bats |
|---|---|---|
| <b>B1</b> | <p>A brick built, rendered mid-19<sup>th</sup> century three-storey residential property (occupied) with tiled apex roof, with a single-storey extension to the south and conservatory to the north. Most brick work, tiles and soffits are in very good condition. Some slipped tiles and cracks in rendering noted giving possible access to bats.</p> <p>No Evidence of bat presence noted during physical / endoscope searches.</p> <p>See Photos and Fig 4 below.</p> | <b>Moderate</b> |

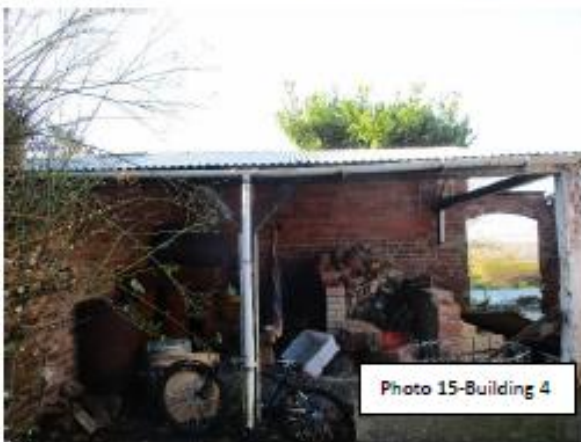
Photo 15-Building 4

| Building Reference<br>(see Appendix 3) | Description | Suitability for<br>roosting bats |
|---|---|---|
| <b>B4</b> | <p>Timber / brick lean-to with corrugated roof, used for storage. Completely open on 2 sides.</p> <p>See Photos and Fig 4 below.</p> | <b>Negligible</b> |
