Updated EcIA and Bat Survey at  
The Old Fire Station,  
Colliery Road, Chirk,  
Wrexham, Clwyd LL14 5PB  
GR SJ 29381 38063

On 18<sup>th</sup> August and 17<sup>th</sup> September 2021

Report completed 10<sup>th</sup> October 2021

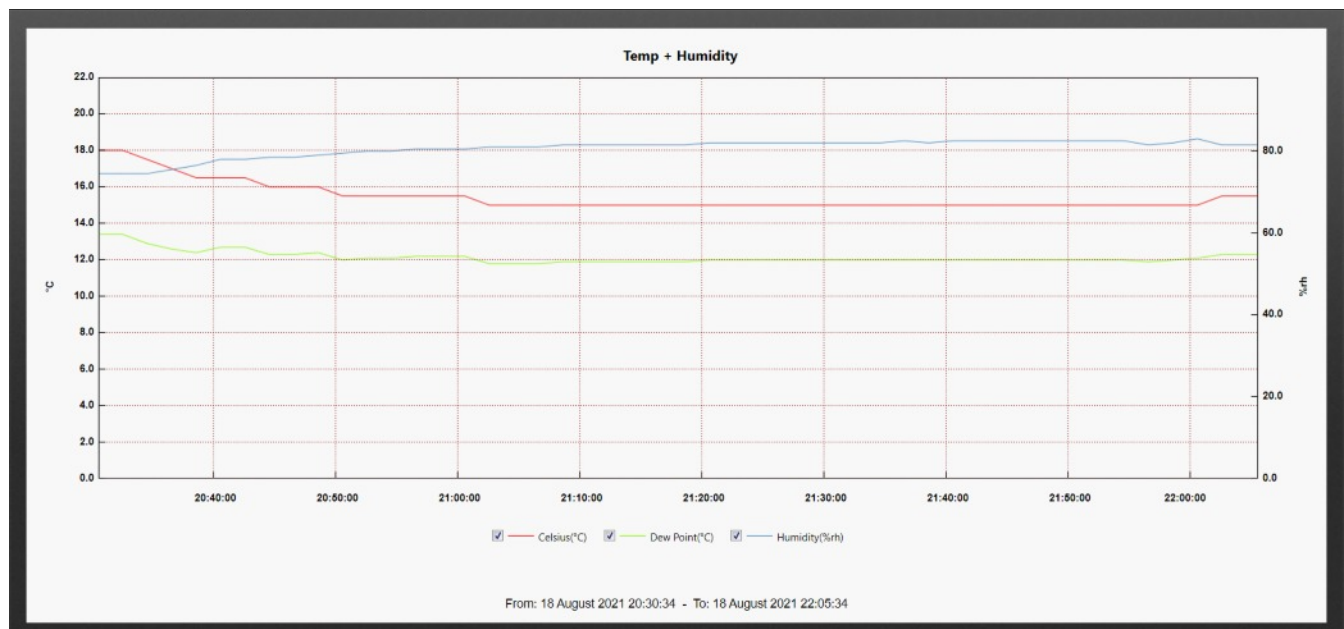
## Temperature and Humidity Chart

| Date | Sunset/<br>Sunrise | Start | End | Temp<br>Start °C | RH Start<br>% | Temp<br>End °C | RH End<br>% | Cloud % | Wind<br>0-6 |
| 18/8/21 | 20.33 | 20.15 | 22:10 | 18 | 74 | 15 | 82 | 90 | 1 |

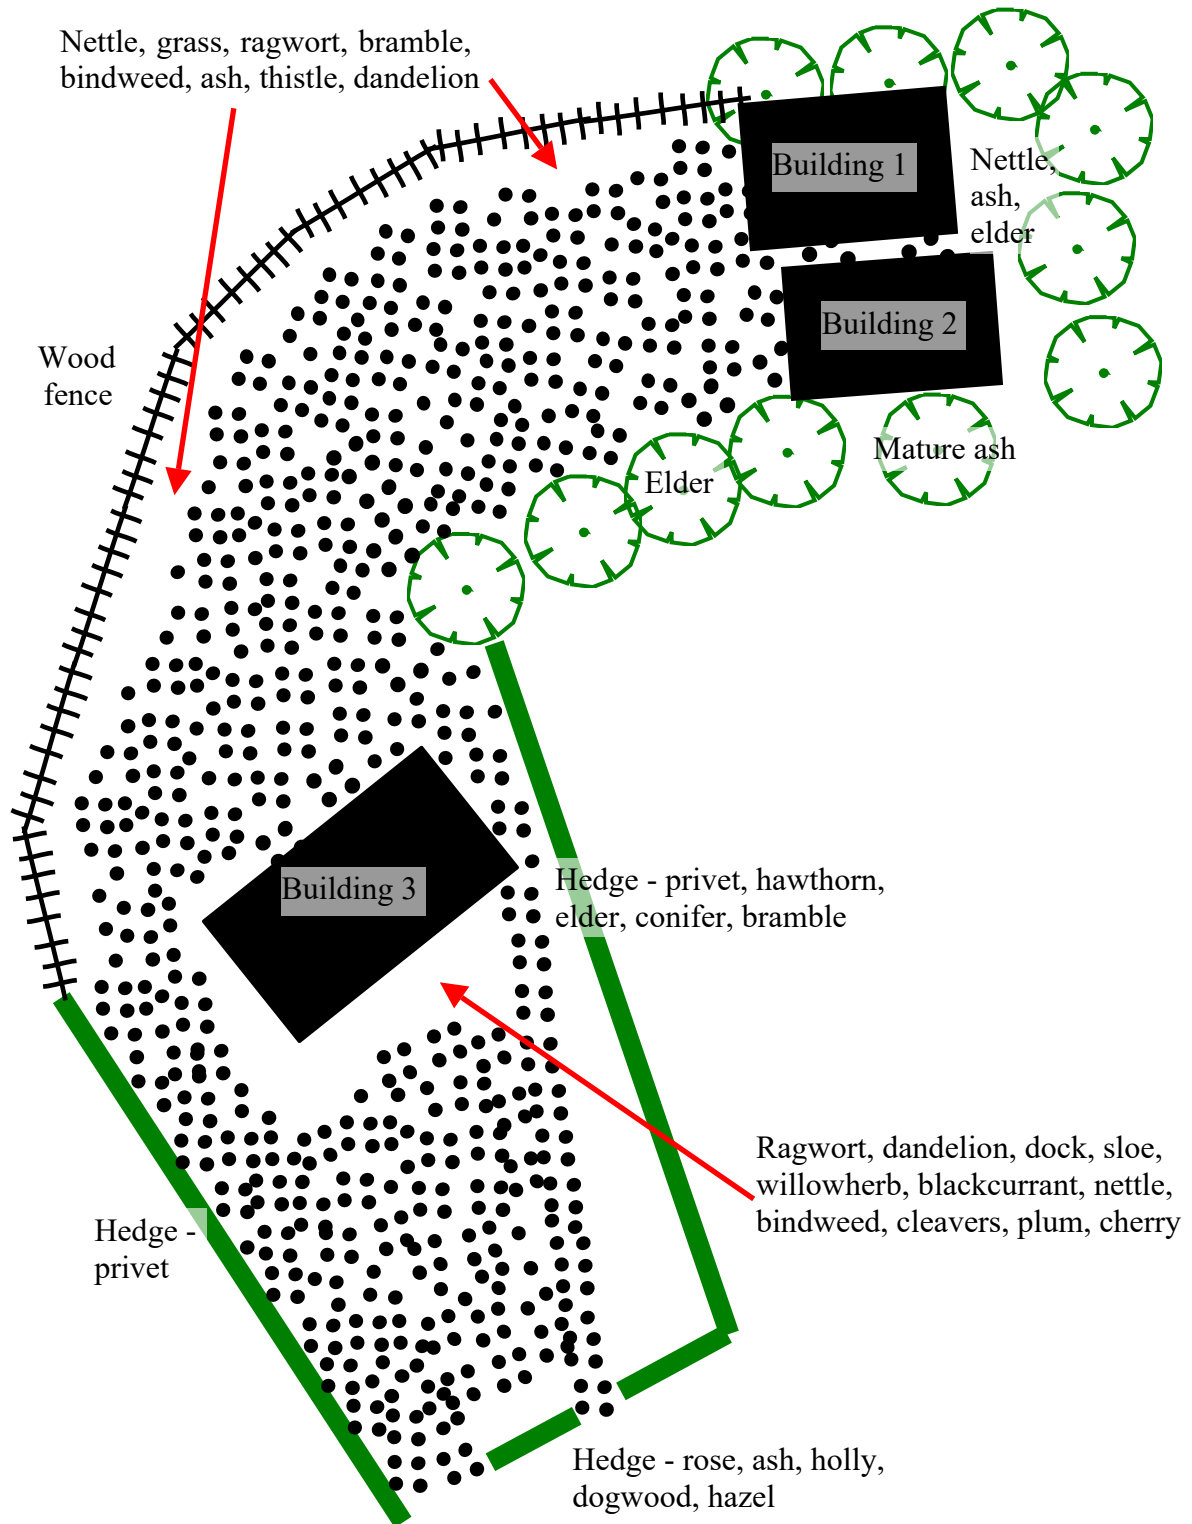
# Survey Diagram

*Observer 1:* SW; equipment: Peersonic RPA3; Station: north corner of building 3

*Observer 2:* CT; equipment : Peersonic RPA3; Station: south corner of building 3
