**The Elms, Darland Lane, Darland, Rossett, Wrexham, LL12 0BA**

**Further Bat Surveys**

**17<sup>th</sup> September 2021**

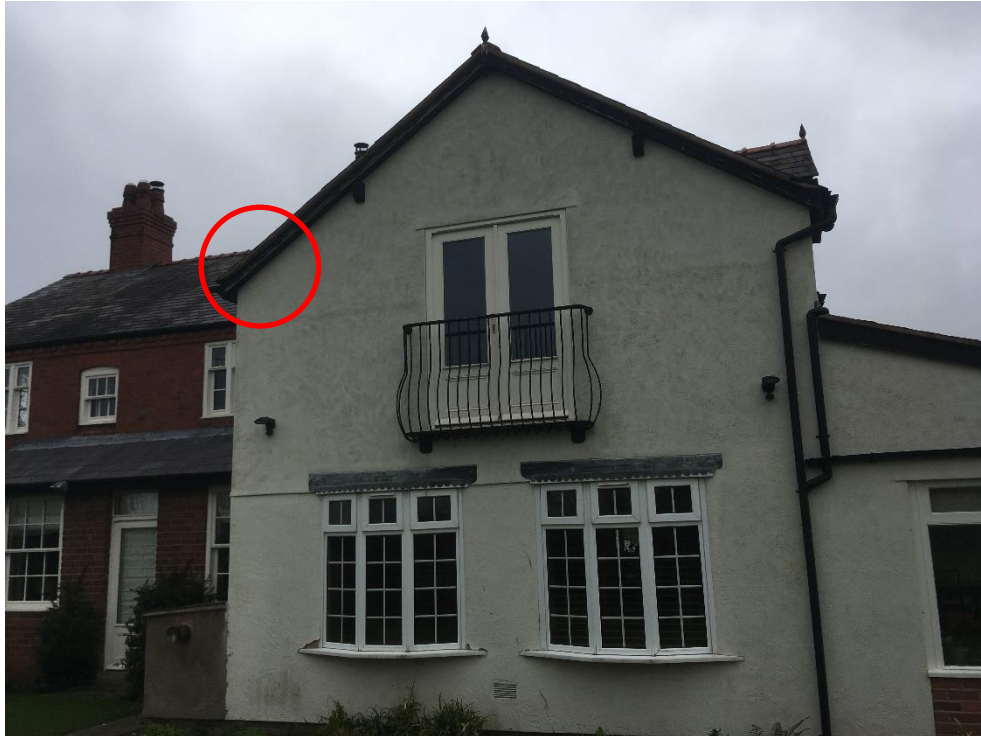
In summary, no bats were identified roosting within the affected parts of the building. However, a soprano pipistrelle bat was recorded roosting within an adjacent section of building. The bat was observed to enter a crevice in the mortar of an east facing gable at 06.18 (see Photograph 1 below and Bat Target Note 2 on Figure 1 for roost location). This section of the building will not be affected by works and so the roost will be retained and remain undisturbed. No other roosting bats were recorded.

*Photograph 1- Bat Roost Location within Unaffected Section of Building*

No roosting bats were identified associated with the affected sections of the buildings. A bat roost was identified within a gable end of the main house but this part of the building will not be affected by works and so the bat roost will be retained.

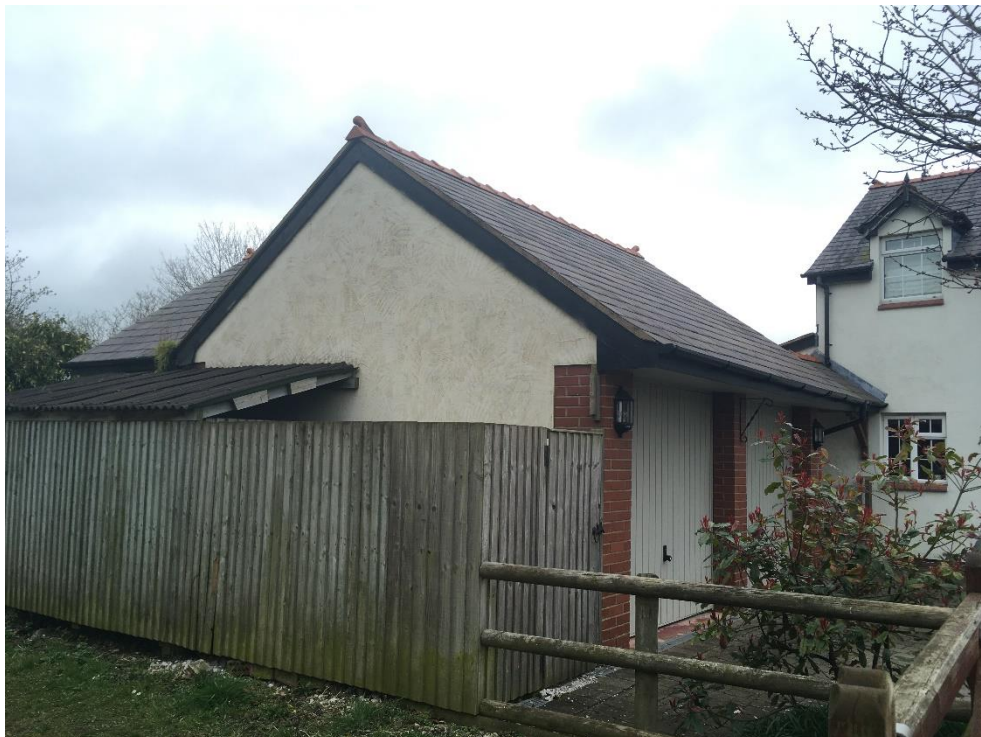
There is also a double garage building at the site. This is a relatively modern structure and is generally well sealed. However, there are some potential bat roosting features offered at the building's north facing gable where decayed verge mortar offers potential access between the roof slates and underfelt; and at the building's west facing gable where there is a narrow crevice between a length of fascia boarding. A single old bat dropping (likely from a pipistrelle bat species) was found behind the fascia boarding (Bat Target Note 1 on Figure 1 and Photograph 2). This dropping confirms that the gap has been used by roosting bats in the past.

A further search for bat droppings at the west facing garage fascia (Bat Target Note 1) was carried out following the dawn survey using a torch and endoscope. No bat droppings or other field signs indicative of recent bat activity were found. This search included both behind the fascia boarding and beneath the boarding.

The scoping survey undertaken in March 2021 had identified a single old bat dropping associated with the west facing fascia of the garage building (Target Note 1 on Figure 1). No bats were identified roosting at this location during the July and September dusk/dawn surveys and no additional bat field signs were found here following the further inspection in September.

*Photograph 2- Fascia Boarding to be removed by hand*

Nevertheless, it is recommended that care is taken during works, in particular the garage fascia boarding at Target Note 1 should be carefully removed by hand prior to demolition. If any bats or further evidence of bats are found, then works should immediately stop and further advice should be sought from an appropriately qualified ecologist.
