## **PROTECTED SPECIES SURVEY**

**BROOKSIDE COTTAGE**

**GARTH, LLANGOLLEN**

**31<sup>st</sup> January 2022**

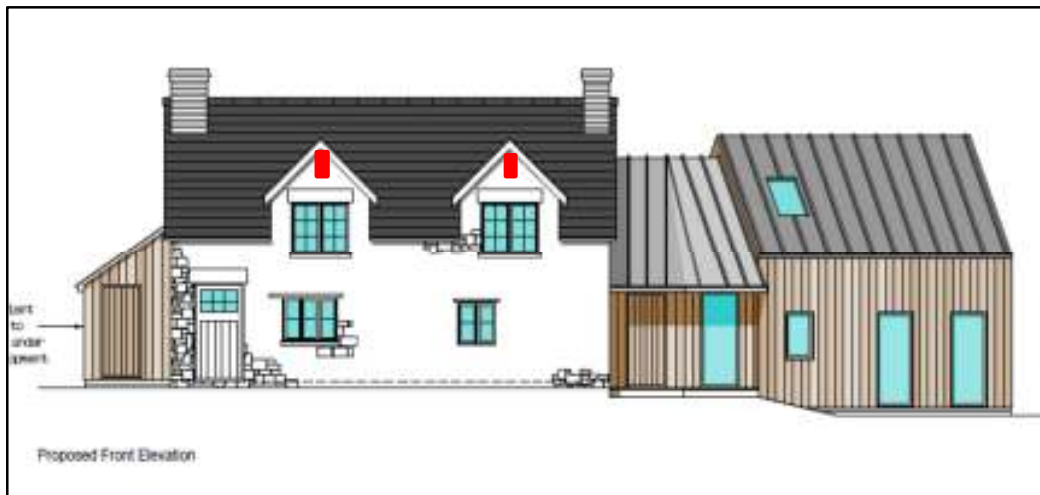
- A Beaumaris “midi” bat box will be secured to the south-west facing elevation above each dormer (two boxes total) as shown below.

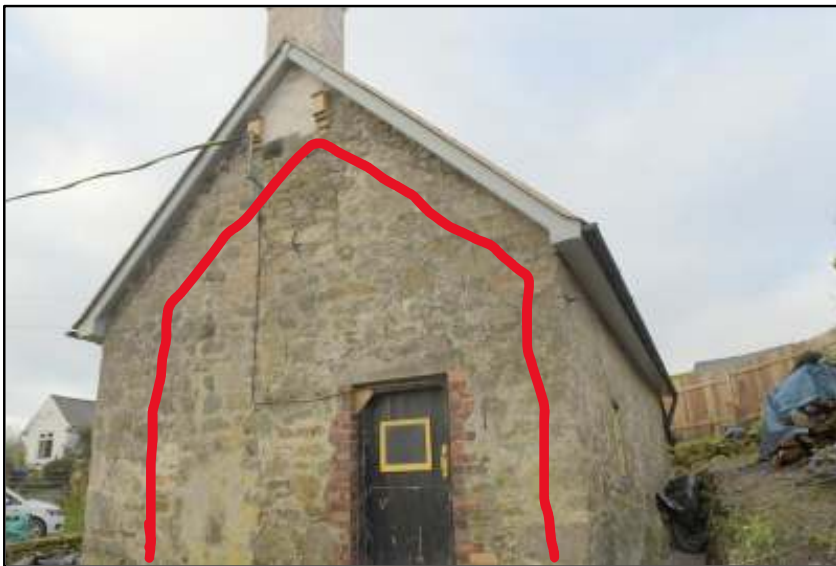
Side elevation where the extension will be constructed below the existing roofline, approximately as shown by the red line – the soffits/fascias on this elevation are all well sealed and the wall is well pointed

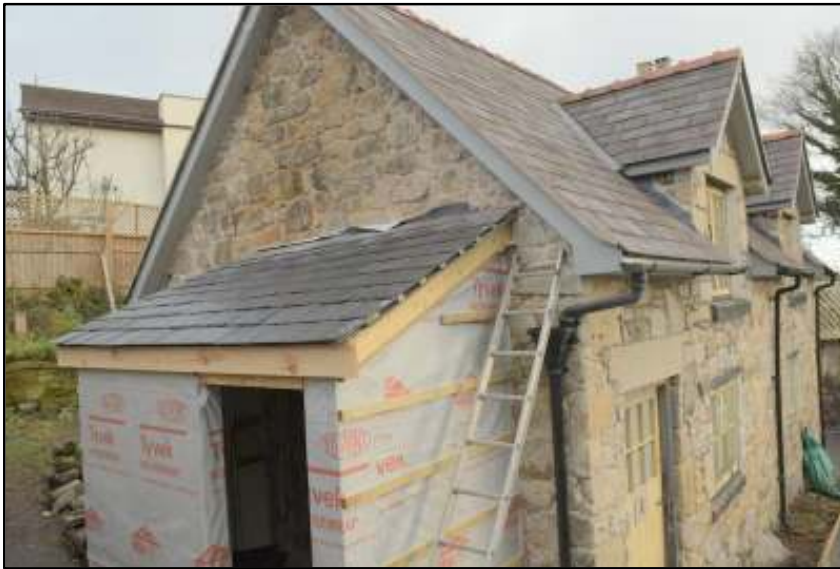
**Side elevation with small monopitch extension**

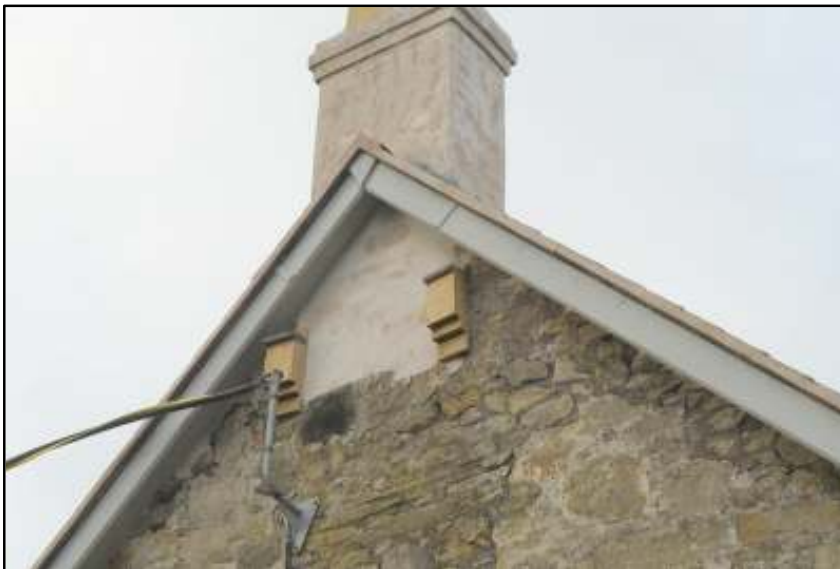
**Bats boxes already installed on the south-east elevation**

- Two well-made and very suitable timber bat boxes have already been installed on the south-east (side) elevation ridge area (as shown in the photos below).

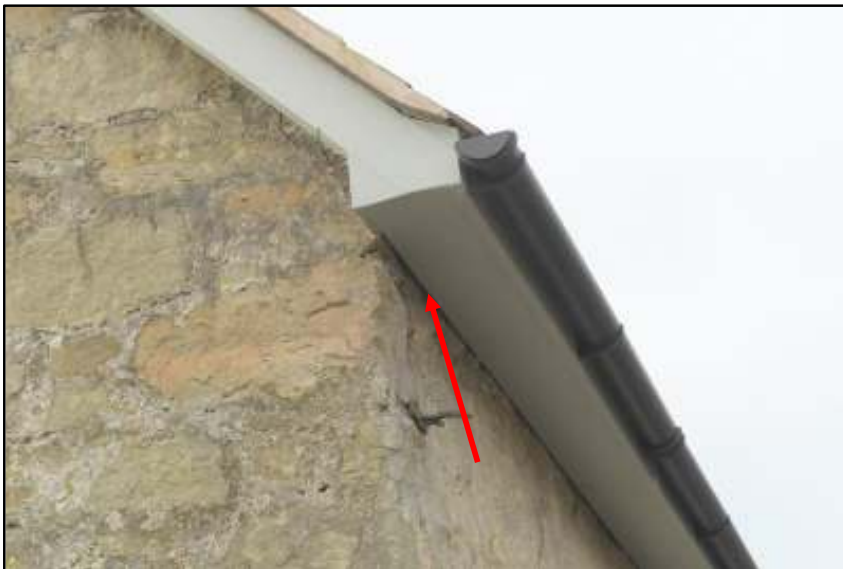
The fascias and soffits have all just been replaced and in most areas they are sealed and tight to the wall, including the south-east gable end where the new extension is proposed. There are a few gaps on the rear and also on the other end of the cottage where the walls slightly undulate which would allow access into the box cavity.

**Gaps along the soffits at the rear**

- Gaps have been left around the fascia/soffit edges on the rear and far end elevation (other end from the extension), these are all suitable for access by crevice dwelling bats.

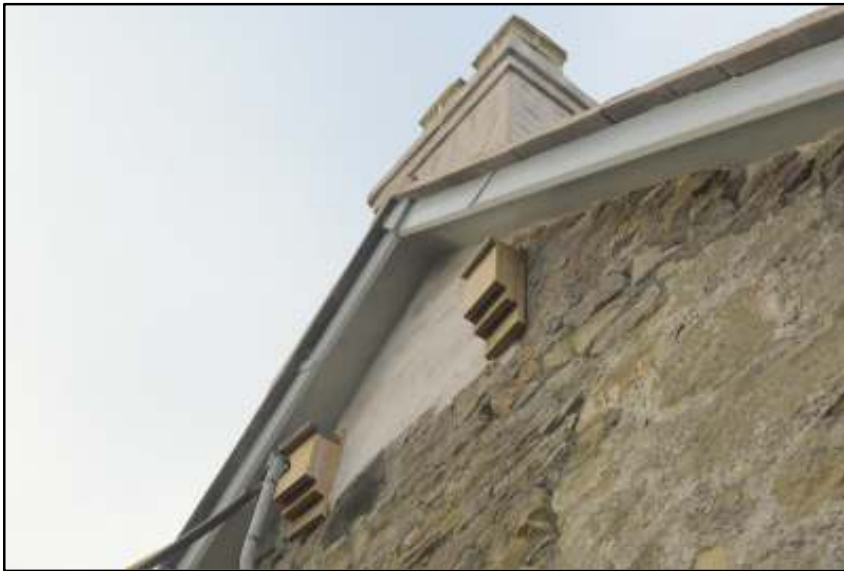
**Gable area is well sealed on the extension end**

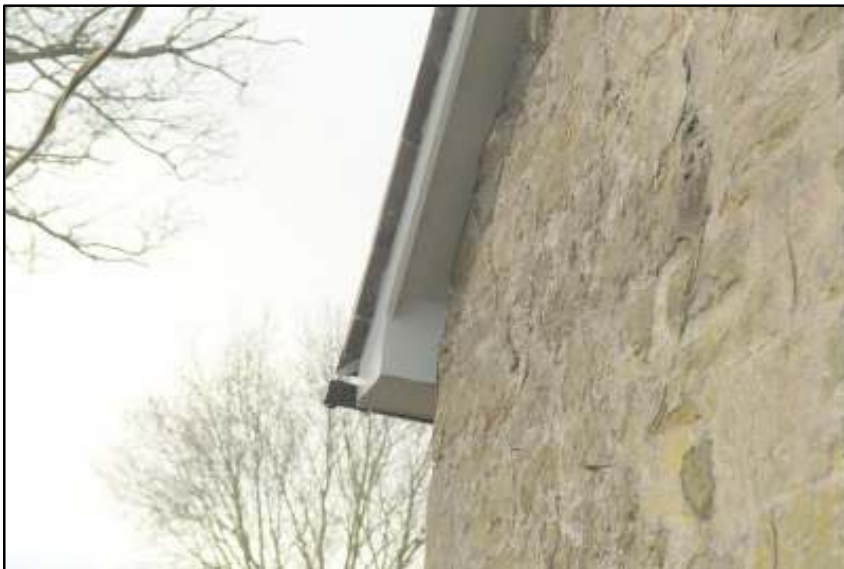
**Gable fascias are well sealed on the extension end**

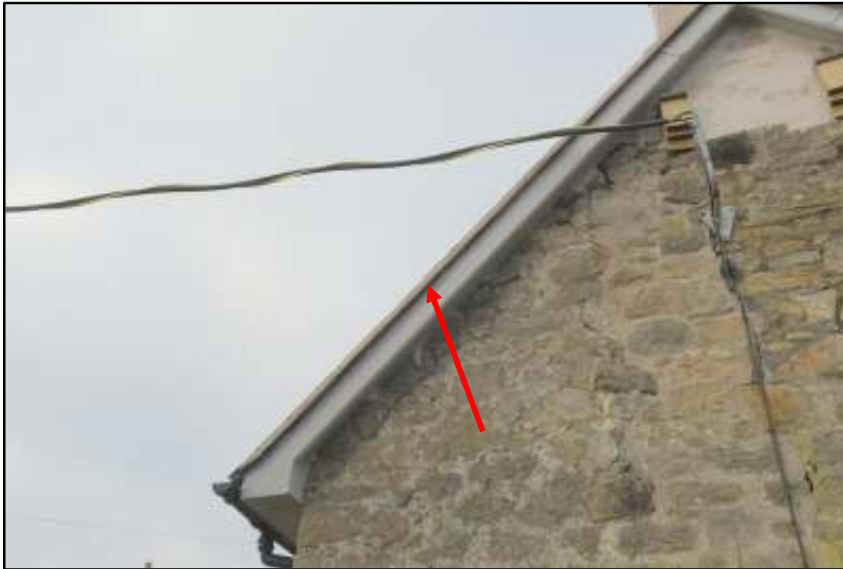
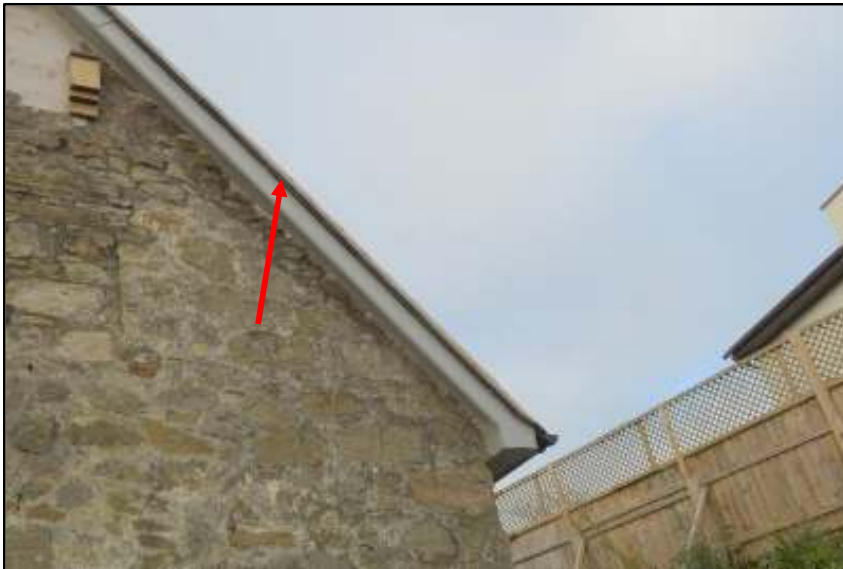
**Gable end wall where the extension is proposed is well pointed, mortar below the slate edge is all recent so no gaps**

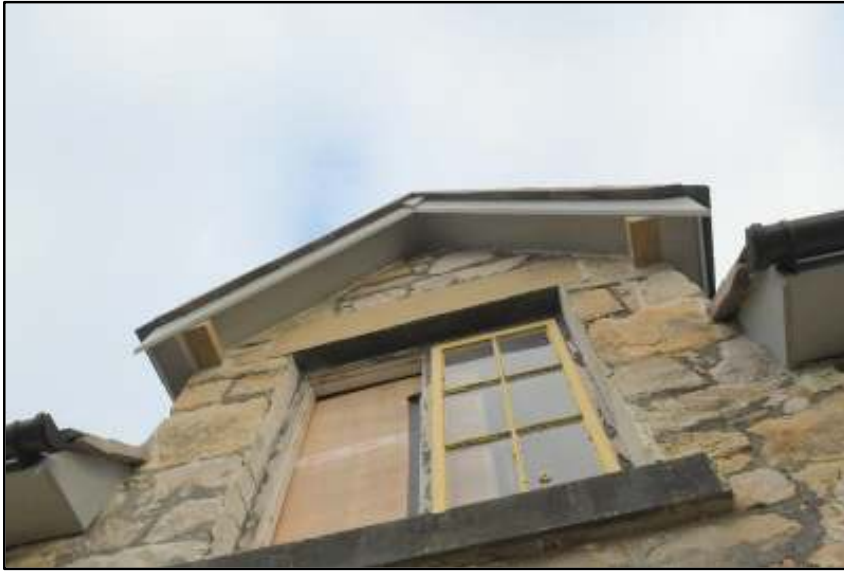
**Front dormers are well sealed**

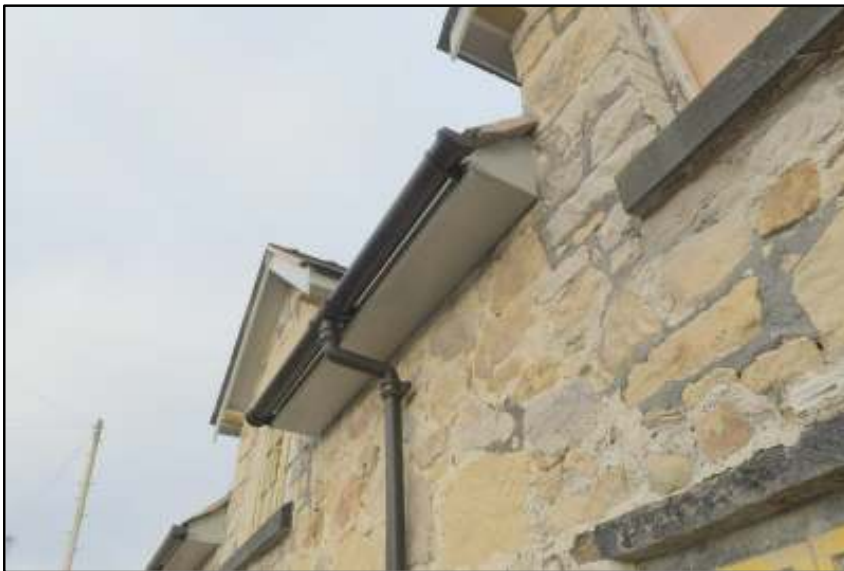
**Front soffit is tight to the wall**

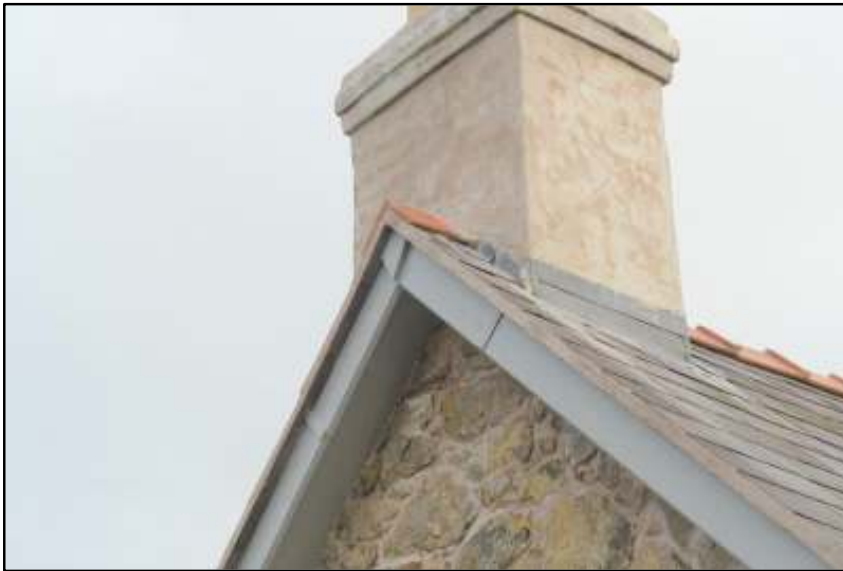
**West gable ridge is well sealed**

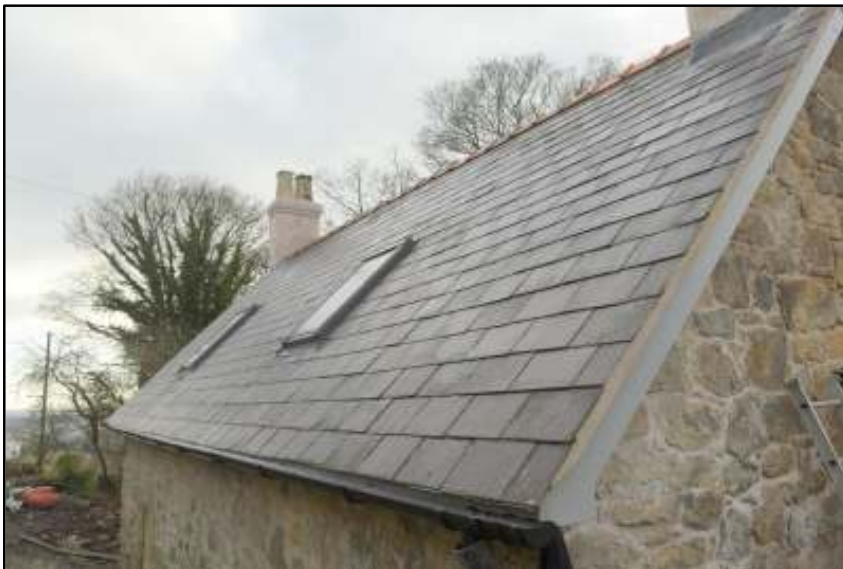
**Two Velux in the rear elevation**

- Blinds will be fitted to the Velux windows to reduce external light spill at night.

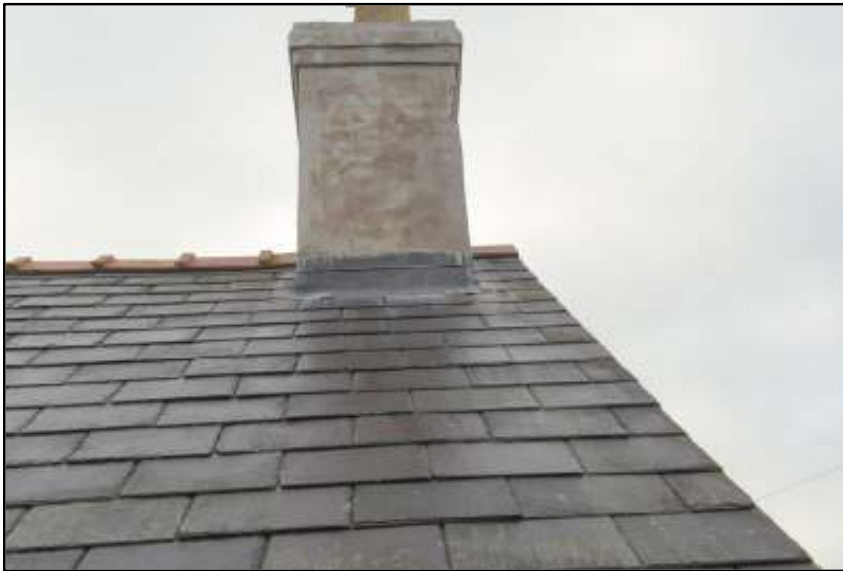
The roof has recently been completely replaced by the previous owner along with the ridge tiles and the inclusion of two Velux windows. The roof area is now completely sealed with intact mortar below the slate edge on each gable end.

**Roof has recently been re-slatted**

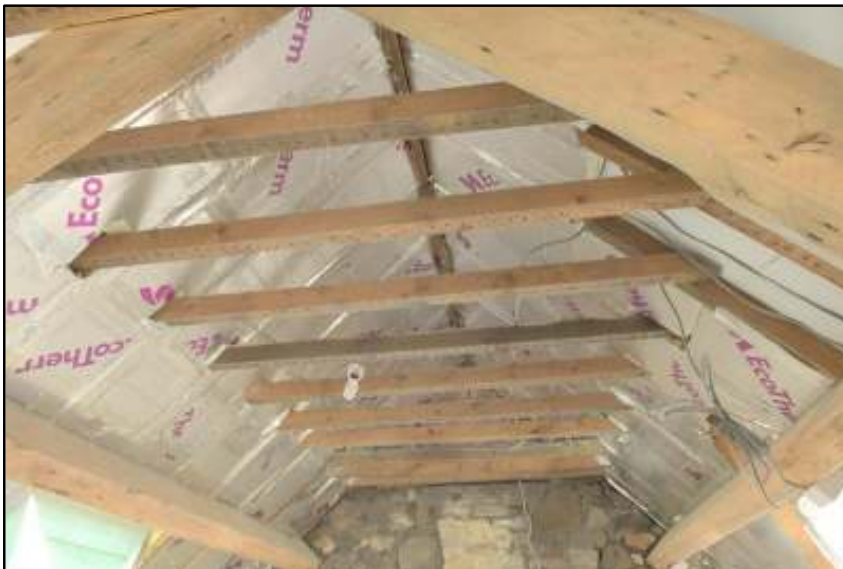
**Interior insulation, ceiling to be put back in**

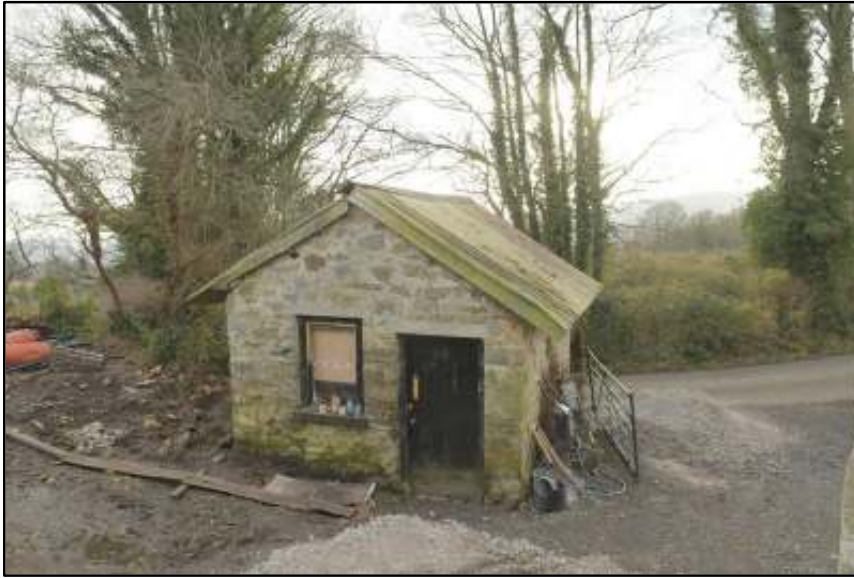
The small stone building in front of the cottage has a negligible potential for bats due to the roof being open with no loft, metals sheets with no insulation and walls with no large gaps or cavities.

**Small stone outbuilding with metal roof**

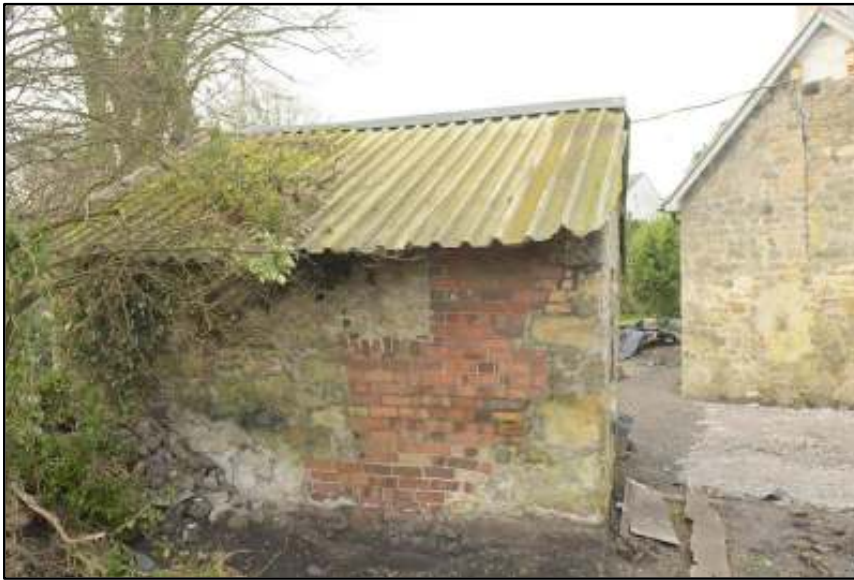
**Side elevation with brick repairs**

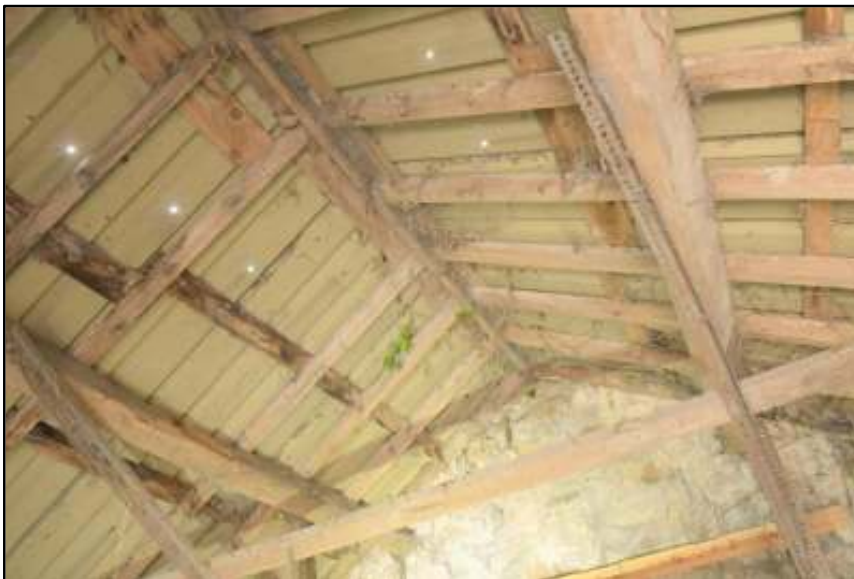
No evidence of bats was found in this building, no droppings, feeding remains, marks or stains. The interior is all exposed with a metal sheet roof and all areas including the tops of the walls at eaves level can be viewed. The walls are well pointed and there are no visible holes or cavities.

**Interior all open and light**
