## GeoEnvironmental Investigation

Ruabon Park  
Wrexham

February 2018

**Report Ref: A2352/18**

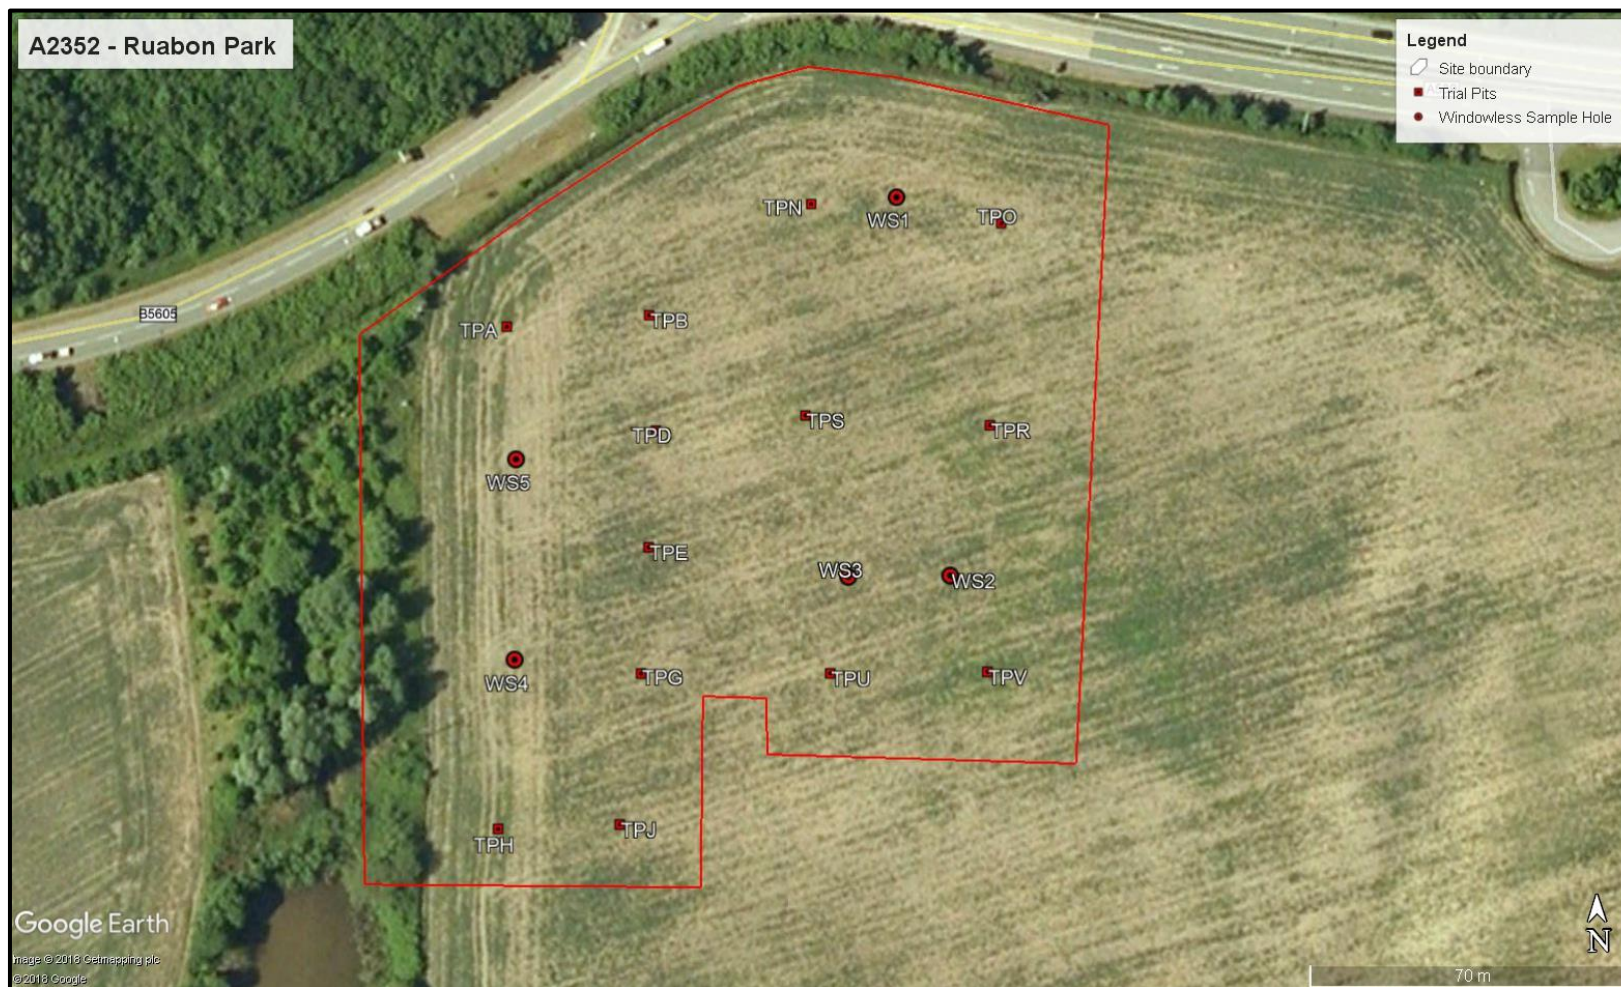
Figure 12 Exploratory Hole Location Plan

- Five window sample boreholes (designated WS1 to WS5 inclusive) were each sunk to depths of between 4.0m and 6.0m below existing ground level. Window sampler boring is carried out with a small, track-mounted rig, which uses a chain-driven trip hammer to drive sampling tubes or penetrometers into the ground. These tools are coupled to the anvil of the hammer by solid drill rods. Sampling tubes comprise “windowless samplers”, which are plain sampler tubes in which a continuous disturbed sample is recovered within a semi-rigid plastic liner. In order to reduce friction within the borehole, sampling tubes of progressively smaller diameter are used as the borehole depth increases. Sampler diameters generally range from between approximately 90mm to 50mm. Standard Penetration Tests (SPTs) were undertaken in the boreholes in accordance with BS EN ISO 22476-3. Exploratory Hole logs are included in Appendix 1.

13 Trial pits (designated TPA, B, D, E, G, H, J, N, O, R, S, U and V) were excavated to a depth between 2.0m and 3.m below existing ground level, using a wheeled excavator. Representative disturbed samples were recovered from the excavated material as pitting proceeded. In situ soakaway testing was carried out in the base of the Trial Pit B, D, G, O and R, in accordance with the methods described in BRE Digest 365<sup>(2007)</sup>, the results of which are included in Appendix 2. The trial pits were backfilled immediately on completion of sampling and testing.
