# Bat Mitigation Report

Ysgol y Hafod, Wrexham

Wynne Construction

September 2021

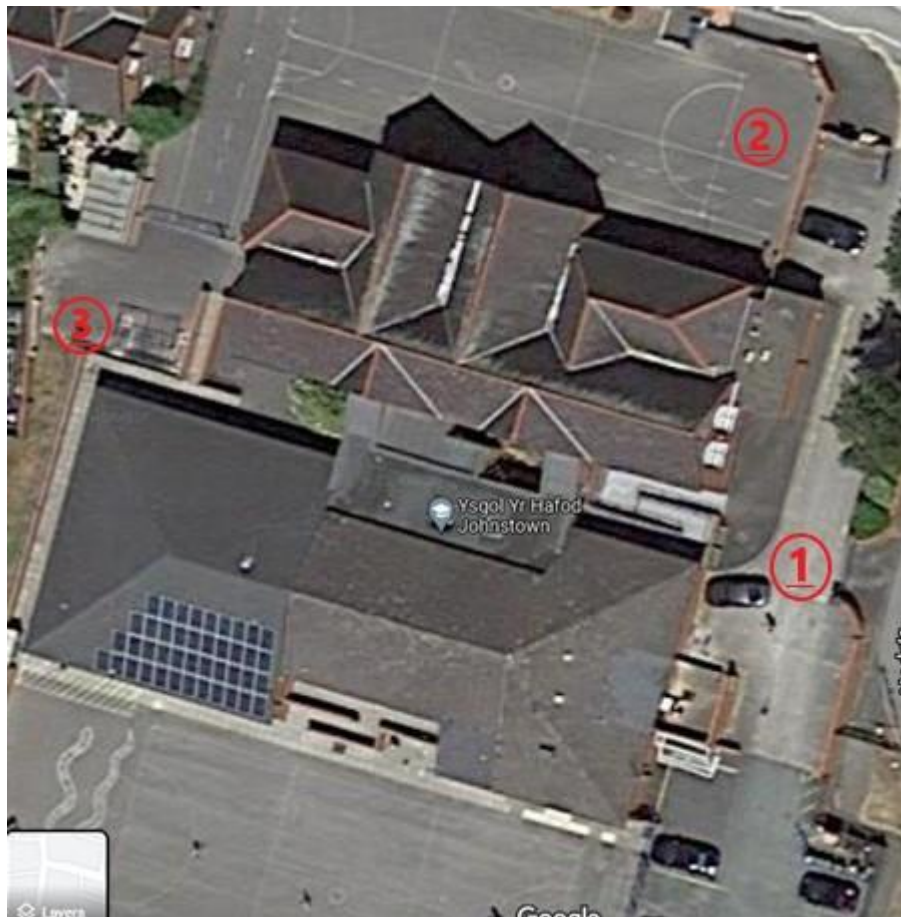
**Figure 1: Surveyor locations for 2021 surveys**

Based in the external PBRA, the features were covered by three surveyors, positioned as shown in the image overleaf.

Surveyor 1 was positioned on a corner between the east-facing aspect of the original school building and the south-eastern end, affording sight of louvre windows, and loose slates in the roof and missing mortar on the gable end.

Surveyor 2 was positioned in the eastern end of the front playground, offering visibility of the front of the school building, with focus on louvre windows, gaps in the lead flashing, missing mortar and slipped slates.

Surveyor 3 was positioned on the western corner of the old school building. This afforded visibility of a partly boarded-up louvre window and gaps in the mortar on the eastern gable end, and on the south-western elevation, slipped slates on the dormer and a further louvre window.

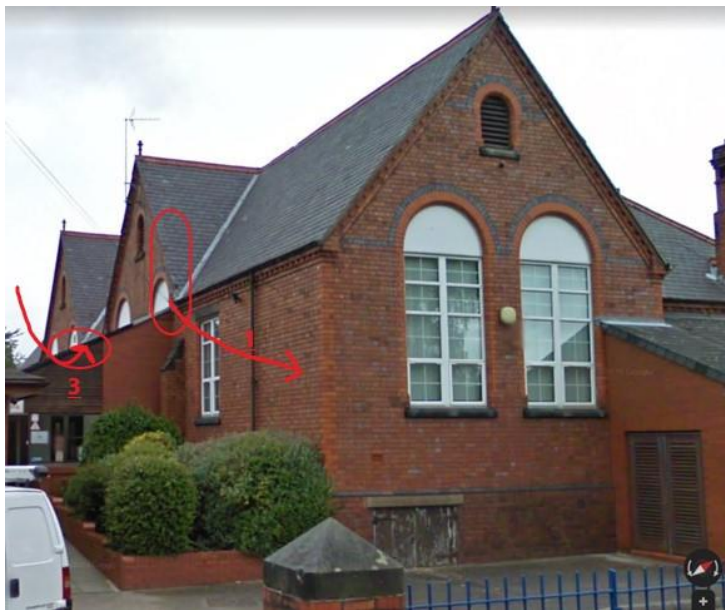
**Figure 2: Roost locations**

On the first bat survey, which was a dusk emergence survey, one soprano pipistrelle *Pipistrellus pygmaeus* emerged from the south-eastern elevation of the building, observed by surveyor location 3 at 20:42. This bat was heard and not seen, but appeared to emerge from the original school building close to the dormer-style roof structure as shown in the image overleaf as number 1. There was one other foraging bat (common pipistrelle) recorded at 21:51 along the tree line to the rear of survey location 3. No other bat activity was recorded during the survey.

During the final dawn survey, one pipistrelle was recorded re-entering at location 3 under the lip of the felt roof at the front of the building at 06:31. This bat emitted social calls whilst circling before re-entering the roof. It did not echolocate a traditional call to enable it to be identified as either a soprano or common pipistrelle, therefore it has been described as a pipistrelle for this reason. Further pipistrelles were recorded commuting and foraging in small numbers during the survey.

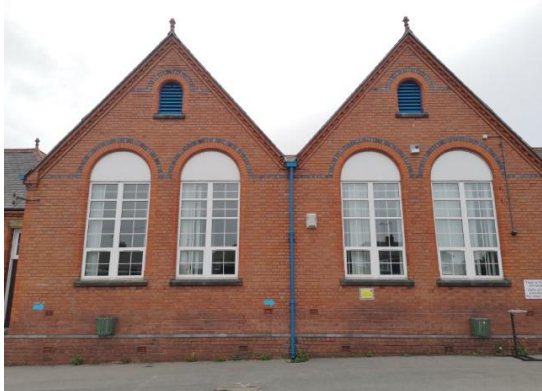
| Description | Images |
|---|---|
| <p>Front north—facing elevation of original school building showing slatted louvres which lead into the loft space</p> | |

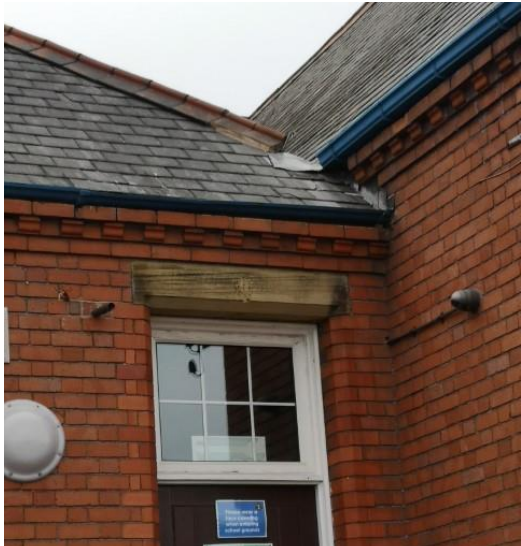
| Description | Images |
|---|---|
| <p>Small gaps beneath lead flashing where front section of building meets a different roof section</p> | |

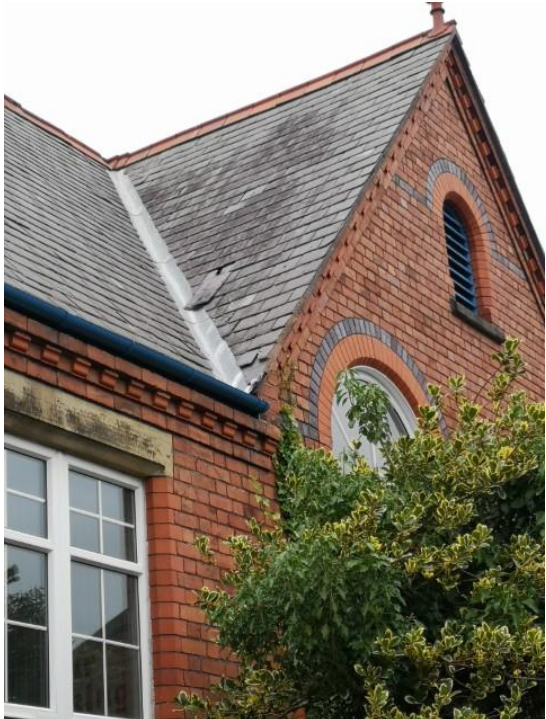
| Description | Images |
|---|---|
| <p>Slipped slates on the rear, southern elevation and louvre window observed by surveyor 3</p> | |

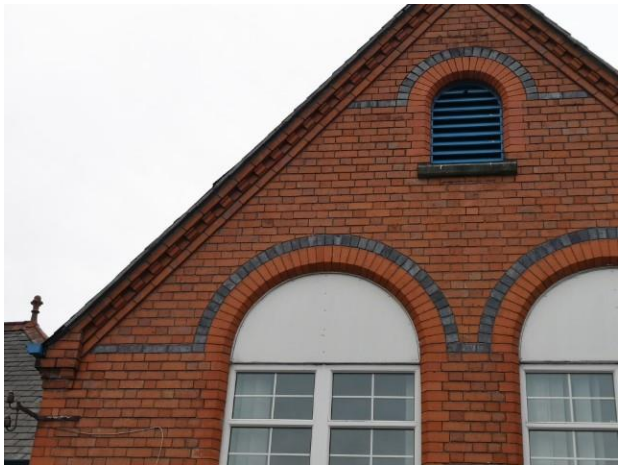
| Description | Images |
|---|---|
| <p>Eastern elevation showing louvre window into loft space and gaps in mortar along roof line</p> | |

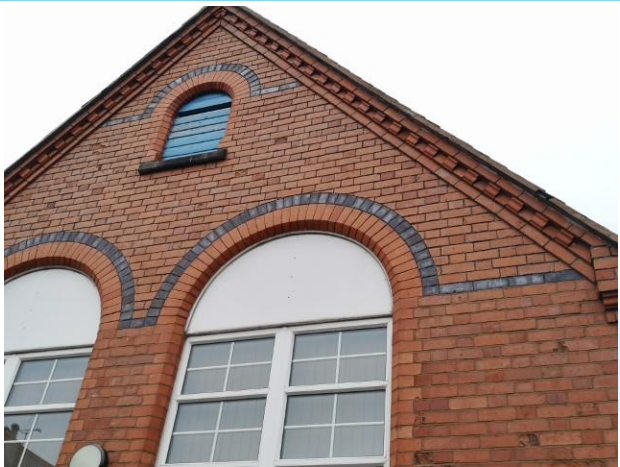
| Description | Images |
|---|---|
| <p>Partially boarded up louvre window into loft space on western elevation of original school building</p> | |

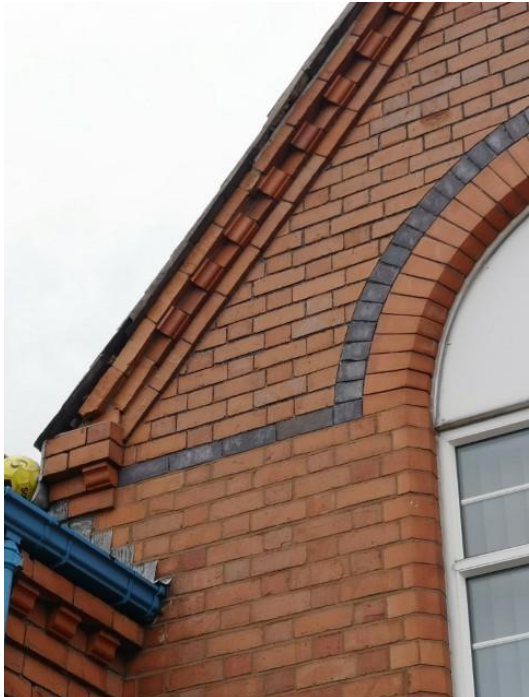
| Description | Images |
|---|---|
| <p>Close up example of missing mortar where roof line meets wall</p> | <p>A close-up photograph of a brick wall and roofline. The bricks are reddish-brown. There is a visible gap in the mortar where the roofline meets the wall, indicating a structural issue. A blue downspout is visible on the left side of the wall.</p> |

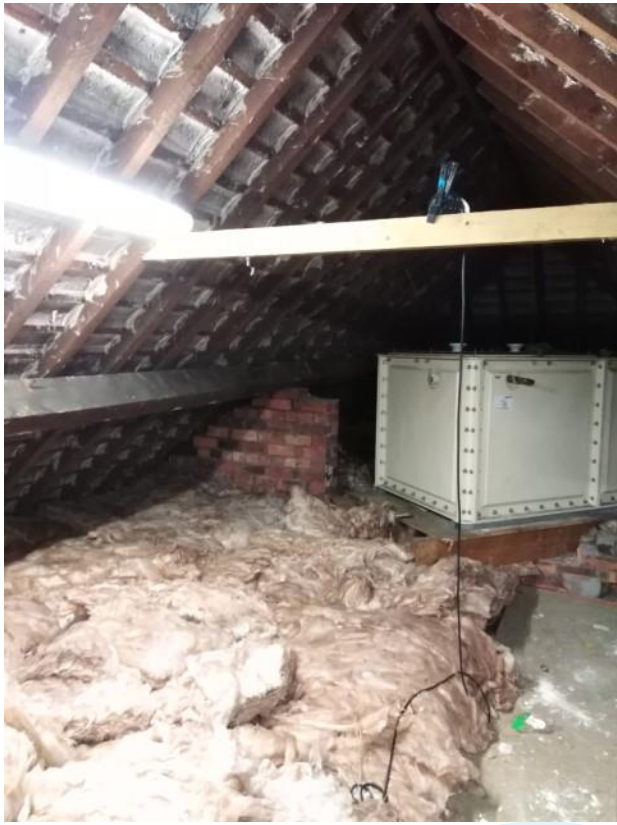
The roof itself appeared to be in reasonable condition internally, with no daylight visible between the lath and plaster. However, the Caretaker mentioned that there are frequent leaks from the roof into the school during bad weather.

| Description | Images |
|---|---|
| <p>Internal loft space in original school building showing lath and plaster lining beneath the slate roof and strip lighting</p> | <p>An interior photograph of a loft space. The ceiling is made of dark wooden beams with lath and plaster lining. A strip of white lighting is visible on the left. The floor is covered with a layer of brown insulation or debris. A white metal box or unit is visible on the right side.</p> |

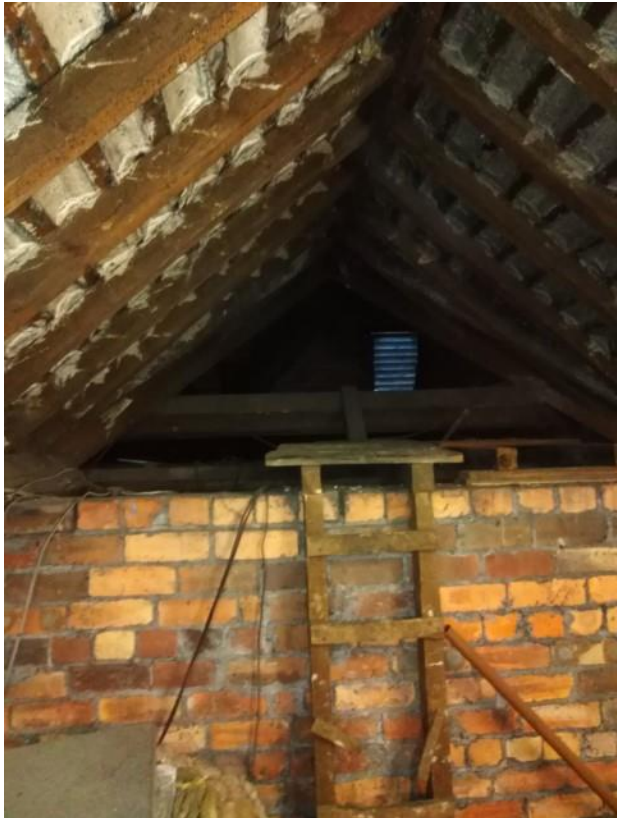
| Description | Images |
|---|---|
| <p>Raised section of loft space accessed by ladder with no boarding. Light from louvre window can be seen in distance</p> | |

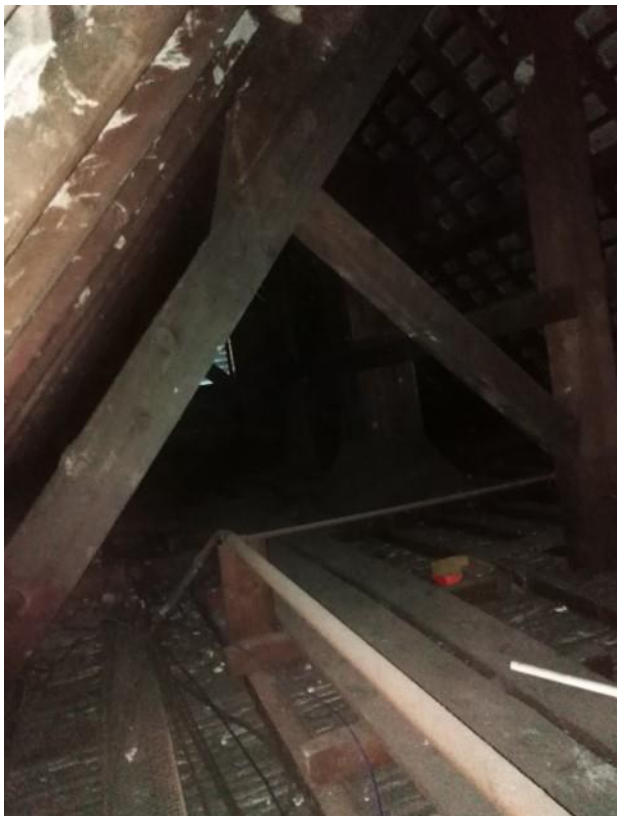
| Description | Images |
|---|---|
| <p>Image into adjacent loft space showing partial boarding and exposed ceiling beneath. Direct access was not made in this area.</p> | |

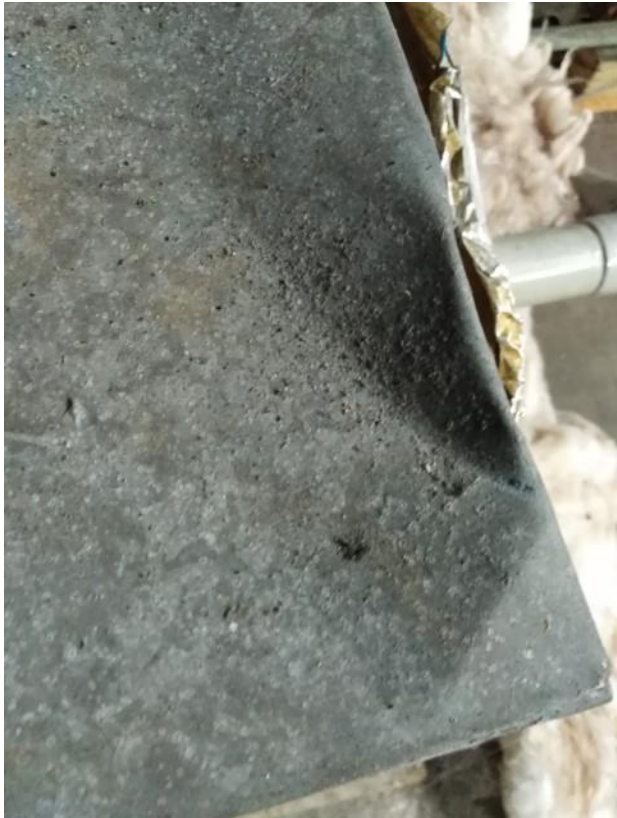
Small numbers of old bat droppings were found on some of the raised surfaces within the loft, but no new droppings. It is possible these were of a similar age to those discovered by Marches Ecology in 2019.

| Description | Images |
|---|---|
| <p>Dust and disintegrated historic bat droppings on top of water tank in loft space</p> | |

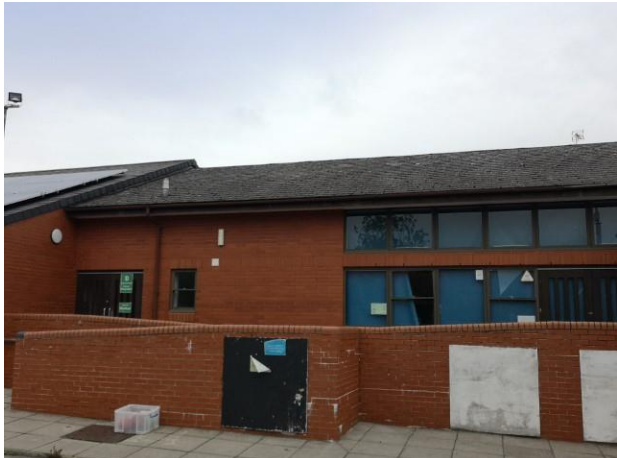
The rear building at the school is a newer extension. It is a single storey building constructed of red brick with a shallow pitched tiled roof with solar panels on the western end. It is of modern construction and in good condition, with a well-sealed roof and the fascias and soffits largely intact. Small gaps in the soffits were noticed where the wood had bowed slightly, however these were covered in cobwebs and subject to night-time illumination due to nearby lighting on the wall beneath the roof.

| Description | Images |
|---|---|
| <p>Newer rear extension showing modern construction and gently sloping roof</p> | |

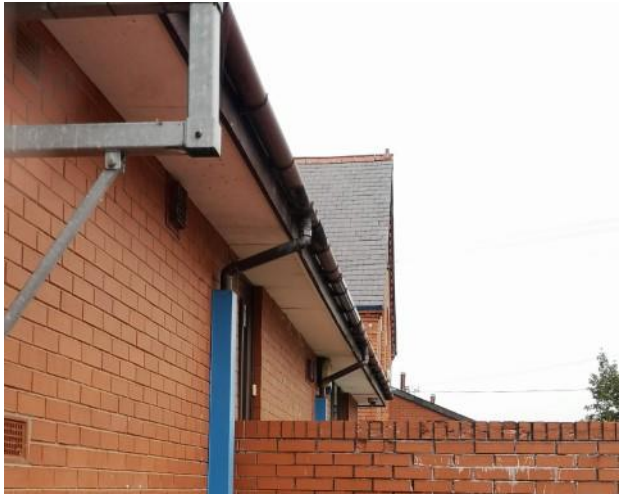
| Description | Images |
|---|---|
| <p>Image to show boarding below roof line with no gaps</p> | |

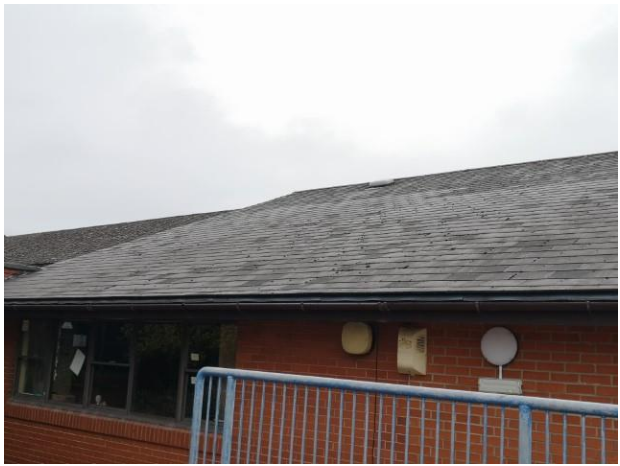
| Description | Images |
|---|---|
| <p>Lighting positioned on wall directly beneath the roof, illuminating the small gaps between the soffits</p> | |

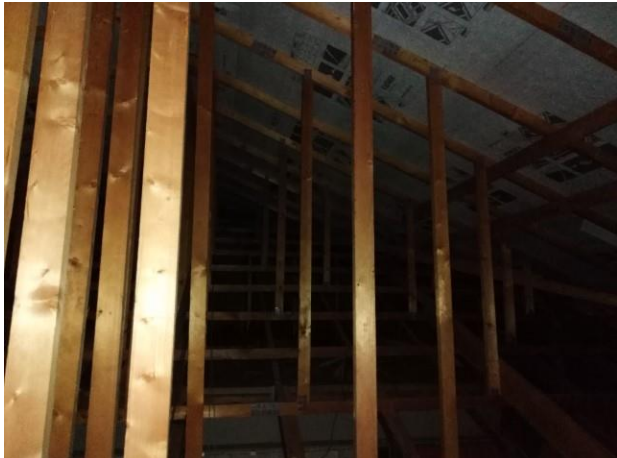
Internally, two roof spaces were accessed in the newer school building. The internal roof was in good, clean condition with intact insulation and felt. No evidence of bats or access points into the roof were noted.

| Description | Images |
|---|---|
| <p>Internal loft space in newer extension</p> | |

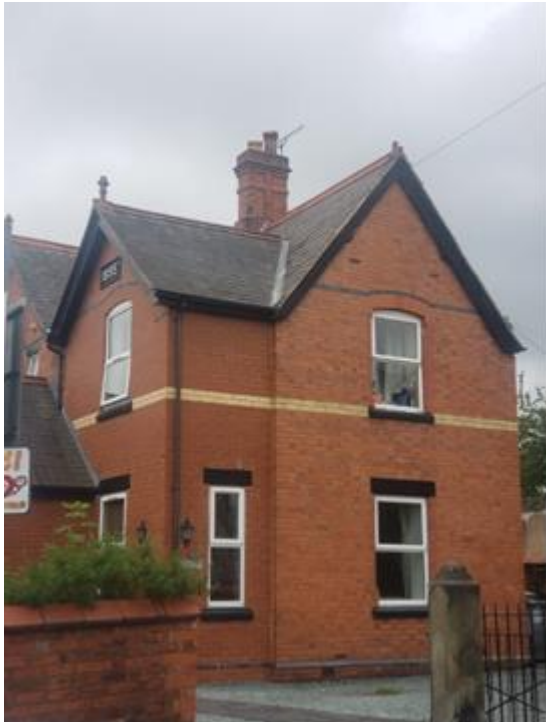
The Old School House is a two-storey building built of red brick construction and with a pitched slate roof. The roof of the Old School House was in generally good condition. Some small gaps were noted beneath lifted tiles but these were only occasional.

| Description | Images |
|---|---|
| <p>Old school House with relatively good condition roof.</p> | |
