# WLYFA, BOWERS ROAD, ACREFAIR, LL14 3TF: BAT AND NESTING BIRD SURVEYS

Report Ref: EE.914.21.JF

## Executive Summary

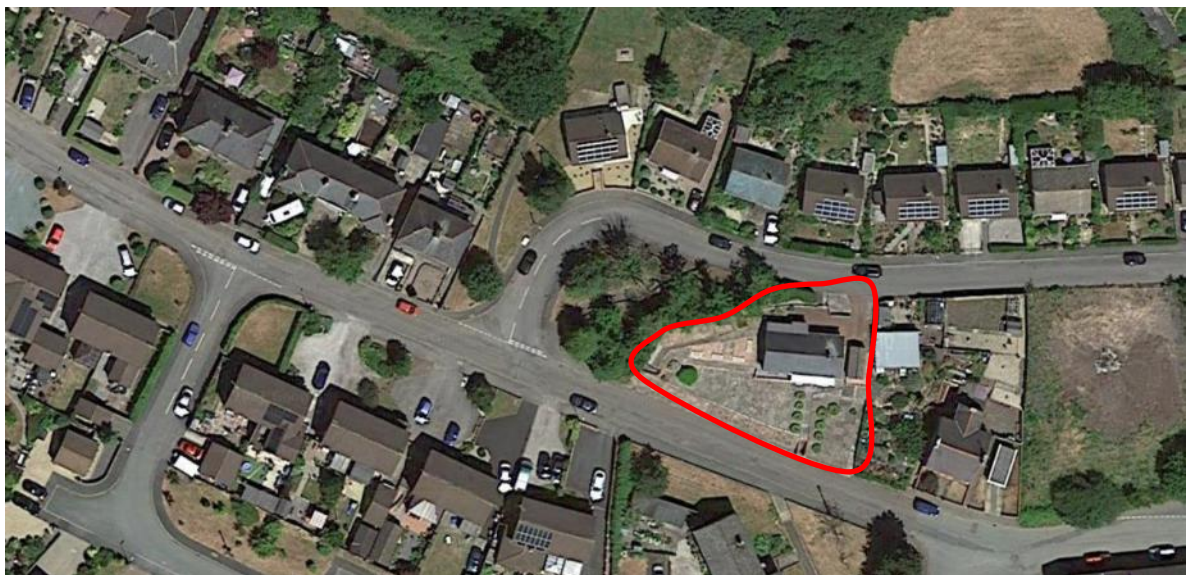
**FIGURE 2.1. THE SITE AND SURVEYED BUILDING (RED). BASE IMAGE © GOOGLE 2021**

The site contains a bungalow and small outbuilding in an urban environment in the village of Acrefair. The nearest town is Llangollen, which lies approximately 6.5km to the west. The property is set just off Cae Bedw, with the main parking area situated to the north of the property. The rest of the plot consists of concrete slabs to the south and red tiling to the west. The property is surrounded by other houses on each boundary, and there is a small group of trees to the west of the property. The next closest building is within 20 metres. The survey area is shown in Figure 2.1.

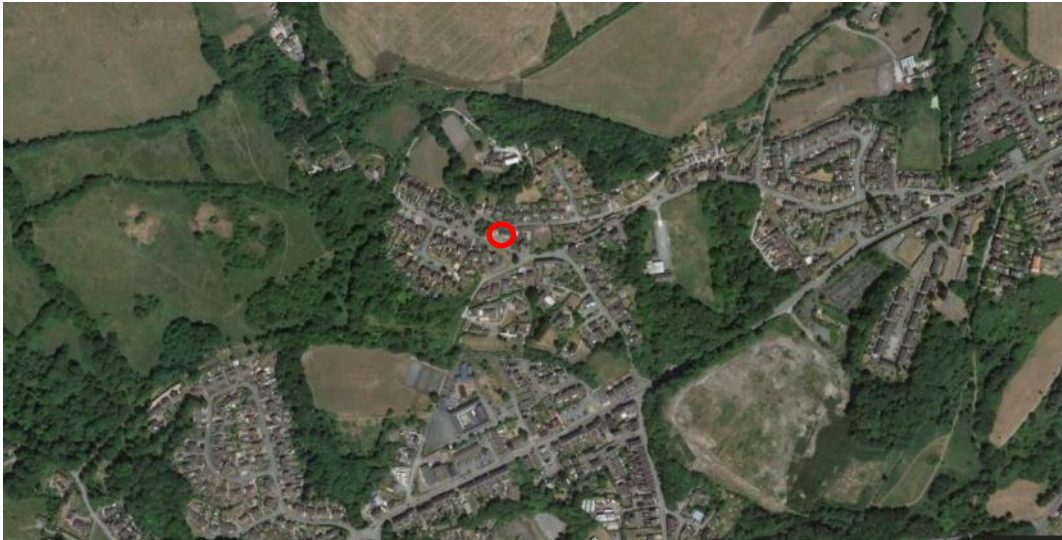
**FIGURE 2.2. THE WIDER LANDSCAPE - THE SURVEY SITE IS SHOWN BY RED CIRCLE. BASE IMAGE © GOOGLE 2021**

2.1.2 The wider surrounding area consisted of pastoral farmland to the north, northeast, and west (185-260 metres away). The north-eastern farmland contains a small body of water (400 metres away). The rest of the farmland contain small areas of woodland. The woodlands are connected in most cases, however, there are sections of missing hedgerow in the northern pastures. This is shown in Figure 2.2 below.

To the east, the environment remains consistent with the immediate area shown above in Figure 2.1. The south is mainly built up with residential properties and gardens with woodlands to the southeast and southwest at approximately 120m and 205m away

respectively. This is shown in Figure 2.2 below. There are adequate features for bats to use for commuting to and from the site, such as the roads, sections of woodland, and hedges.

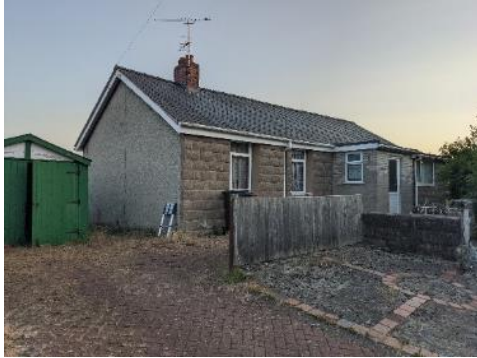
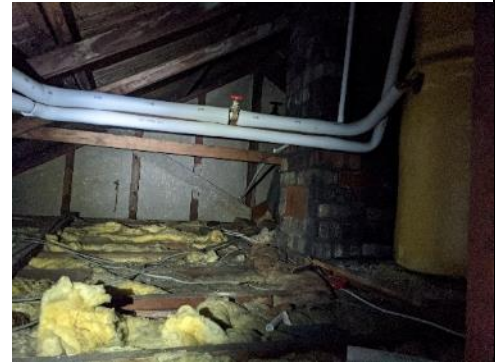
| Main Bungalow | | | |
|---|---|---|---|
| <p>Walls were split faced concrete blocks, with gable ends rendered with pebble dash.</p> <p>Concrete block porch with bitumen roofing felt on northern elevation.</p> <p>Double pitched roof with slate tiles and ridge tiles; one red brick chimney.</p> <p>Plastic fascias, soffits and barge boards.</p> | <p><b>NORTHERN ELEVATION</b></p> | <p>Entire loft space approx. 13m x 6.3m x 1.7m high.</p> <p>Gable walls clad in fibre cement board.</p> <p>Wooden roof frame and old insulation across floor.</p> | |

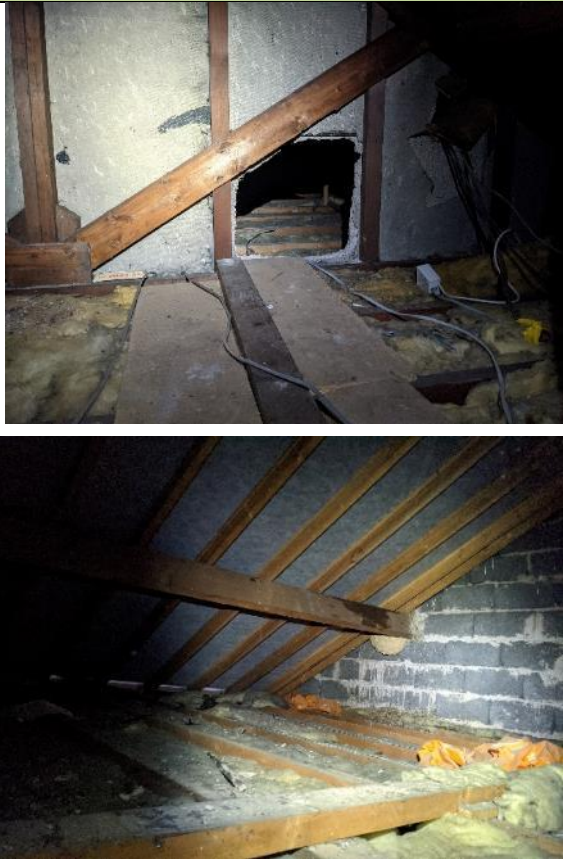
| Main Bungalow | |
|---|---|
| <p>Thin dividing wall between loft spaces. Small approx. 50cm x 50cm access hole.</p> <p>Loft space through dividing wall approx. 5.5m x 6.3m x 1.7m high.</p> <p>Gable ends were exposed breeze block.</p> <p>Wooden frame and flooring, with a thin layer of insulation between joists.</p> <p>Slates lined with what appears to be a breathable membrane.</p> | |

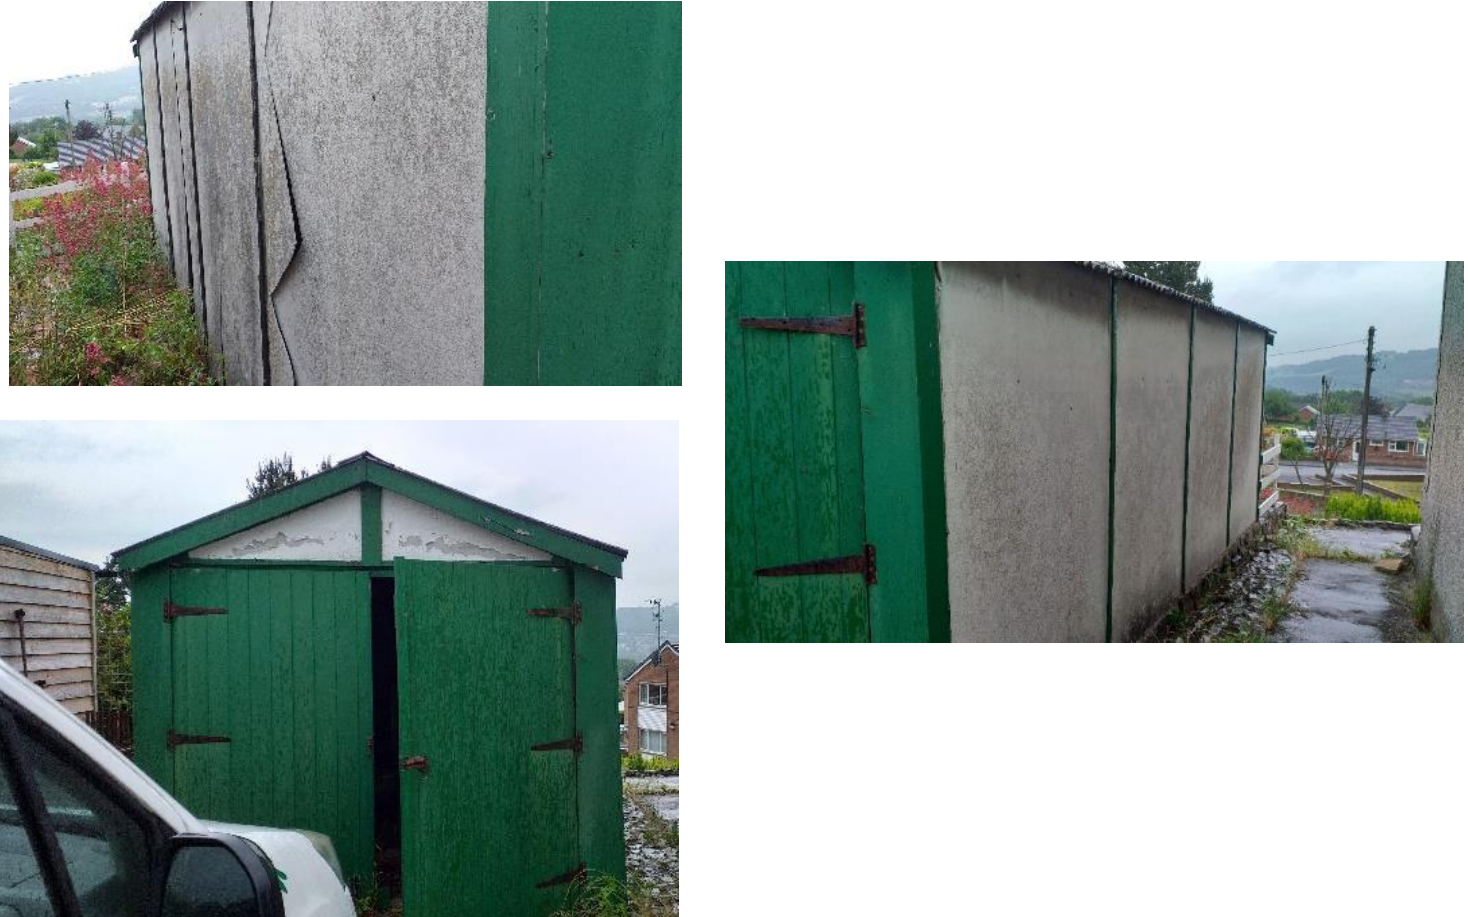
| Outbuilding | |
|---|---|
| <p>Asbestos like material used for external walls</p> <p>Painted wooden doors</p> <p>Galvanised metal sheet roof</p> | <p>The 'External Photo' column contains three photographs of an outbuilding. The top-left photo is a close-up of the wall, showing a grey, textured surface (asbestos-like material) and a green-painted wooden door. The bottom-left photo shows the full outbuilding, which has a green-painted wooden door and a galvanised metal sheet roof. The right photo is a side view of the outbuilding, showing the green-painted wooden door and the grey, textured wall.</p> |

The outbuilding had negligible potential to provide roosting sites for bats.

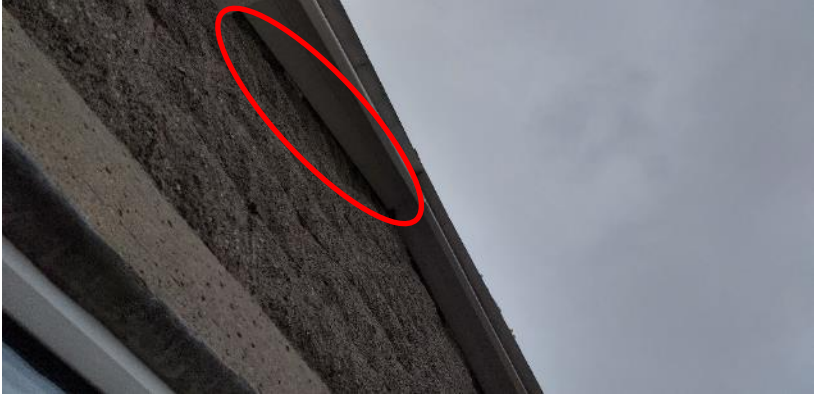
| Feature | Description | Example Photos |
|---|---|---|
| 1 | Gaps between soffits and western gable end wall | |

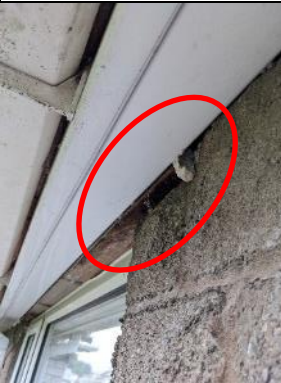
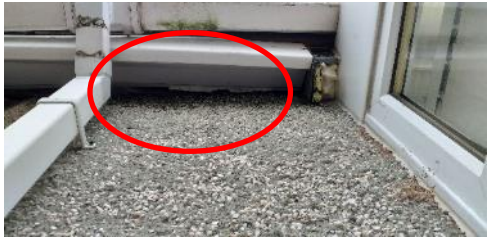
| Feature | Description | Example Photos |
|---|---|---|
| 2 | Gaps behind barge boards | |

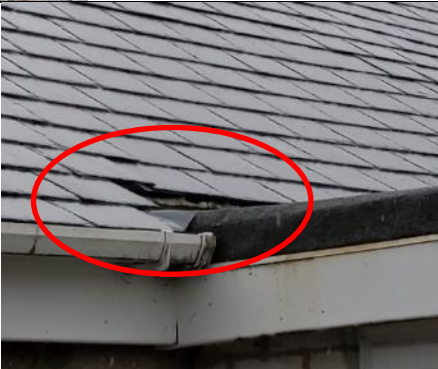
| Feature | Description | Example Photos |
|---|---|---|
| 3 | Gaps under slates | |

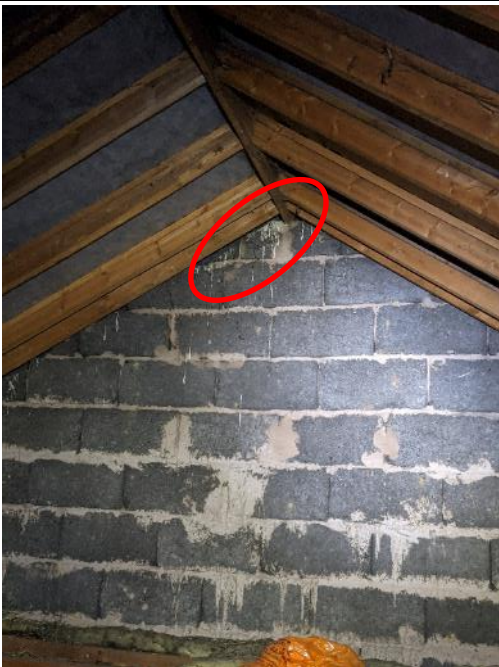
| Feature | Description | Example Photos |
|---|---|---|
| Internal Loft Space | Cavity behind the gable wall | |

- 5.3.1 There was no evidence of bats found within the building. However, there were areas in the loft space; behind the western gable wall, and behind the wooden cladding that were not accessible and potentially useable, and several features around the exterior of the building that could be used by bats. The gaps behind the soffits, bargeboards, and slates could provide roosting areas for crevice dwelling bats.

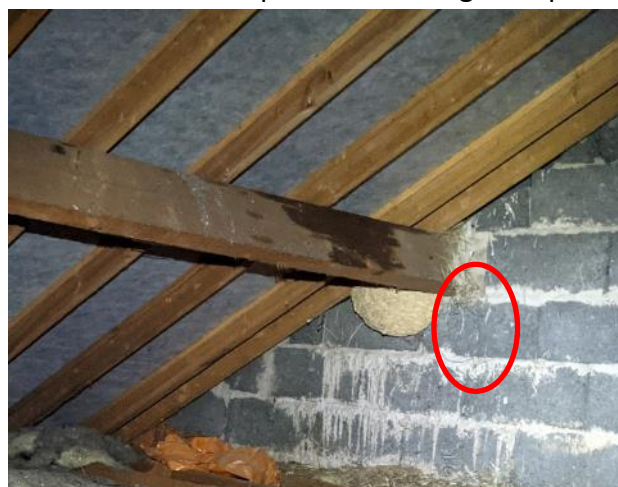
The bungalow provided suitable habitat for nesting birds and a couple of access points were present. Nesting areas within the loft space were seen during the PRA, as well as sparrows using the soffit boxes. Surveyors were unable to get close to the nest due to awkward entry into the partitioned loft space. General bird chatter was heard during the PRA in both the soffit boxes and loft space. Some large wasp nests were also present.

**FIGURE 4.3: NEST MATERIAL NEXT TO BEAM OF THE LOFT**

- 6.2.1 Evidence was found that birds are nesting within the building, specifically sparrows. Where possible work to these areas within the buildings should be avoided during the bird nesting season (April to September inclusive). If this is not possible a bird nest check needs to be carried out by a qualified ecologist no less than 48 hours before works commence. If birds are found nesting in the building during any point in the works, all works to that area must **stop** and only continue once the chicks have fledged.

- 6.2.2 To compensate for the loss of bird nesting habitat and enhance the site for birds; bird nesting opportunities will be provided by erecting sparrow terraces/ bird boxes around the site. A minimum of 2 boxes suitable for small birds need to be erected on site, suitable for house sparrows with a 32mm entrance. These must not be placed on the southern elevations of the new buildings. Inbuilt habitat or woodstone boxes are recommended.

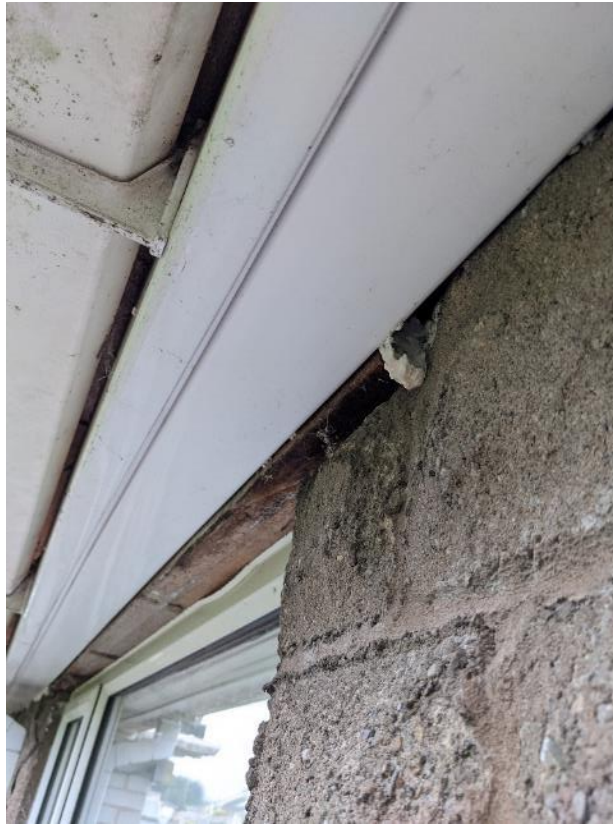
**FIGURE 4.4: SPARROW ENTRY POINT UNDERNEATH BARGEBOARD ON NORTHWESTERN CORNER**

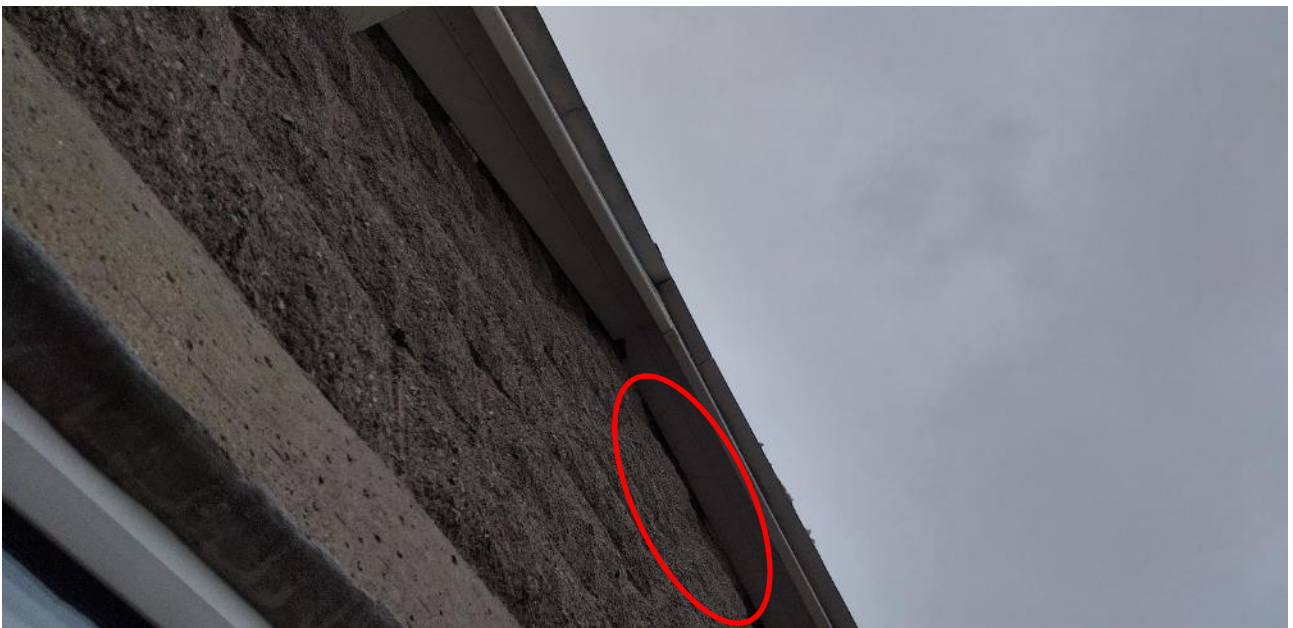
**FIGURE 4.5: SPARROW ENTRY POINT BEHIND SOFFITS ON SOUTHWESTERN GABLE**

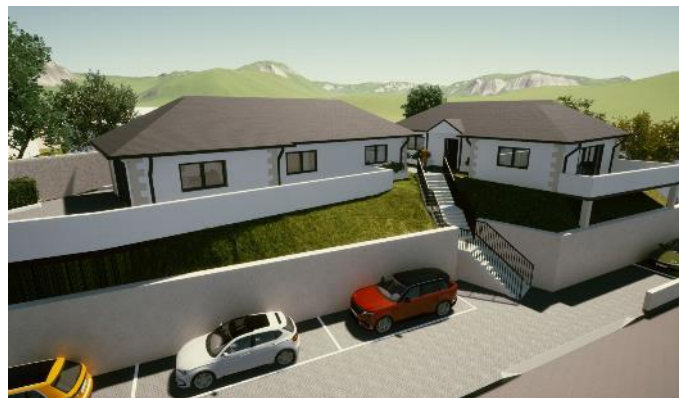
**FIGURE 5.1. THE PROPOSED PLANS SHOWING THE TWO NEW BUNGALOWS AND PARKING FACILITIES.**  
**BASE IMAGE © NAMAR STUDIO**

- 5.1.1 The most current plans at the time of this report propose the demolition of the existing bungalow and outbuilding. There are two new bungalows to be built, with parking facilities parallel to the road running along the southern boundary of the property. The current garden will be lost and re-landscaped – additional planting will take place (see figure 6.2) The trees to the west of the site are outside of the site boundary. The new bungalows will be constructed out of rendered blocks for the walls, reconstituted sandstone quoins for the corner stones, metal finish down pipes and guttering, and concrete roofing tiles. Both bungalows will have a hipped roof, with loft spaces below them. The floor of the loft space will be lined with 300mm of Rockwool insulation. A digital drawing of the finished bungalows is shown in Figure 5.1

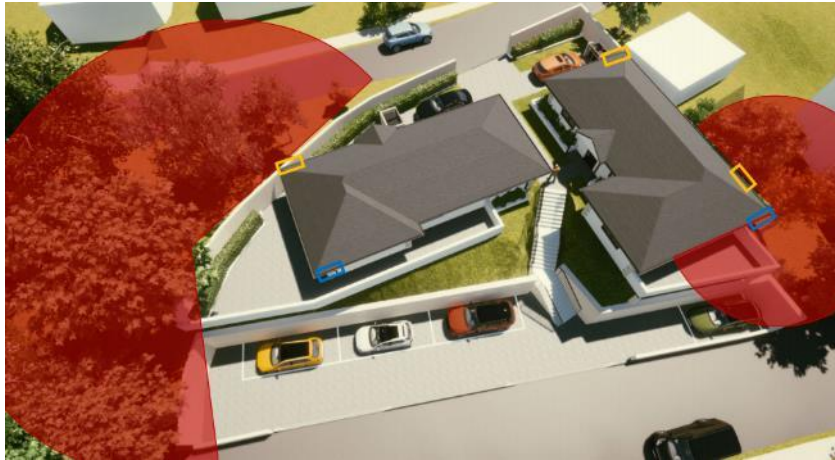
**FIGURE 6.1. PROPOSED SITE WITH DARK BUFFER ZONE (RED AREA), BAT BOXES (BLUE), AND SPARROW TERRACES (YELLOW) BASE IMAGE © NAMAR STUDIO**

- 6.1.5 In order to enhance the site for bats, at least one bat box suitable for crevice dwelling bats will be erected on each building. Inbuilt bat boxes such as the habibat bat box come in a variety of styles to match the exterior wall décor. The bat boxes will go on the southern elevations where possible, just under the eaves – as far away from windows as possible to prevent light spillage onto the entrance – indicative locations have been illustrated in figure 6.1.

6.1.8 The aerial image of the site illustrates (Figure 6.1) a wall present surrounding the site, small gaps or holes (approx. 13cm x 13cm) must be made in the bottom of the proposed walls, (figure 6.3), to allow hedgehogs and other species to commute and forage across the area. The location of the gaps need to allow hedgehogs and small mammals access through the gardens as well as areas to exit the gardens but not directly on to the roads.

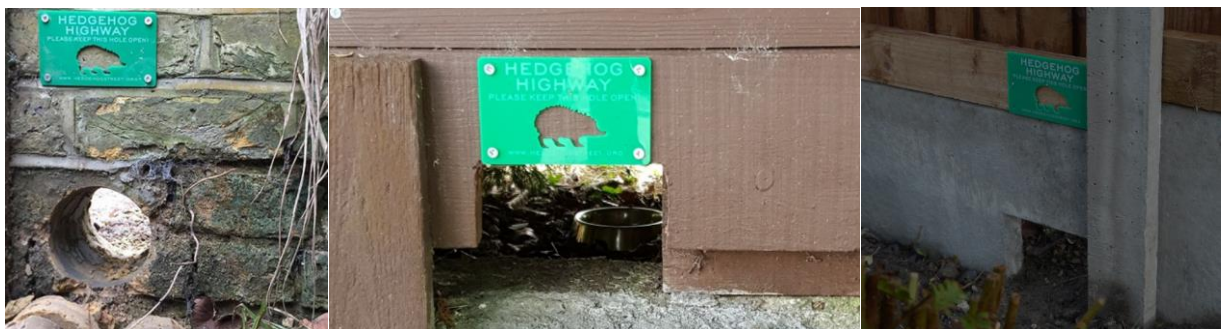
**FIGURE 6.3: EXAMPLES OF HEDGEHOG/SMALL MAMMAL ACCESS HOLES THROUGH FENCING AND WALLS.**
