| <b>Report Title</b> | <b>Proposed Demolition of Centre 67, 67 Rhosddu Road, Rhosddu, Wrexham, LL11 2NW – Bat Survey and Bird Assessment</b> |
| <b>Report Version</b> | <b>C421/ 1.0</b> |
| <b>Client</b> | <b>Wrexham County Borough Council</b> |

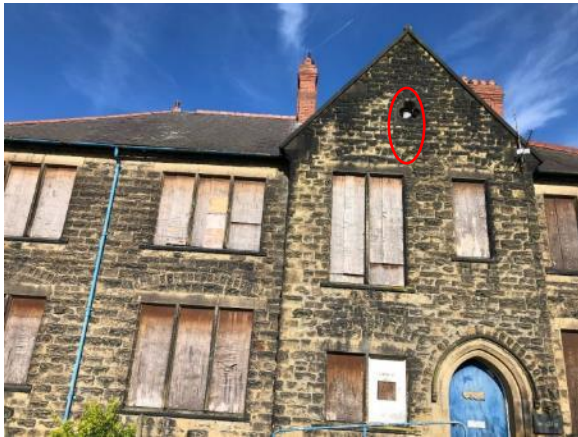
The external assessment of the building revealed that ingress opportunities for bats are present to all elevations in the form of gaps under the hip tiles, under loose/ lifted roof slates and along the eaves line of the entire building. A potential point of ingress is also present in the form of a gap within the

stone work above the window at the south-east elevation. It is also possible that further Potential Roost Features (PRFs) may be obscured by the *Hedera hibernica* (Atlantic Ivy) lining the north-west face of the structure. In accordance with the current BCT survey guidelines the PRFs that have been identified at Centre 67 are categorised as providing 'moderate' roost suitability.

**Plate 1: South-east elevation of Centre 67 showing loft window**

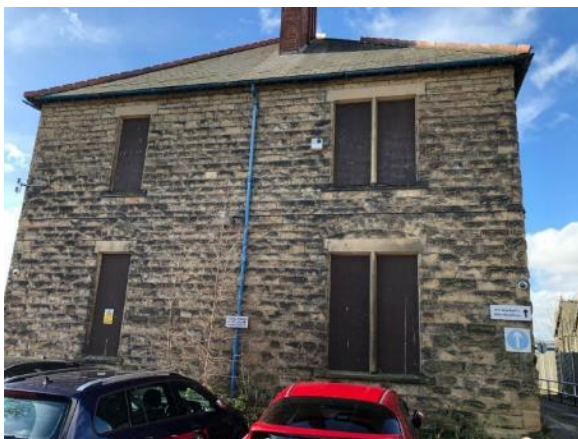
**Plate 2: North-east elevation**

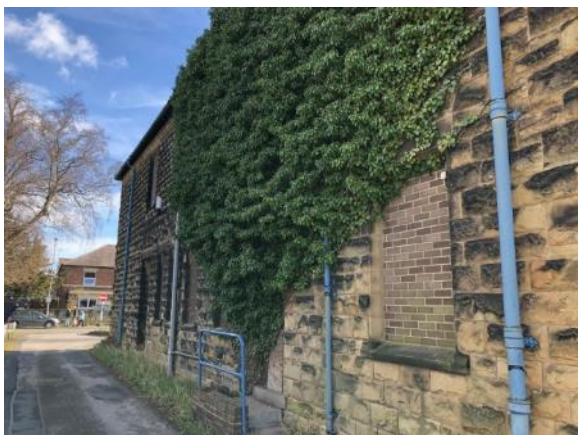
**Plate 3: North-west elevation with Ivy**

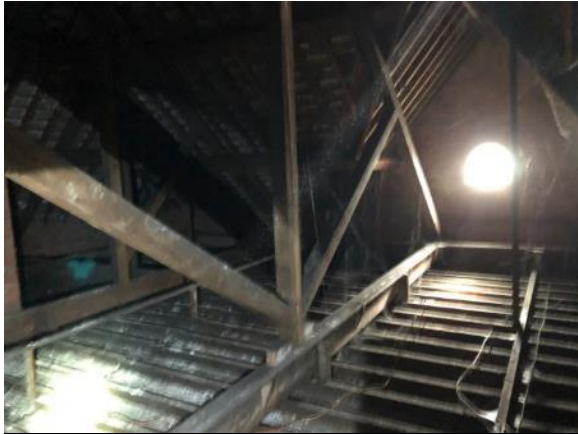
Internally a loft space is present to approximate dimensions of 18 m long x 9 m wide and 3 m high. The loft space is divided into two sections by an internal brick wall. During the inspection it was found to be partially illuminated due to a small window located in the south-east elevation. Whilst the loft dimensions would be suitable for loft dwelling bats such as Long Eared or Horseshoe bats, illuminated loft spaces are generally avoided by both species. Furthermore, the immediate built up environment does not provide the preferred habitat features suitable for foraging/ commuting favoured by either species. No evidence of bats was recorded in the loft space.

**Plate 4: Condition of the loft space showing the window**

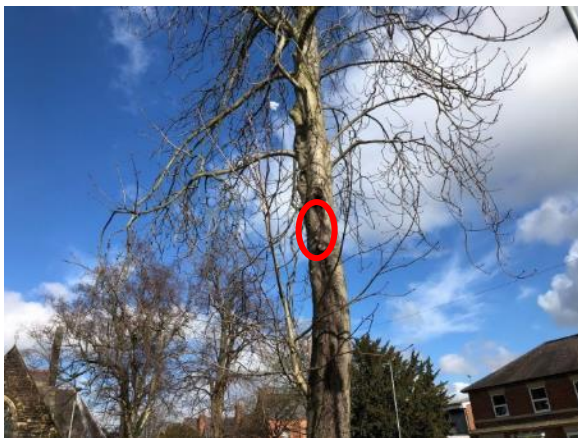
There are two semi-mature *Aesculus hippocastanum* (Horse Chestnut) trees located to the east and south-east of Centre 67 (see Figure 5 below). Tree T1 is approximately 8 m from the building whilst T2 is approximately 12 m away. Rot-holes were identified at 2.5 m height (T1) and 3.5 m height (T2) but from ground level the extent of the rot-holes could not be ascertained.

**Plate 5: T2 Horse Chestnut with rot-hole circled**

It is understood that the trees (T1 and T2) to the east of the building will not be directly affected during the proposed demolition, however due to their proximity to the building and therefore potential for disturbance (of any bats that might be present) it is recommended that further investigation is undertaken. Prior to the proposed demolition work the identified Potential Roost Features (PRFs) require further investigation to determine the full extent of the rot holes and confirm whether or not they provide roost suitability or bats/ evidence of bats is present.

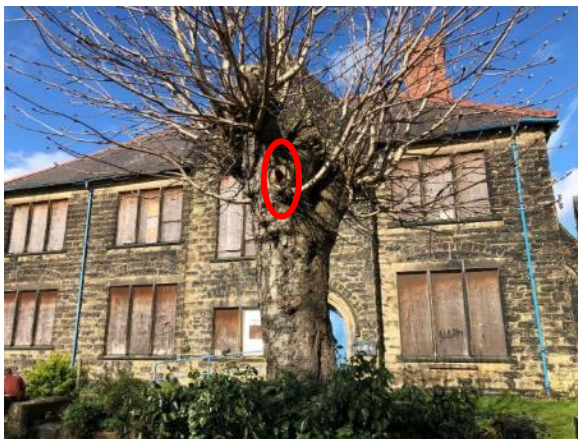
**Plate 6: T1 Horse Chestnut with rot-hole circled**

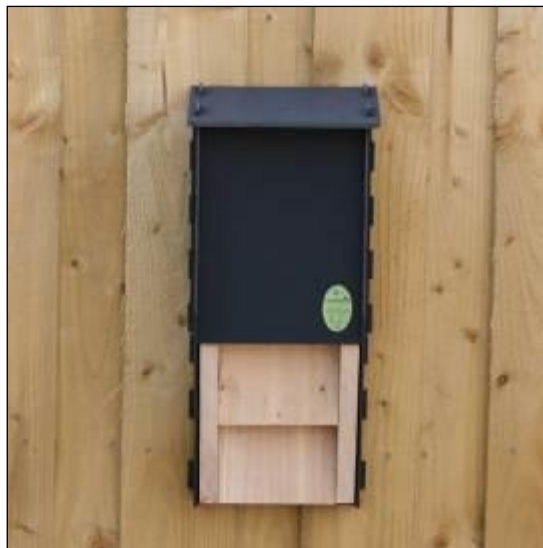
### Externally fitted boxes

A large number of externally fitted box models for bats exist for buildings and trees. Suitable models for both buildings and trees may include the Eco Kent Bat Box.

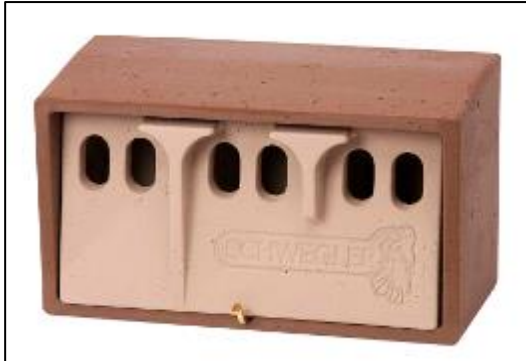
### House Sparrow

The Sparrow Terrace has been designed to help re-dress the balance of falling House Sparrow numbers. The current UK population is half what it was in 1980 and this is thought to be due to habitat destruction and lack of suitable nesting spaces. Sparrows are social birds and like to nest in company, therefore, this terrace provides ideal nesting opportunities for three families.

The terrace comes in two colours and can be fixed on to the surface of a suitable wall or incorporated into the wall. It is suitable for most types of buildings.

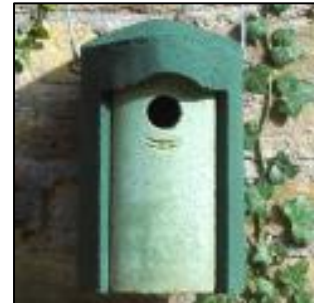
### Blue/ Great Tit

This nest-box should be hung on trees 3-4 m off the ground.

**NB; Bird nest-boxes should be located on a cool aspect (north-east to avoid overheating).**
