**Carter Jonas**  
**Ruabon Park, Wrexham**  
**Phase 2 Preliminary Geoenvironmental Assessment Report**

**Document Ref:** 773135-REP-ENV-002  
**Revision:** 0  
**Date:** 27 November 2015

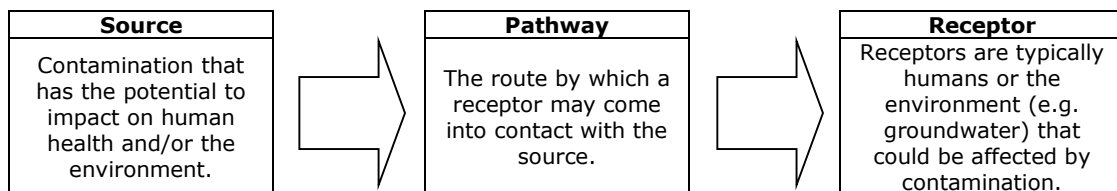
The assessment of risk from contamination follows the source-pathway-receptor (SPR) approach. Each of these elements is described as follows.

Without a source-pathway-receptor linkage in place, it is considered that there is no risk of harm and remediation is unlikely to be required. If, however, there is a linkage between source and receptor then a risk-based approach is used to assess the significance or potential impact of the SPR-linkage to determine if remediation is required.

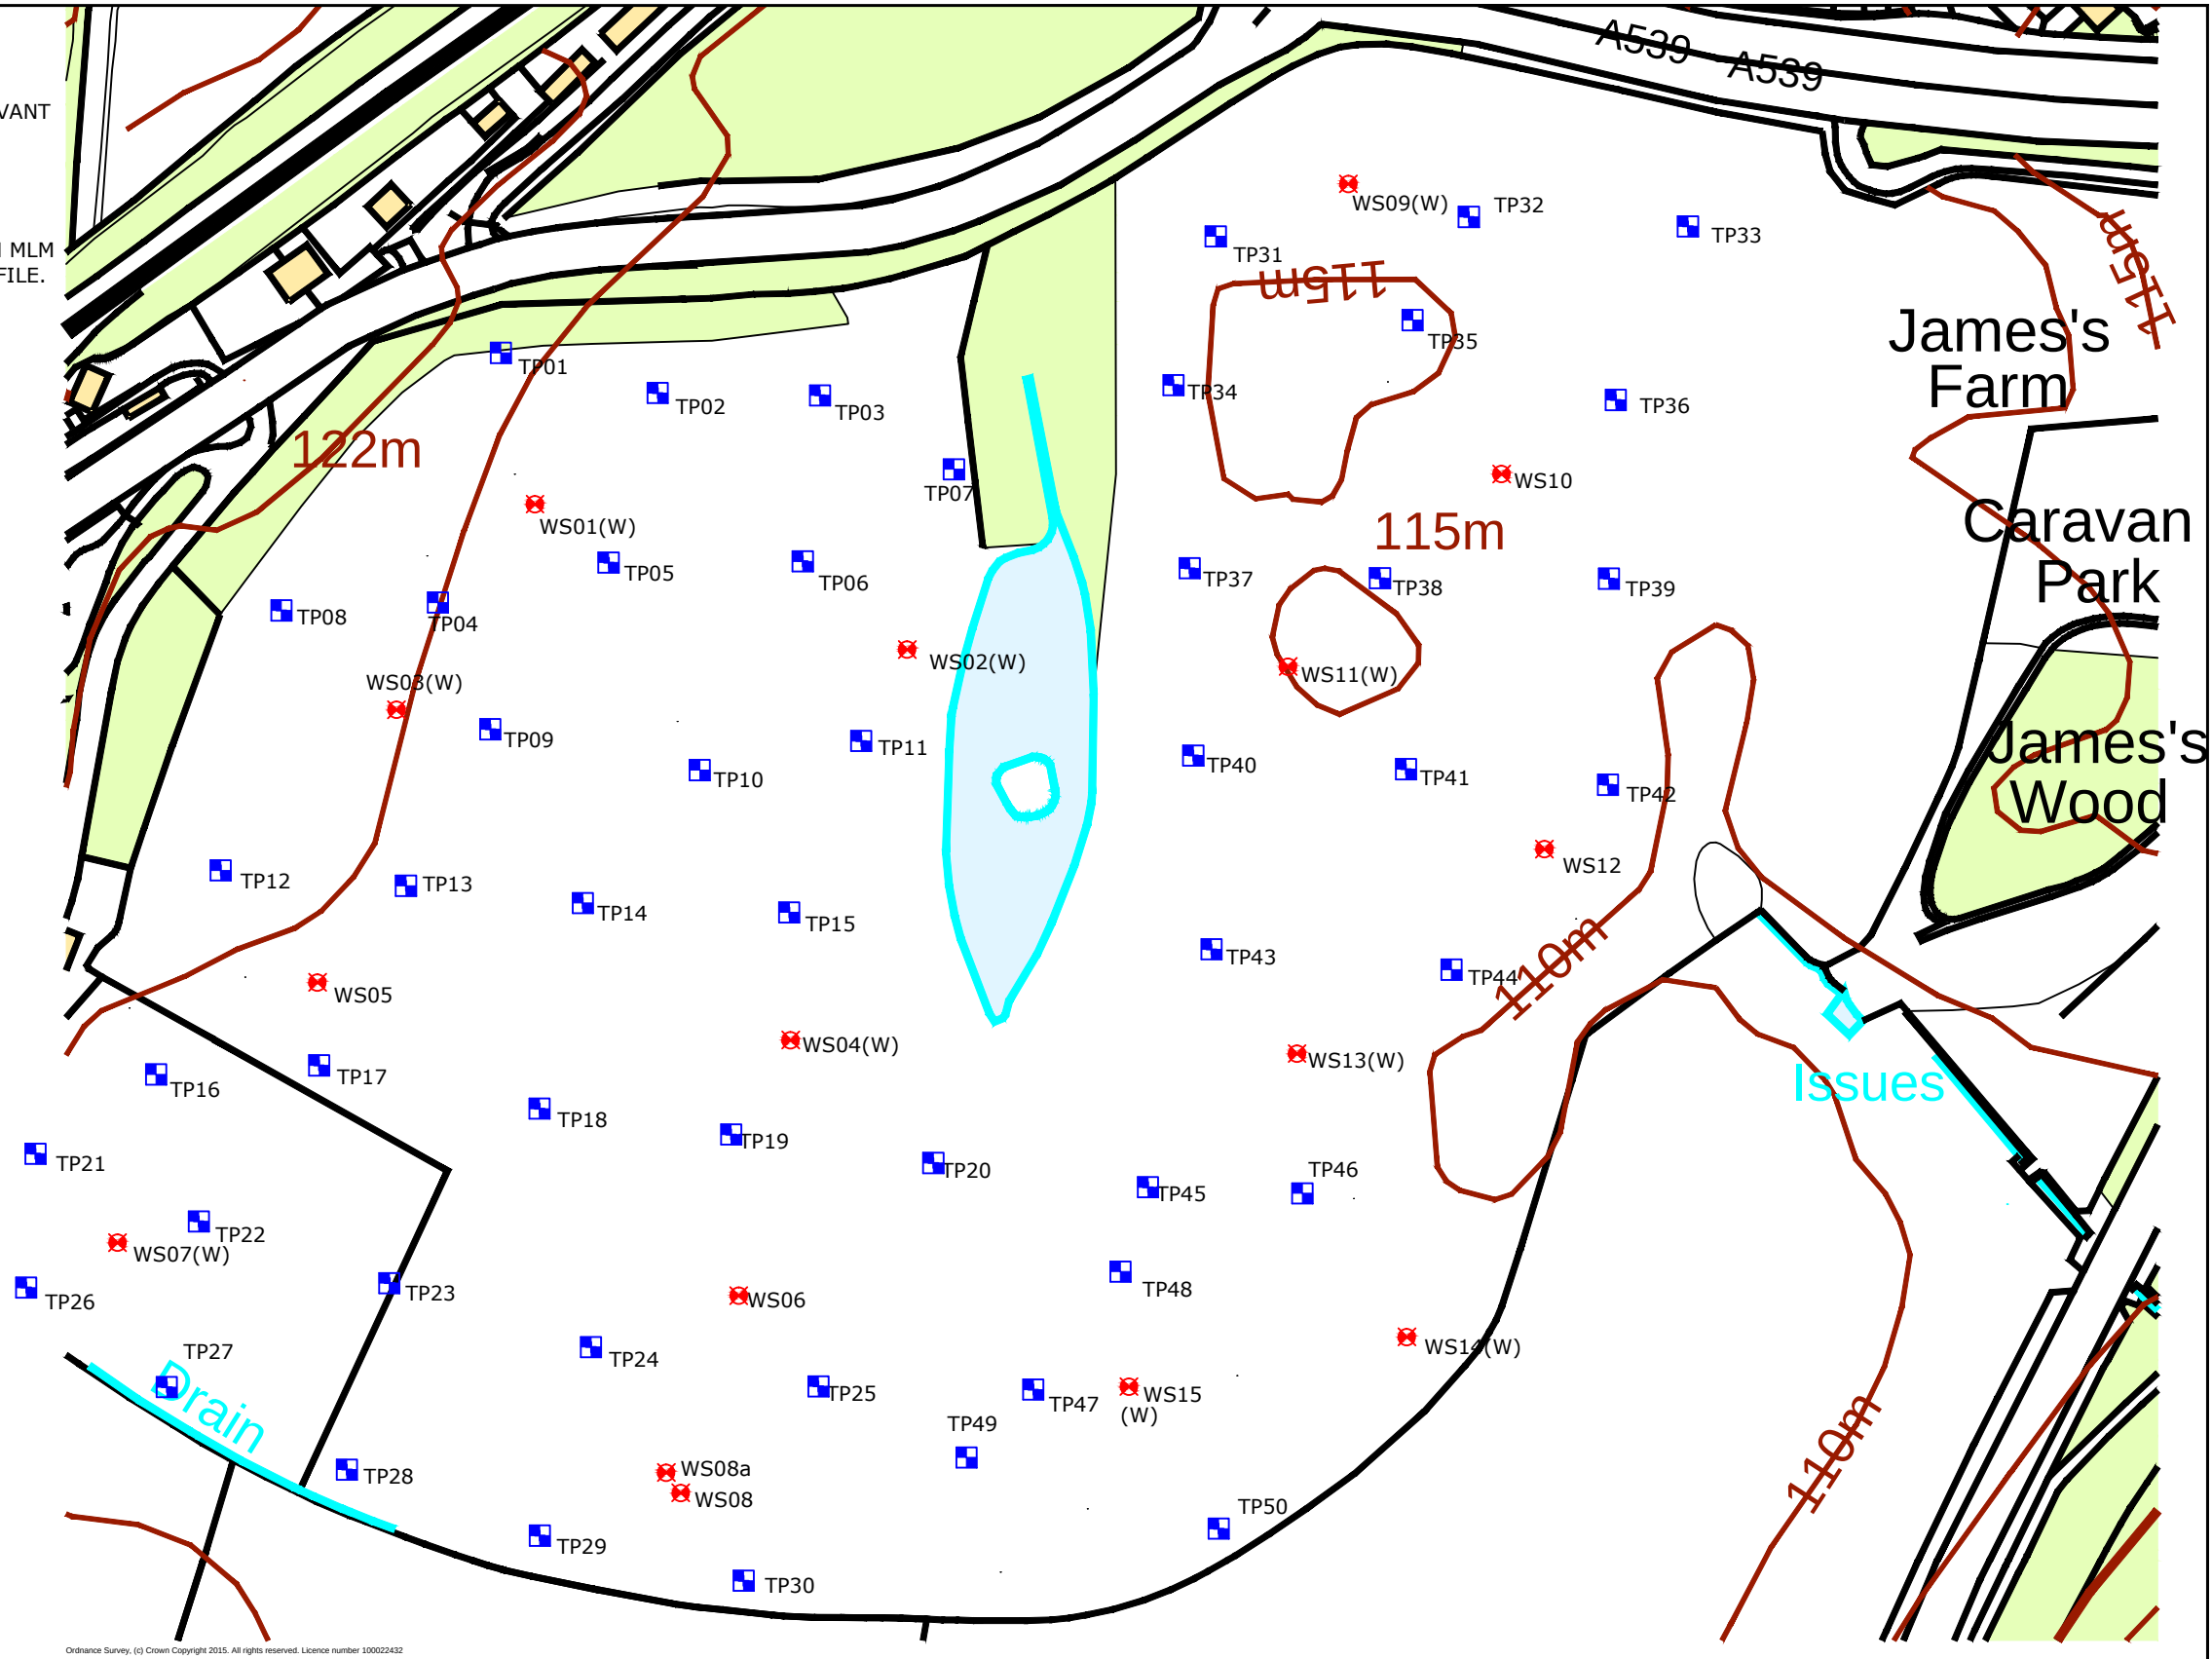
WINDOWLESS SAMPLER BOREHOLE LOCATION

MONITORING WELL LOCATION

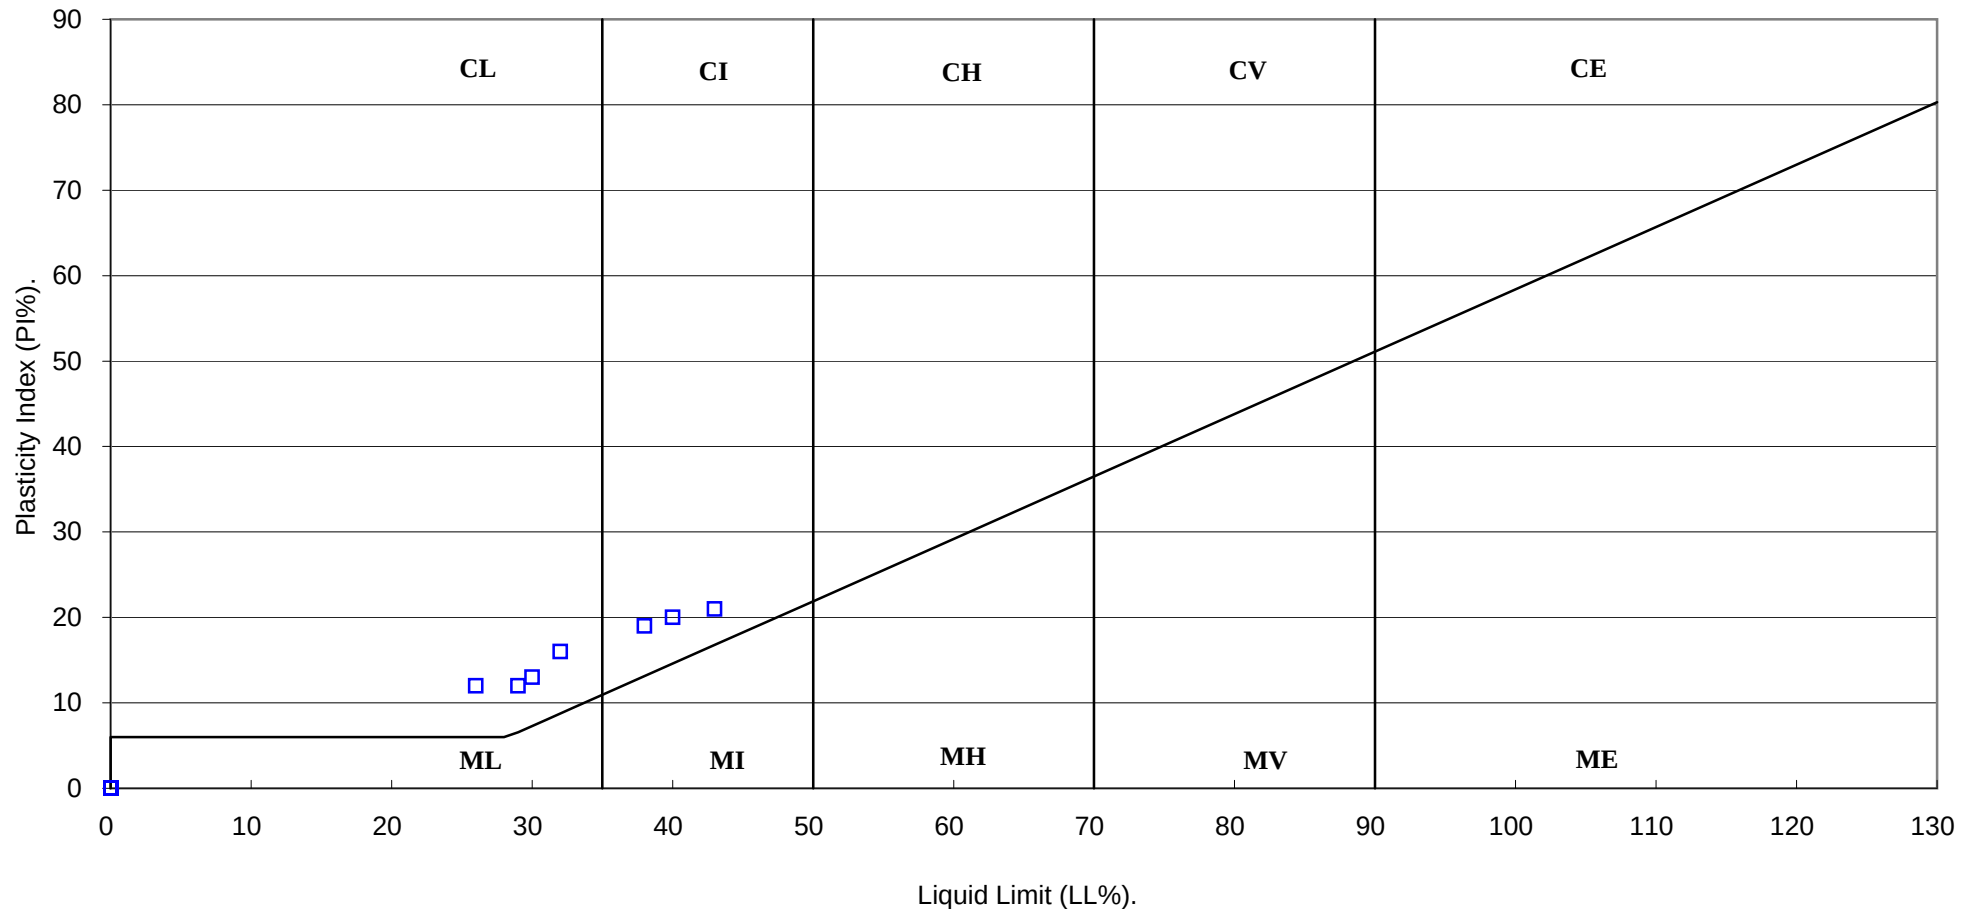
# PLASTICITY CHART FOR CASAGRANDE CLASSIFICATION.

(B.S.5930 : 1999)

Natural moisture contents in the fine fraction of these materials range from 9% to 20% and modified plasticity indices range from 10% to 13%. On this basis these soils are classified as of low plasticity (CL soils) and of low swelling/shrinkage potential on change of moisture content.

Natural moisture contents in the fine fraction of these materials range from 10% to 30% and modified plasticity indices are between 8% and 21%. On this basis these soils are classified as of low to intermediate plasticity (CL/CI soils) and of low to medium swelling/shrinkage potential on change of moisture content.

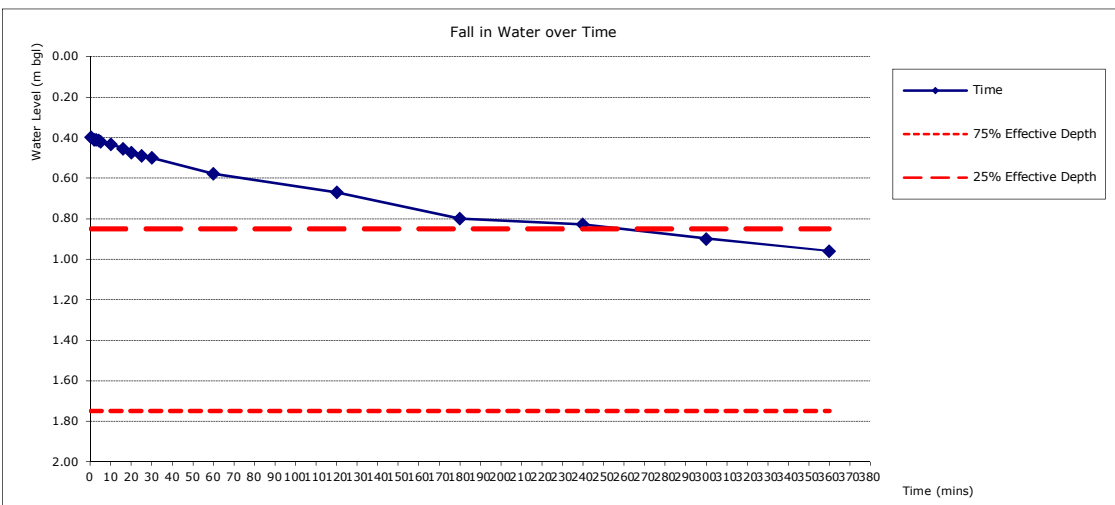
Soil Infiltration Rate (m/sec)  $f = \frac{V_{p75-25}}{a_{p50} \times t_{p75-25}}$

Soakaway testing was undertaken as part of the investigation within TP12, TP21, TP32 and TP33. The results of these tests are presented in Appendix E. Three of the four soakaway tests undertaken (TP12, TP21 and TP32) were not completed in the time allowed due to the slow infiltration rate of the water. Approximated infiltration rates for these three soakaway tests gained by extrapolating the results of the information indicate infiltration rates in the order of  $5 \times 10^{-6}$  m/sec. The soakaway test undertaken within TP33, recorded an infiltration rate of  $2.96 \times 10^{-4}$  m/sec within the glacio-fluvial sand and gravel materials in the north east of the site.
