Ruabon Road, Johnstown  
Proposed Residential Development  
Geo Environmental Report  
Gower Homes

This report presents the findings of the desk study and both site investigations. It gives geotechnical recommendations for the development, along with an updated conceptual ground model/environmental risk assessment.

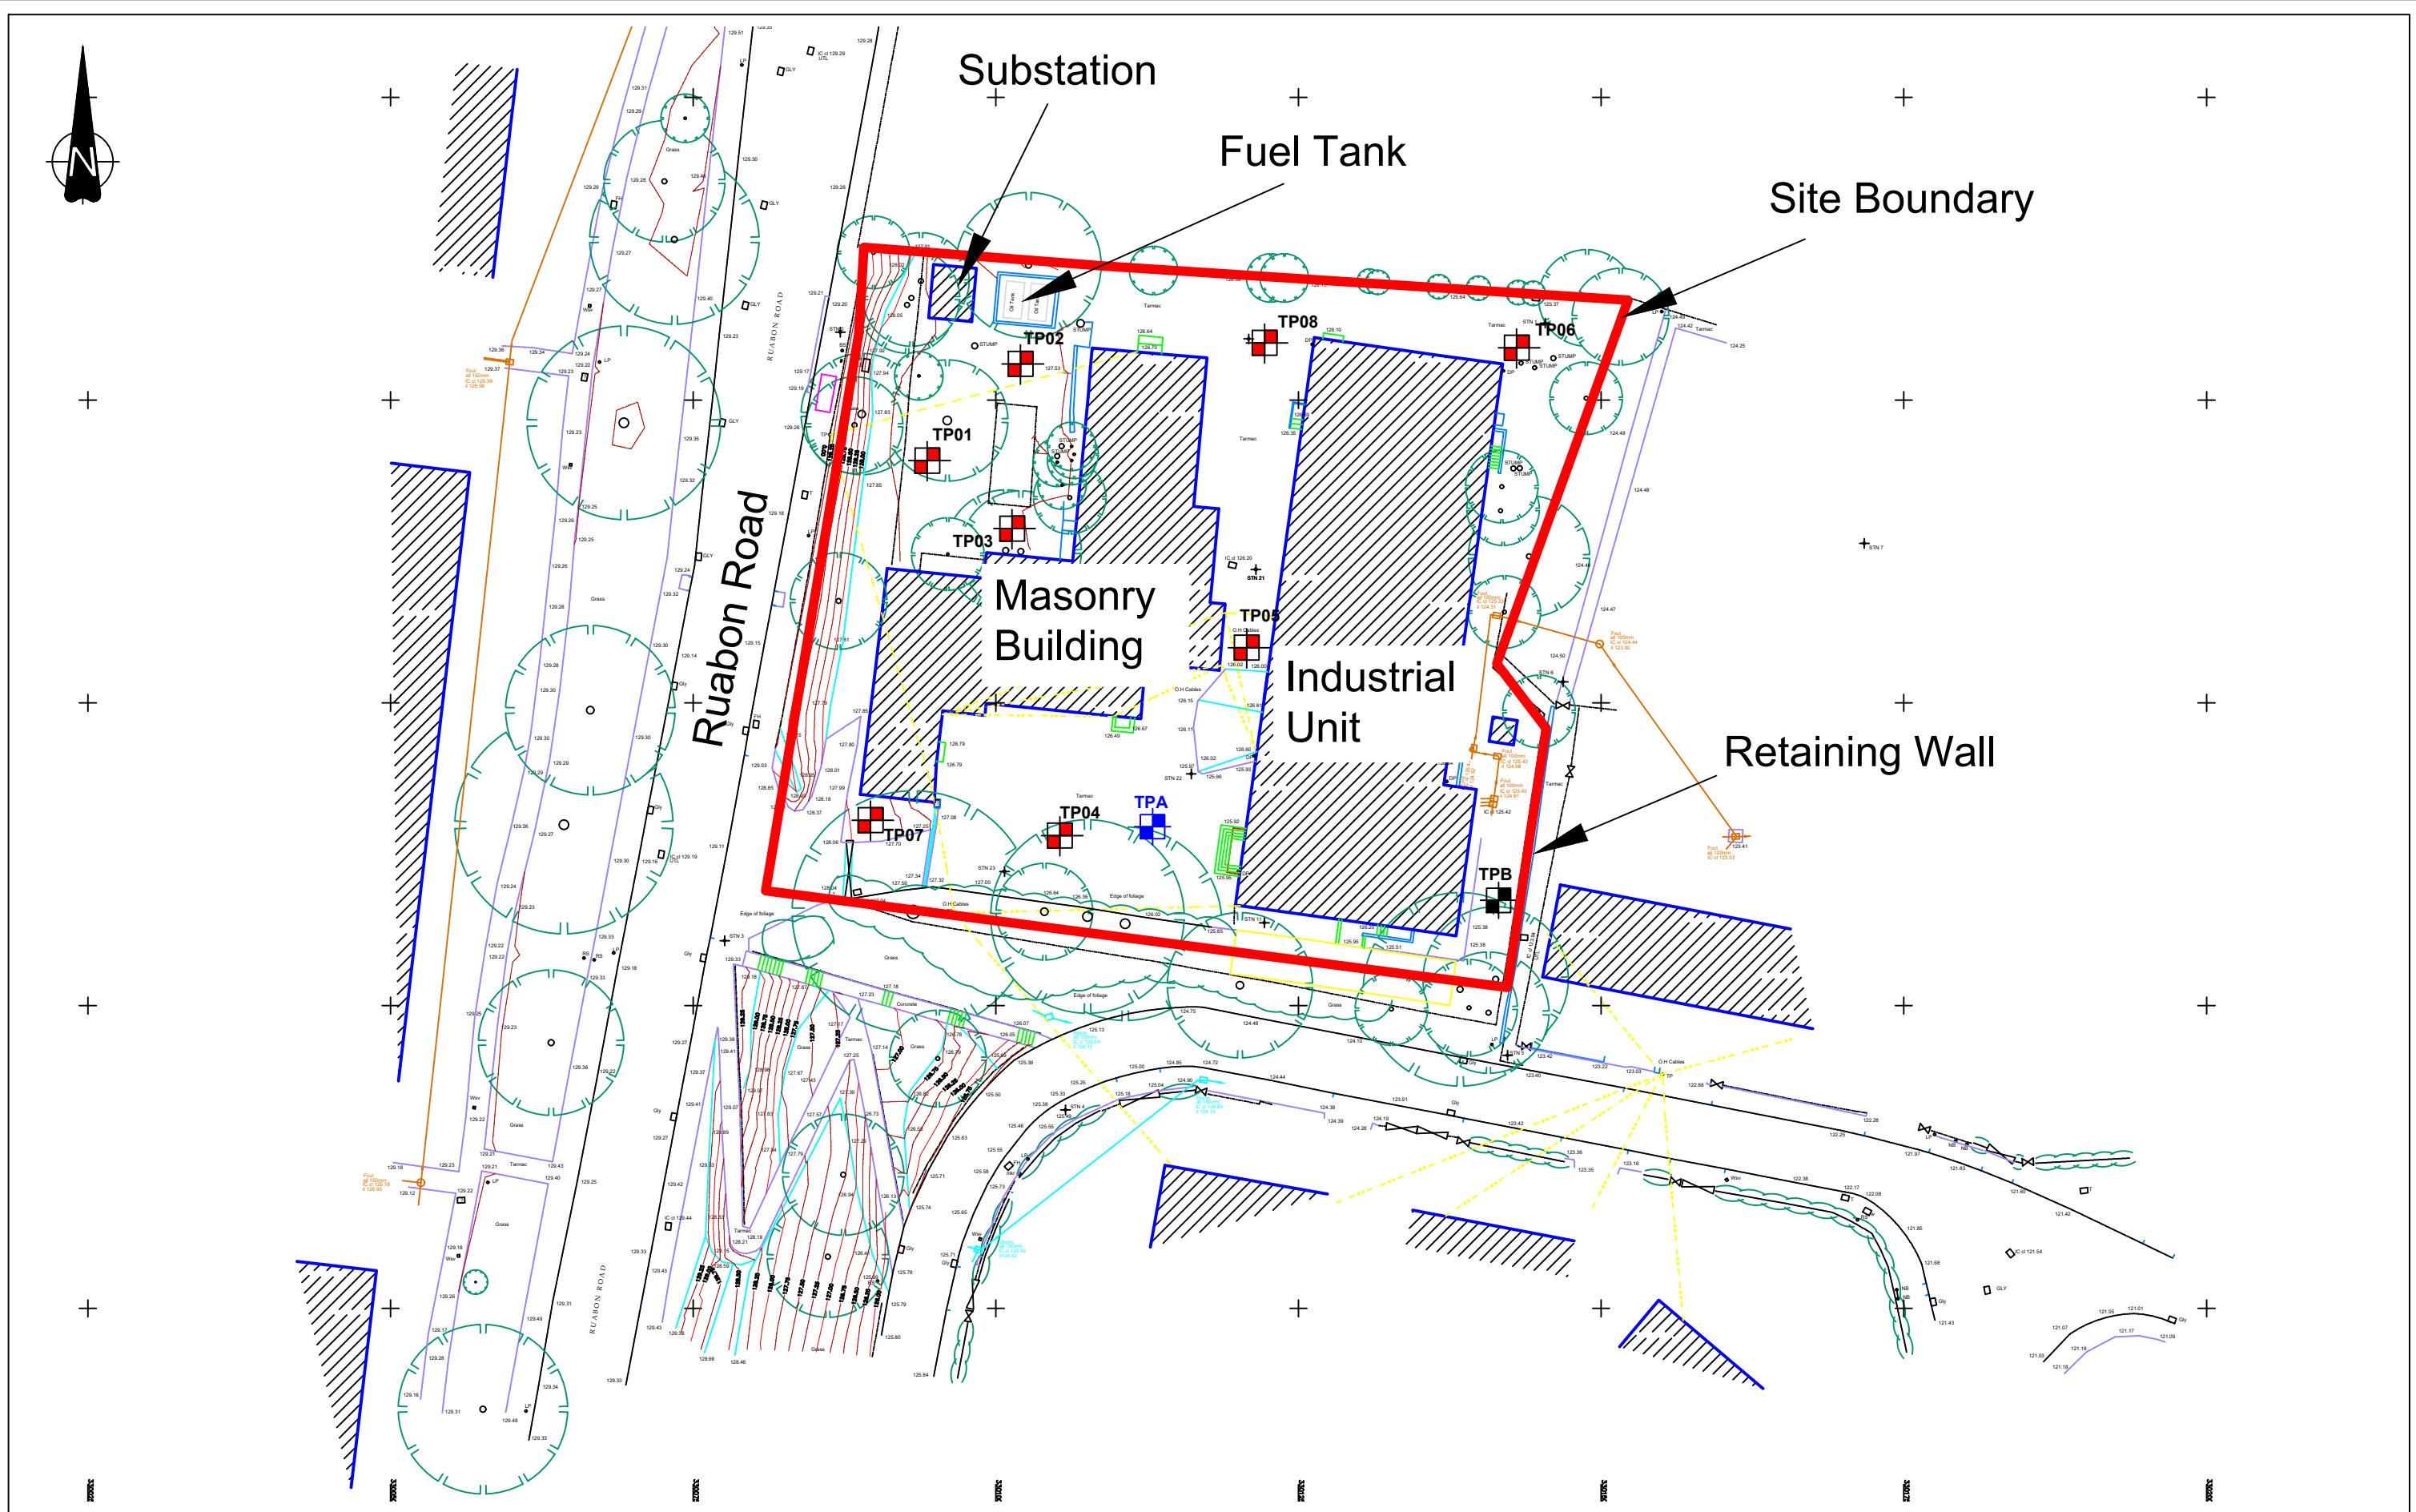
FIGURE 2

Figure Title  
Site Layout  
& Exploratory Hole Locations

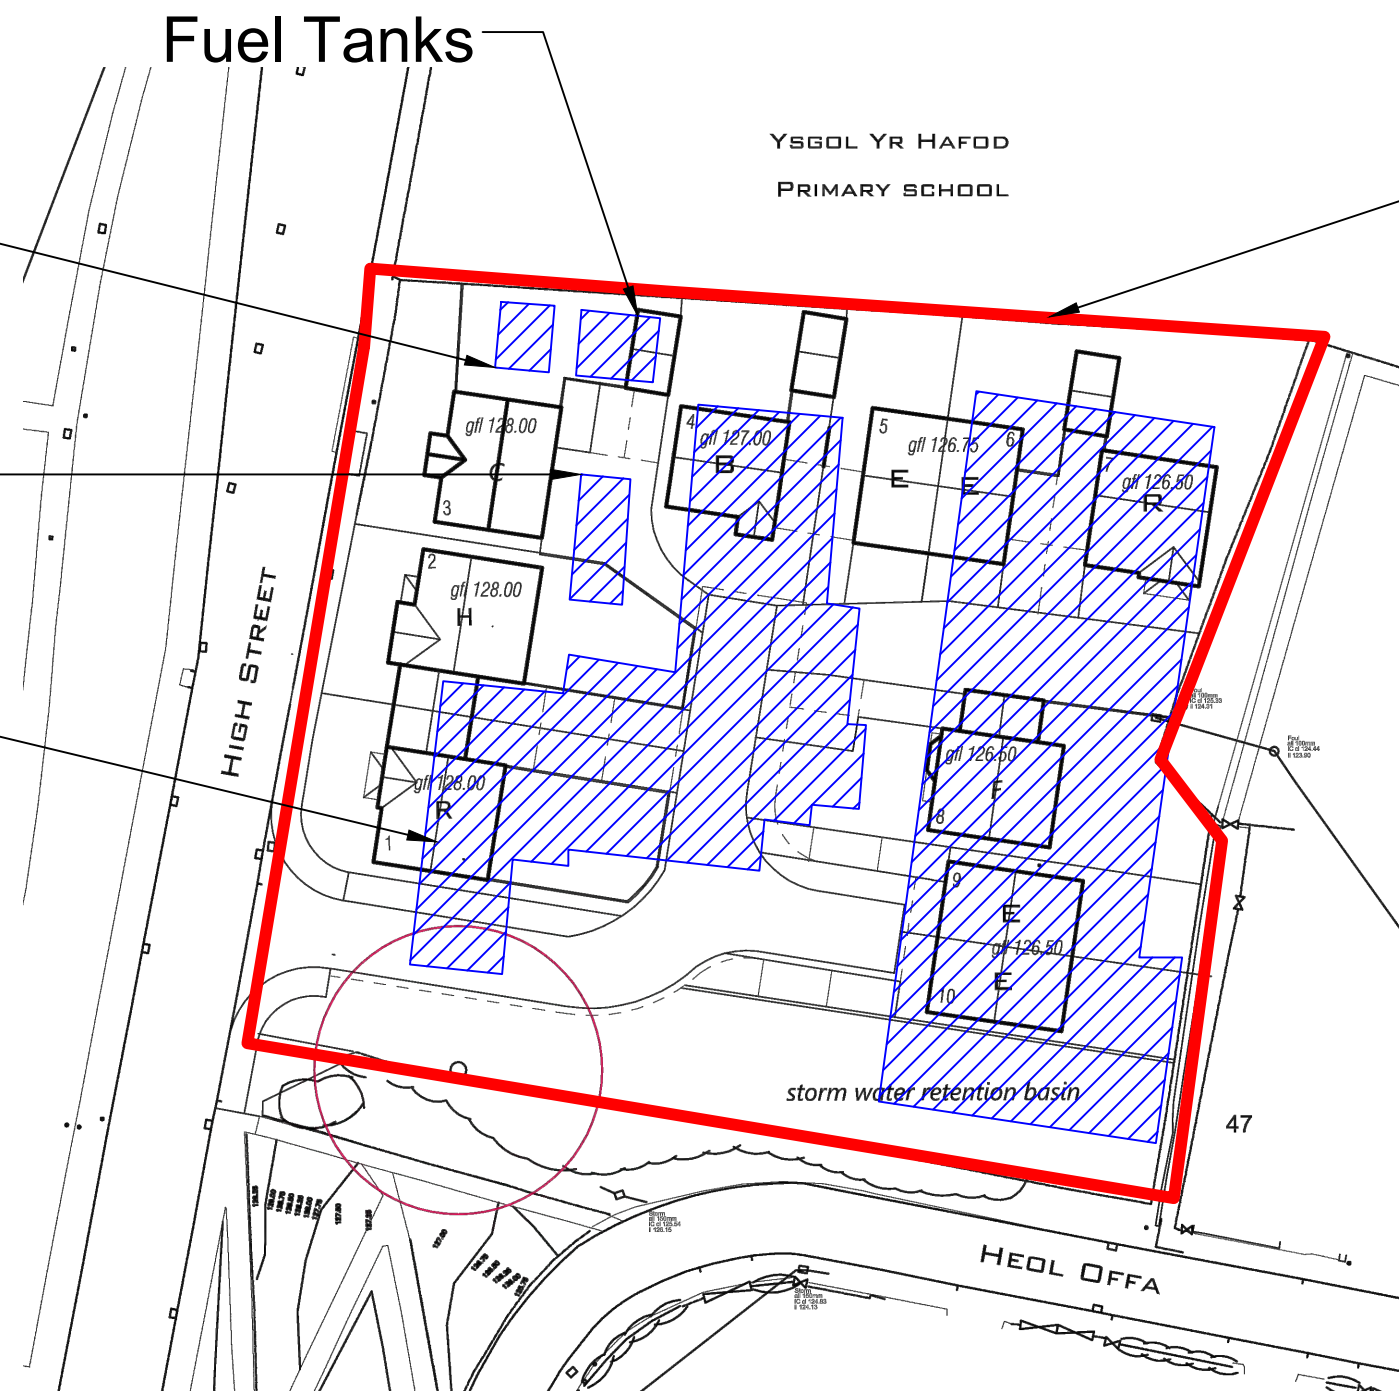
FIGURE 5

To assist with the geotechnical recommendations, and planning the site works, a geotechnical constraints drawing has been produced, see Figure 5. This shows the location of the proposed plots in conjunction with the location of the existing buildings on site.

Firstly, it will be necessary to demolish the existing buildings and hardstandings on site, along with any concrete floor slabs, and existing foundation where they interfere with new foundation, see Figure 5.

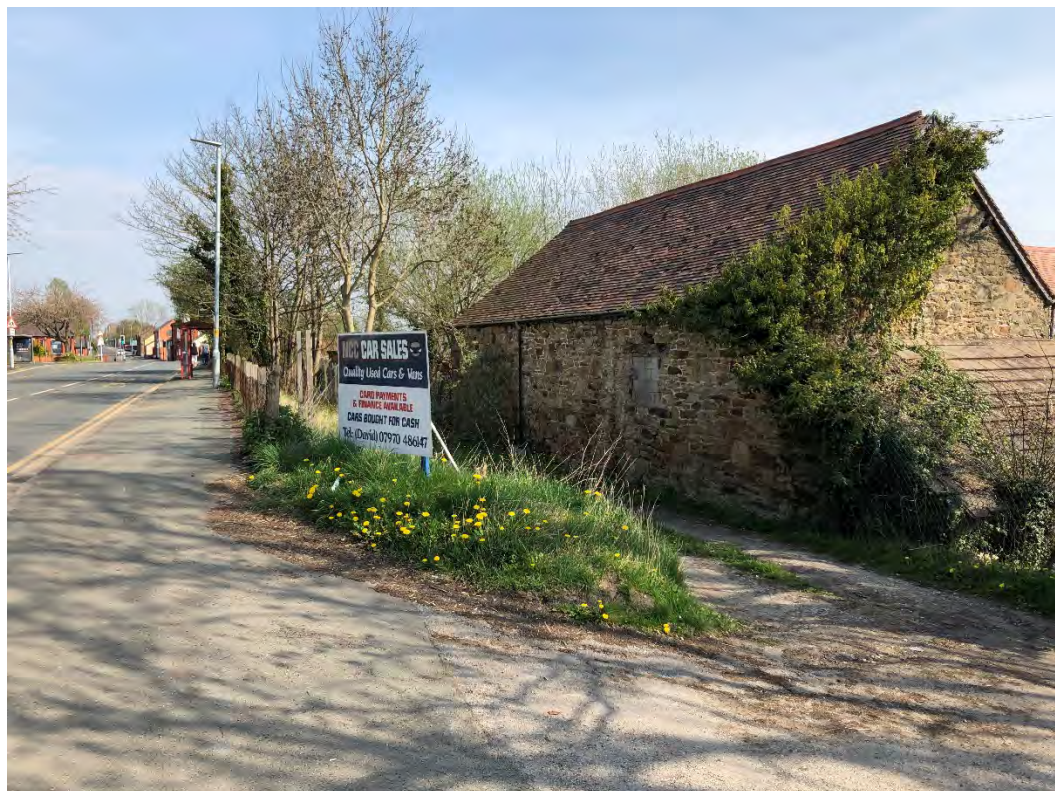
Photograph 2 – Western boundary of site showing elevation difference from Ruabon Road

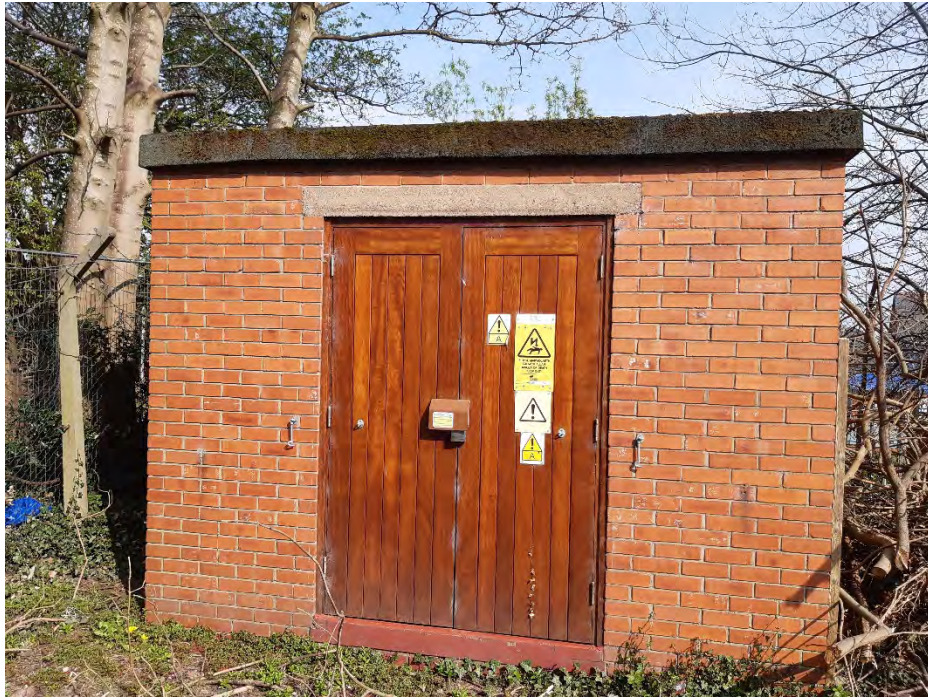
Photograph 5- Facing north showing the substation.

An electrical substation is also situated immediately northwest of the site, together with a bunded fuel tank, although no evidence of leaks was noted during the site walkover.

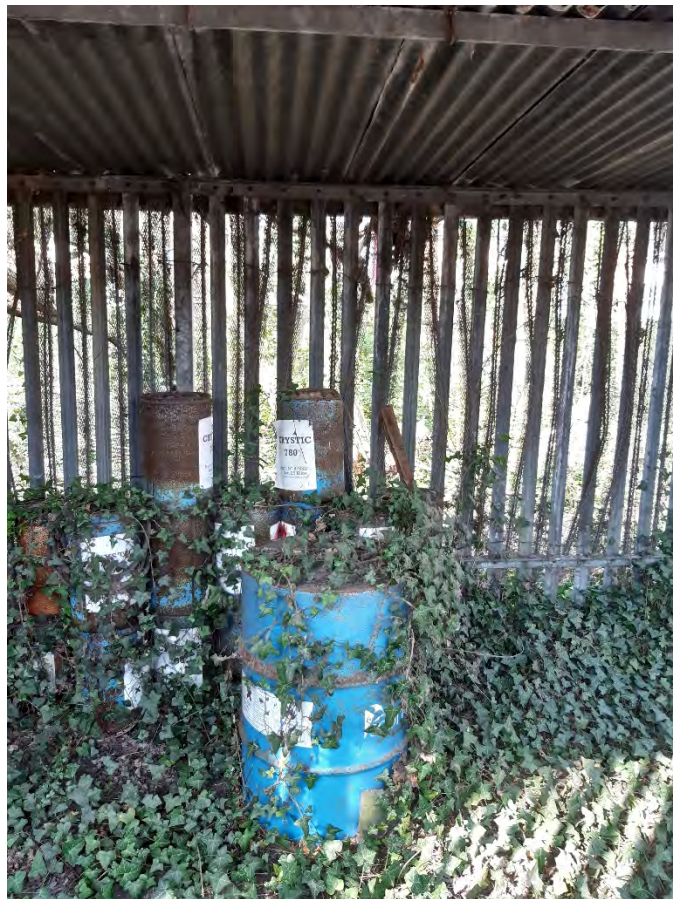
Photograph 6- Showing the chemical storage facility.

The site is occupied by several masonry buildings on the western section of the site, and a more modern brick and metal-clad industrial unit on the eastern section of the site, accessed via a central tarmac parking area/driveway. The site was formerly used as a car salesroom and for vehicle maintenance repair. A storage shed is situated in the northwestern part of the site, where flammable chemicals used for vehicle bodywork repair were previously stored.

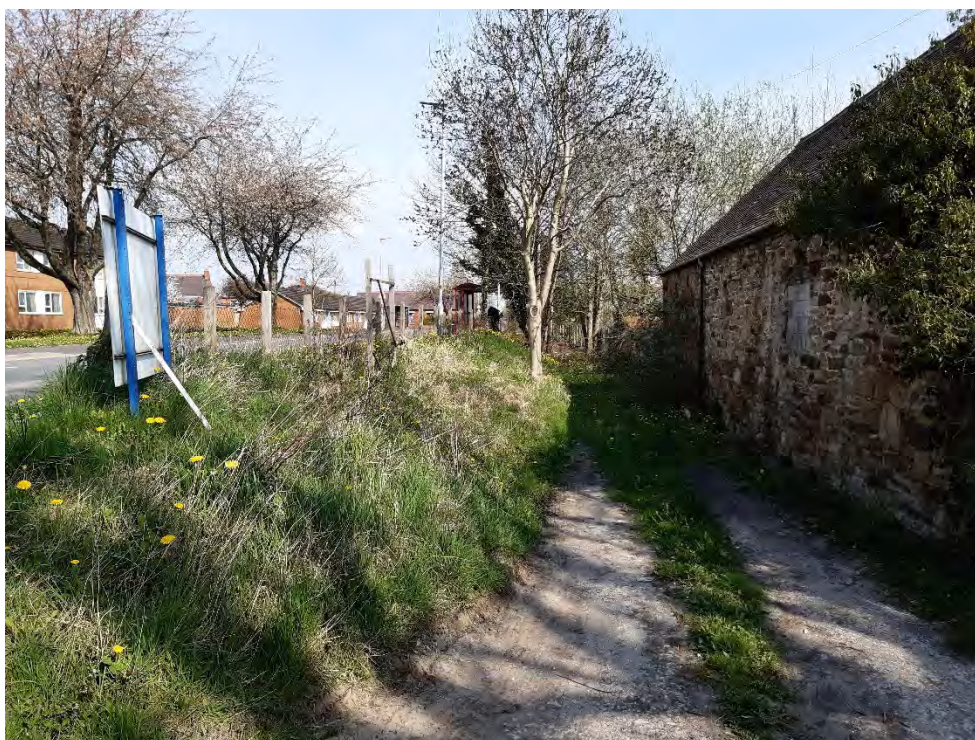
Photograph 7- Facing North showing difference in road and site level.

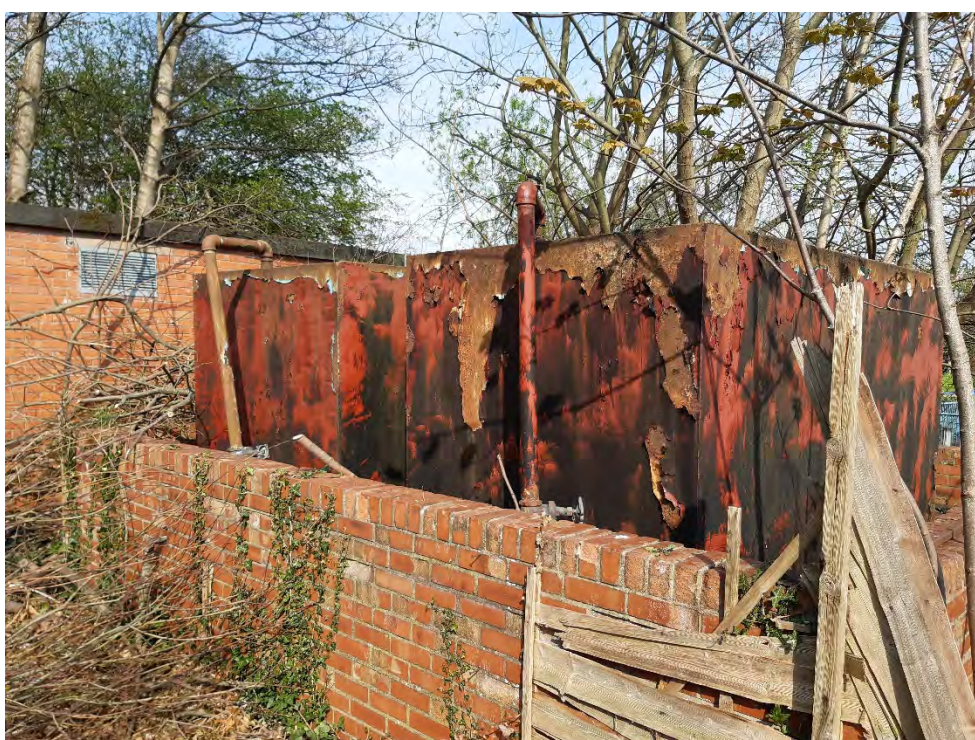
Photograph 8- Showing tanks on site.

The desk study has revealed that the site has historically been in residential use, and later used as a factory, before being used as a car/tyre sales and vehicle repair centre, with fuel tanks still visible on site, although these are above ground and bunded, with no evidence of fuel spills outside of the tank perimeter. In addition, a chemical storage area was present in the north western section of the site, see Figure 2. However, the remaining barrels were overgrown with Ivy, and it was not possible to determine what chemicals were stored on site, although they are likely to have been associated with paint spraying of vehicles.

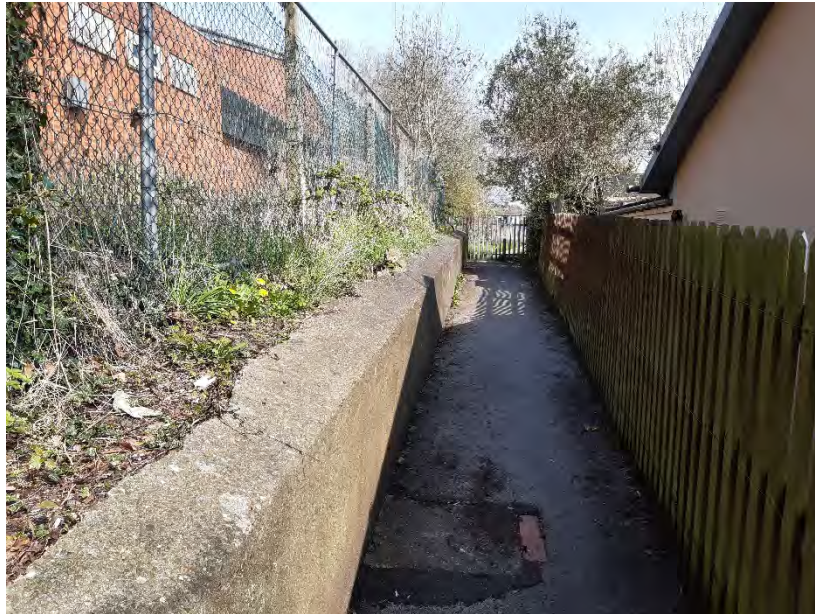
Photograph 9- Showing Retaining wall on eastern site boundary.

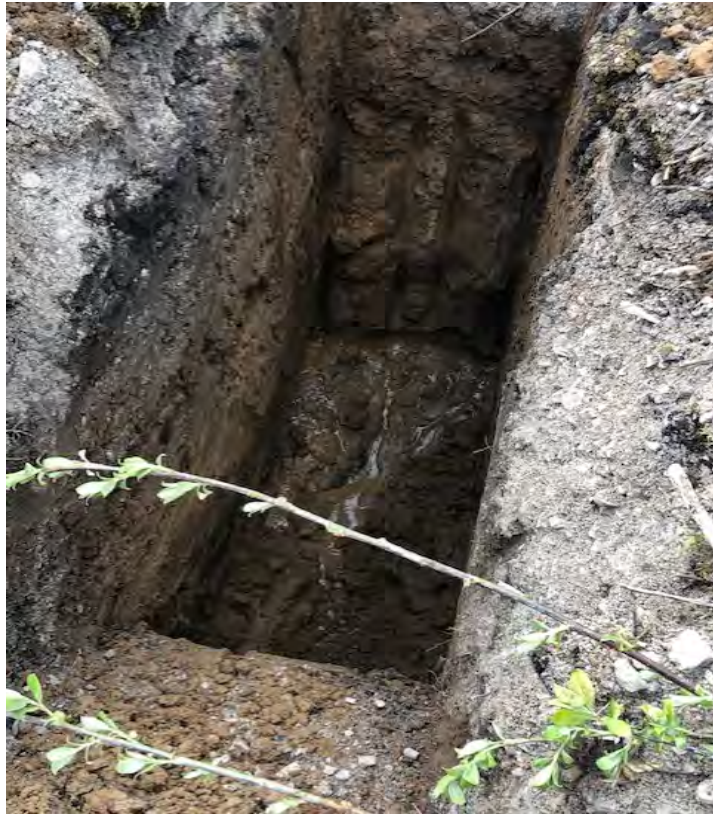
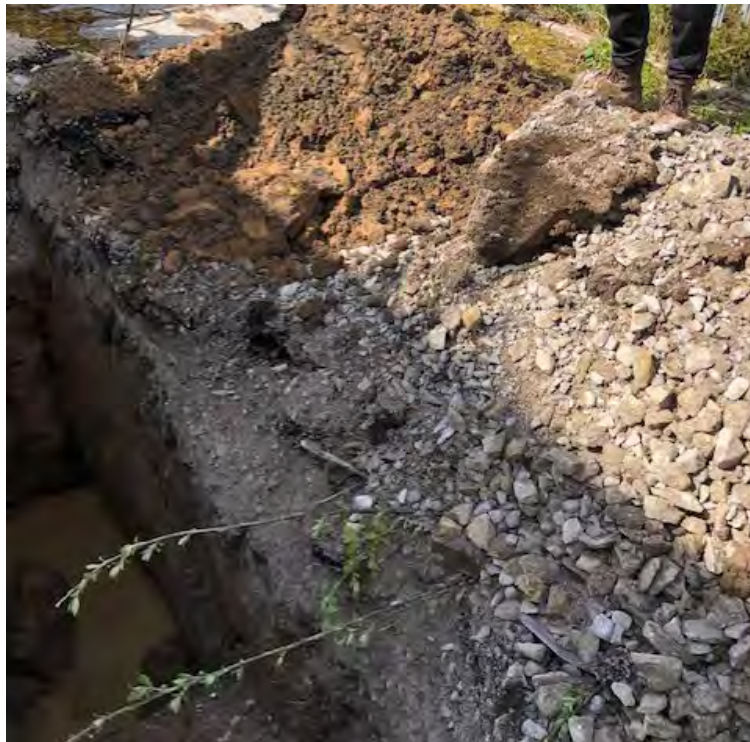
TP06- Pit Walls

TP06- Spoil

Thin layers of sand were encountered either on top of, or within the glacial till, in TP06 and TP08, between depths of 1.50m and 1.90m. These comprised running sand conditions, with fast water inflows, described as loose, brown, slightly gravelly sand, with a fast inflow of groundwater, which stabilised at a depth of 1.50m.

However, loose bundles of Chrysolite Asbestos were detected in TP06. This was quantified at 0.14%.

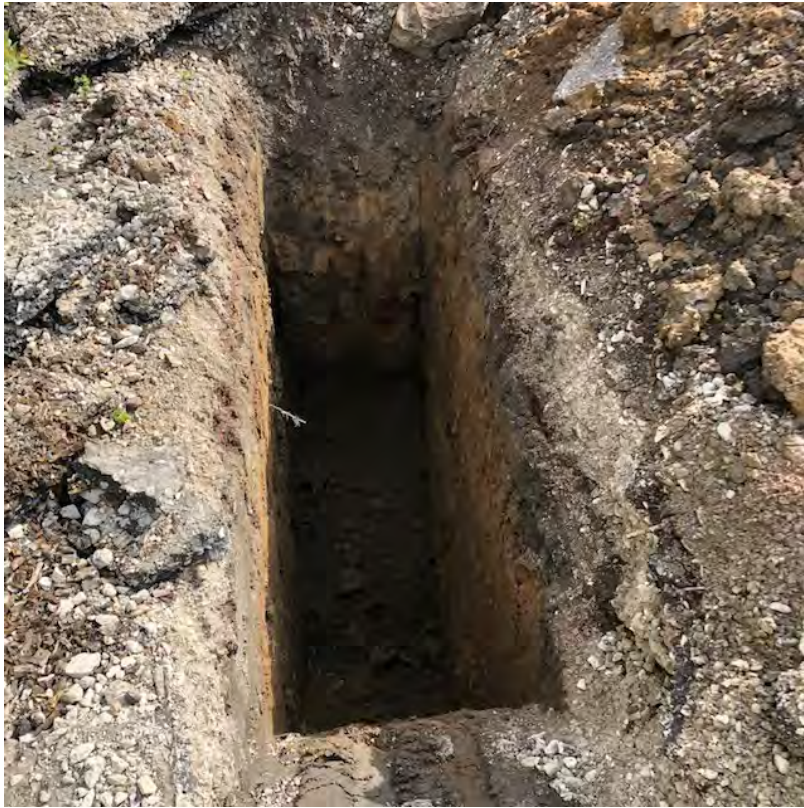
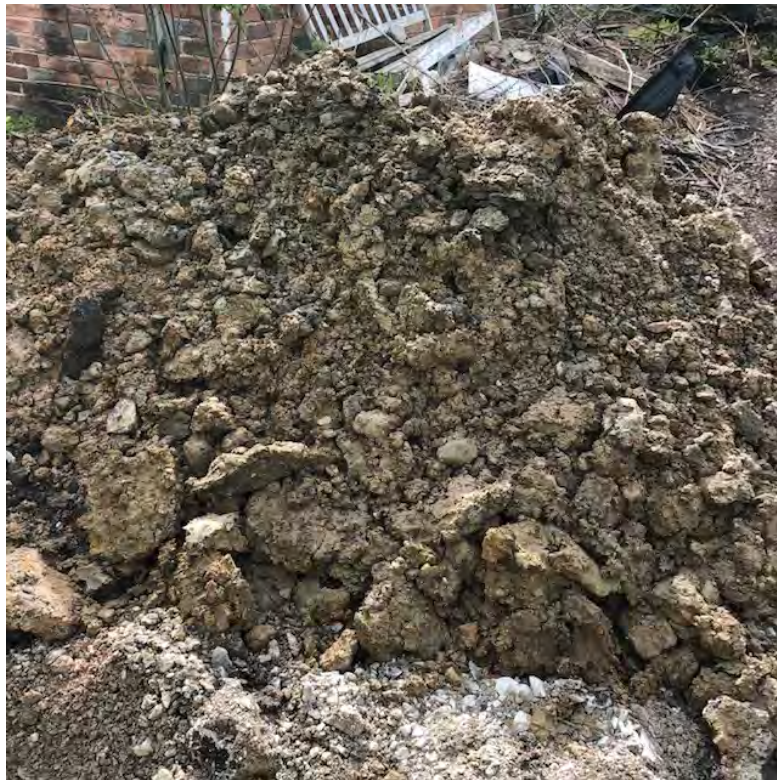
TP08- Pit Walls

TP08- Spoil

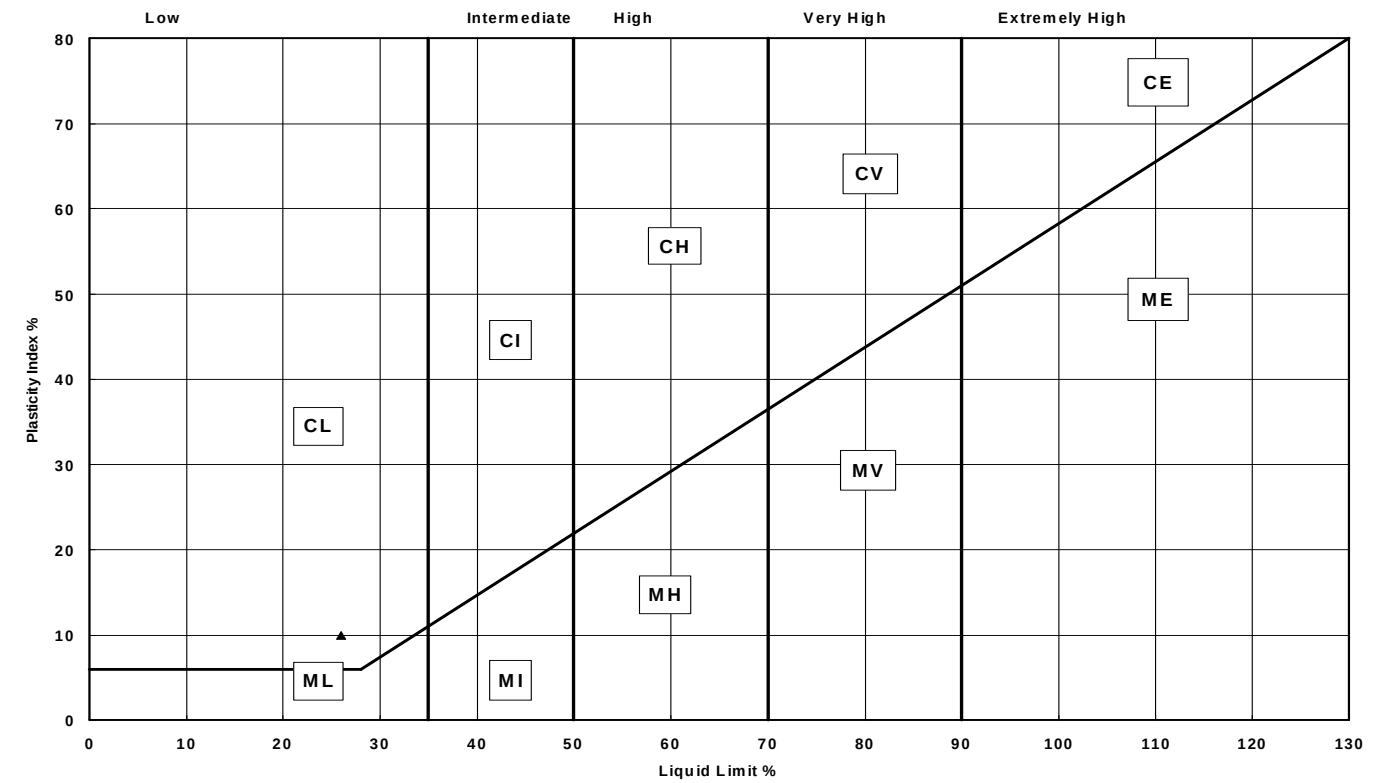
PLOT OF PLASTICITY INDEX AGAINST LIQUID LIMIT  
for all items tested

Atterberg limit testing recorded liquid limits between 25 and 48%, plastic limits between 16 and 26%, and plasticity indexes between 9 and 26%, indicating a low to intermediate plasticity clay. Natural moisture contents were between 19 and 16%.

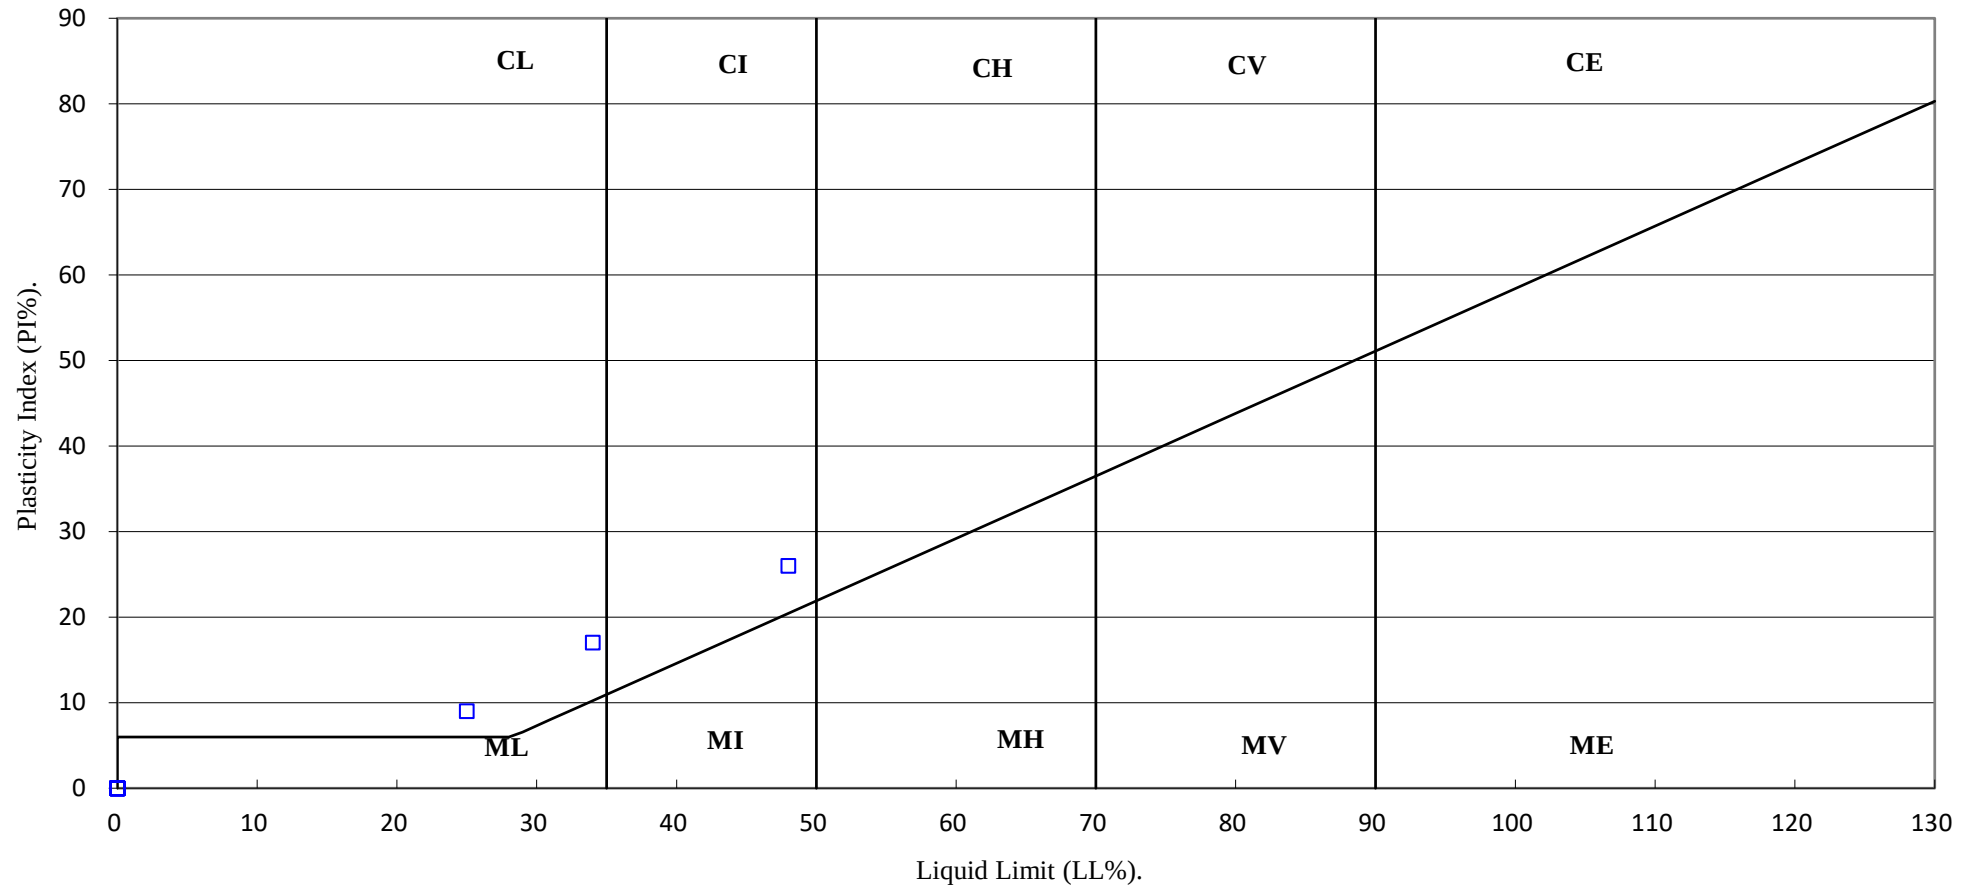
# PLASTICITY CHART FOR CASAGRANDE CLASSIFICATION.
