## Preliminary Bat Roost Assessment (PRA) Report

**Project:** (Former) Natwest Bank, Crane Street, Cefn Mawr, LL14 3AB

**Reference:** 100818MM

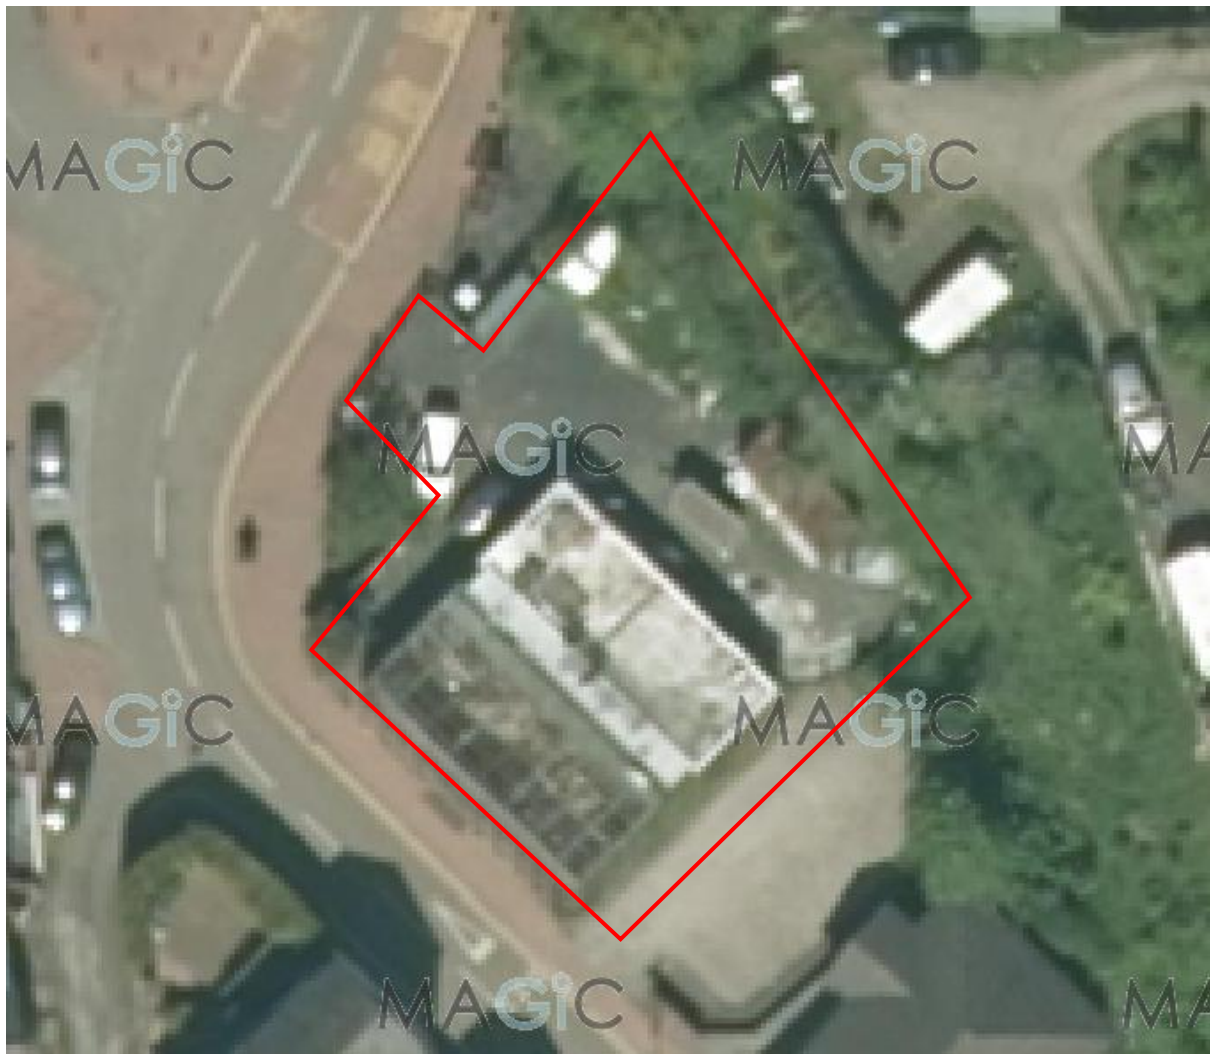
**Figure 3.2** Aerial view of the site (outlined) and near surrounds, reproduced using freely-available online mapping resources (2018)

- The site consists a single built structure, summarised below (**Figure 3.2**):
  - **B1** – a detached building of brick build with a flat roof of partial concrete and timber with a felt top (**Image 3.3**).

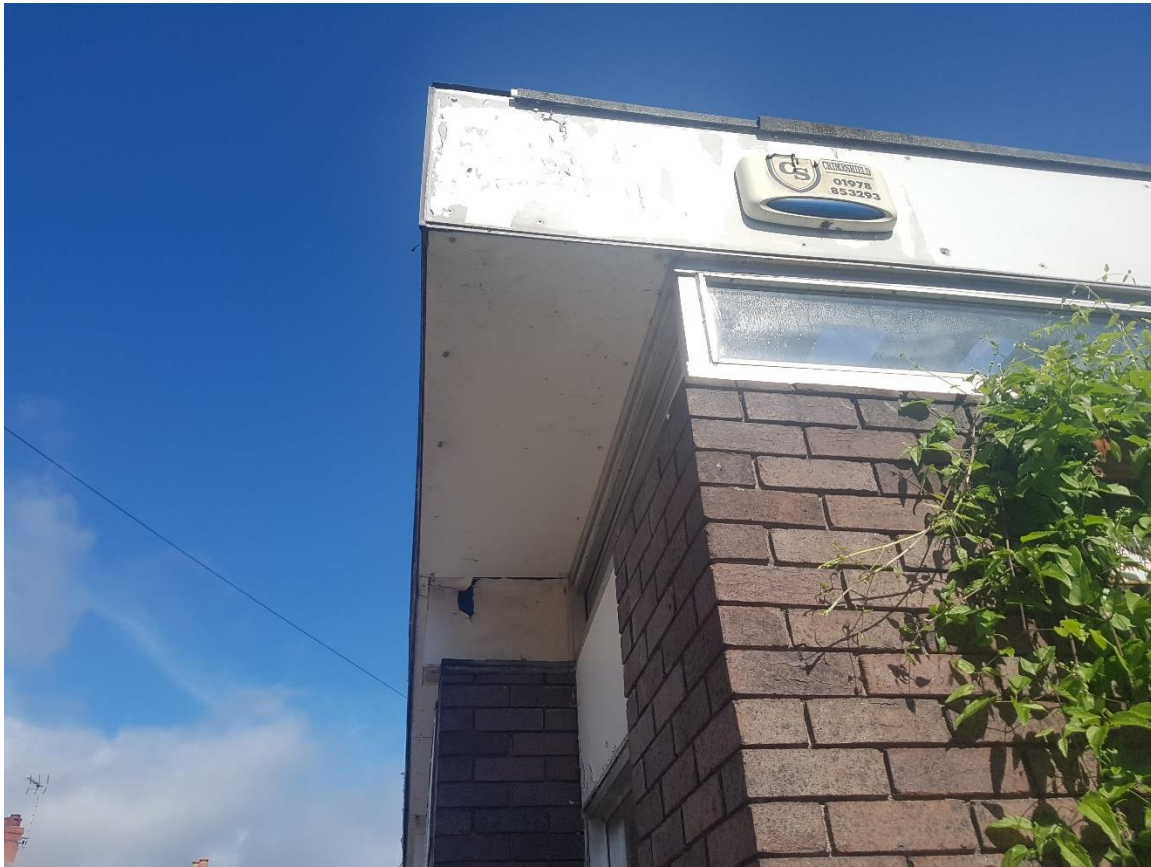
**Image 3.4** The soffits and eaves of **B1** in good condition

- **B1** (SJ 27864 42293; **Image 3.3**) is a detached single-storey building of brick build with a flat part concrete and timber roof with a felt top.
- Externally, **B1** is in good condition with tightly fitting soffits and eaves (**Image 3.4**). No potential ingress features were noted.
- The southernmost section of the building has had the roof recently removed and replaced with timber boards (**Image 3.5**). Some light infiltration suggests potential bat ingress opportunity between the timber boards, however, this has not been the historic form of the building.
- The northernmost section of the building contains a concrete roof with no potential bat ingress observed (**Image 3.6**).
- There are no loft spaces present on the building.
