## **Structure ELW/12, Cae Dyah Lane, Overton**

HE Historical Railways Estate

### **Ecological Survey Report**

ELW/12

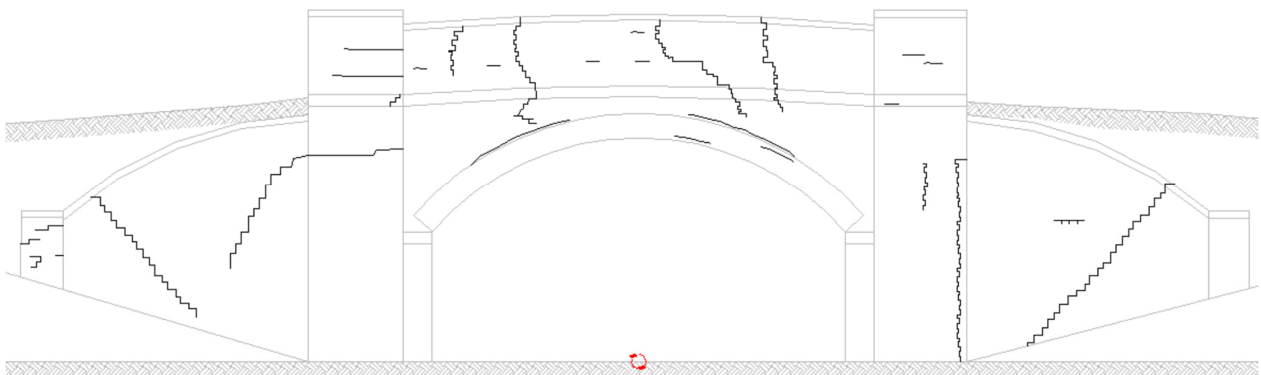
**Figure 3.1 : South elevation showing locations of the main fractures providing potential roost features**

There were a number of roosting opportunities for bats in suitable crevices on both the northern and southern elevations of the bridge. On the south elevation, horizontal and diagonal fractures in the brickwork were noted to the east and west spandrels, wing walls and parapet sections (Figure 3.1). On the northern arch face, a number of the cut bricks appear loose around the arch extrados with deep open joints to the spandrel area and collar joint. A fracture extends transversely into the soffit where the bricks are displaced. The north arch face first ring crown area has six bricks that have dropped by 15 mm creating a narrow void.

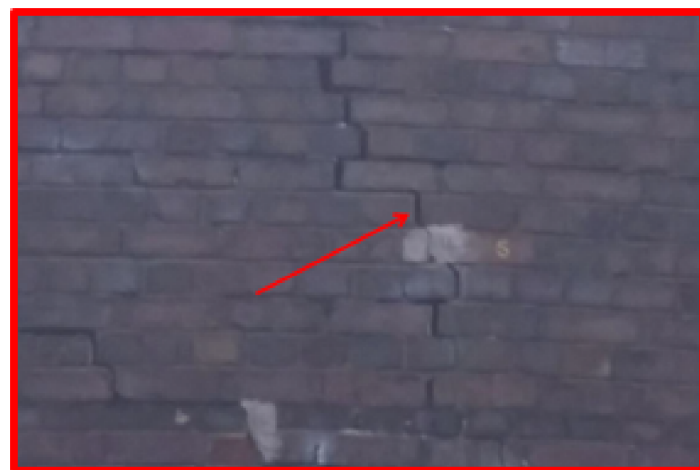
Dawn re-entry on 24/08/2016

A common pipistrelle (*Pipistrellus pipistrellus*), which had been foraging around the bridge throughout the majority of the dawn re-entry survey on 24 August 2016, was observed re-entering a cavity on the south side of the structure at about 15 minutes before sunrise.

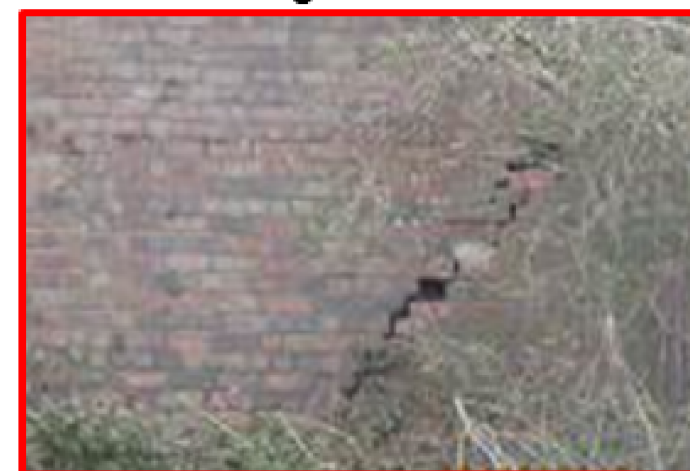
Possible emergence on 12/07/2016

There was also a possible emergence from the south of the structure during the second dusk emergence survey on 12 July 2016. Calls from two species were recorded at the time of emergence; common pipistrelle and a *Myotis* species. The area of the structure that the bat was observed flying from was obscured by dense vegetation but there were crevices extending into the structure here.

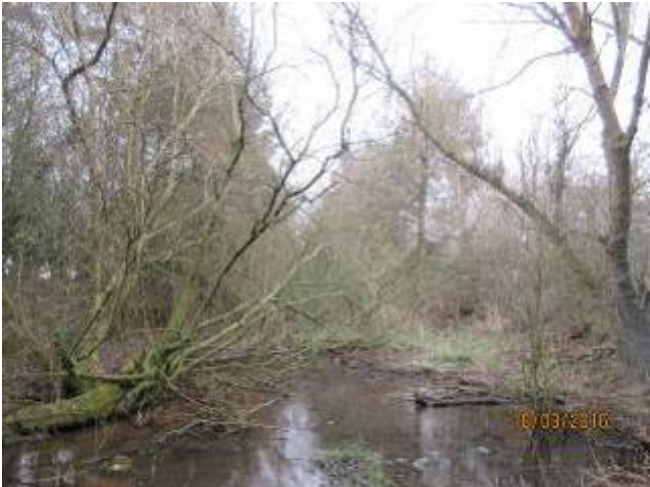
| Target Note Number | Description | |
|---|---|---|
| TN1 | Ephemeral pond underneath structure extending from under the bridge along the track bed. | |

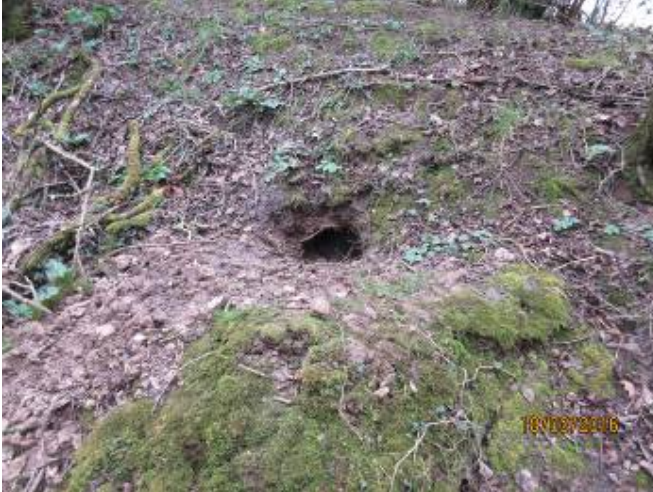
| Target Note Number | Description | |
|---|---|---|
| TN2 | Outlier single hole sett. Potentially still used by badgers. | |

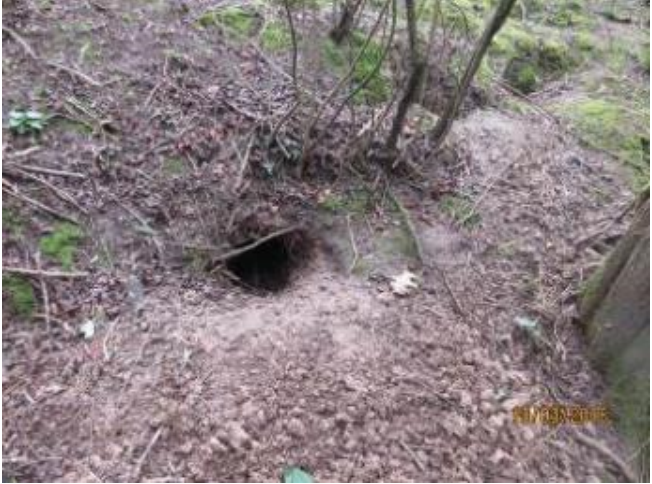
| Target Note Number | Description | |
|---|---|---|
| TN4 | Two hole outlier sett considered to be in use by badgers. | |

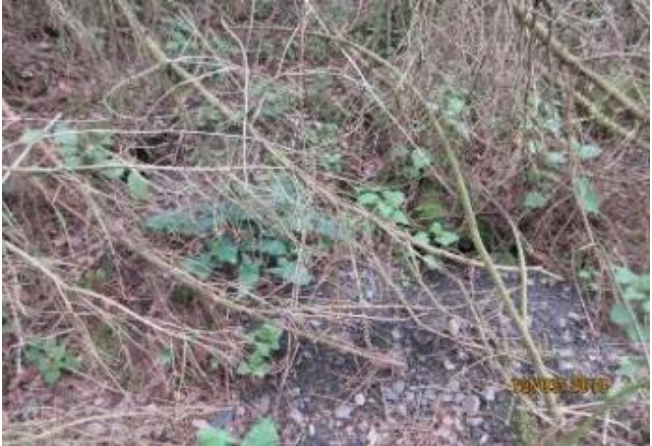
| Target Note Number | Description | |
|---|---|---|
| TN5 | Mammal signs, two collapsed badger holes used by rabbit. | |

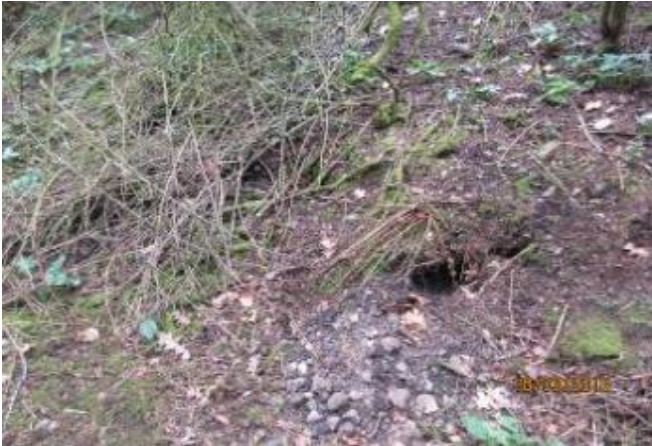
| Target Note Number | Description | |
|---|---|---|
| TN6 | Badger signs, likely to be foraging hole. | |

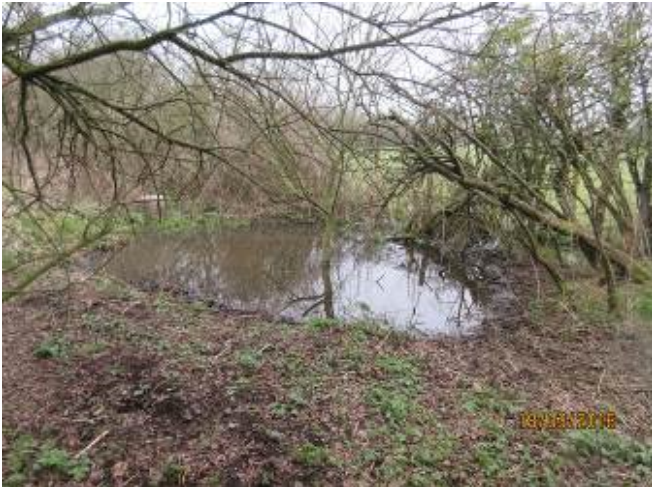
| Target Note Number | Description | |
|---|---|---|
| TN9 | Small pond, dries annually. Potential habitat for GCN. | |

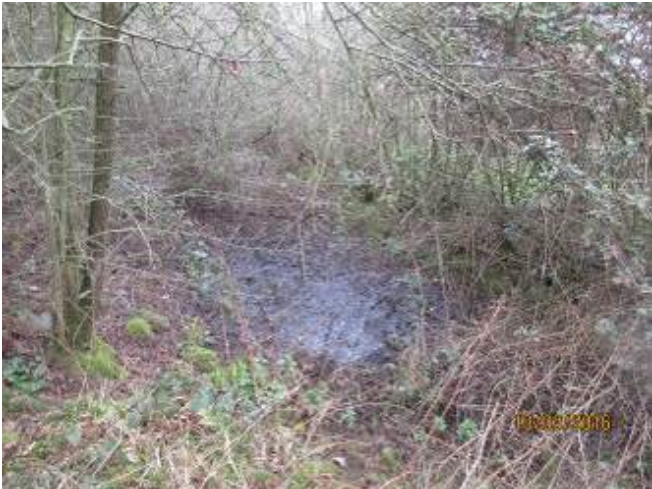
| Target Note Number | Description | |
|---|---|---|
| TN10 | Small pond, dries annually. Potential habitat for GCN. | |

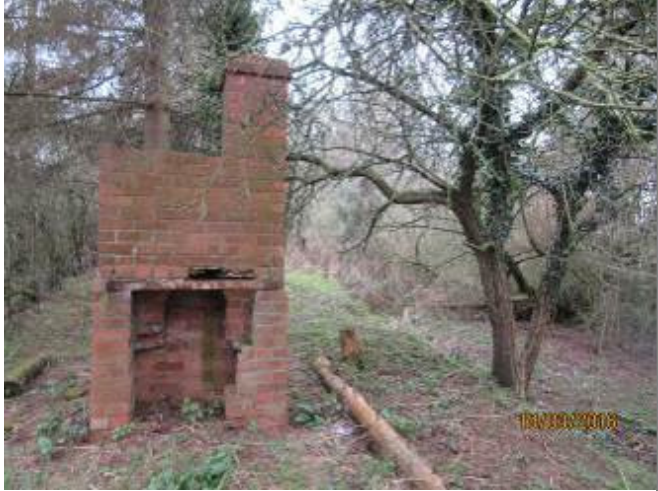
| Target Note Number | Description | |
|---|---|---|
| TN11 | Remnant chimney stack located along the track bed approximately 200m to the north of structure ELW/12. No evidence of bat roosting observed. | |

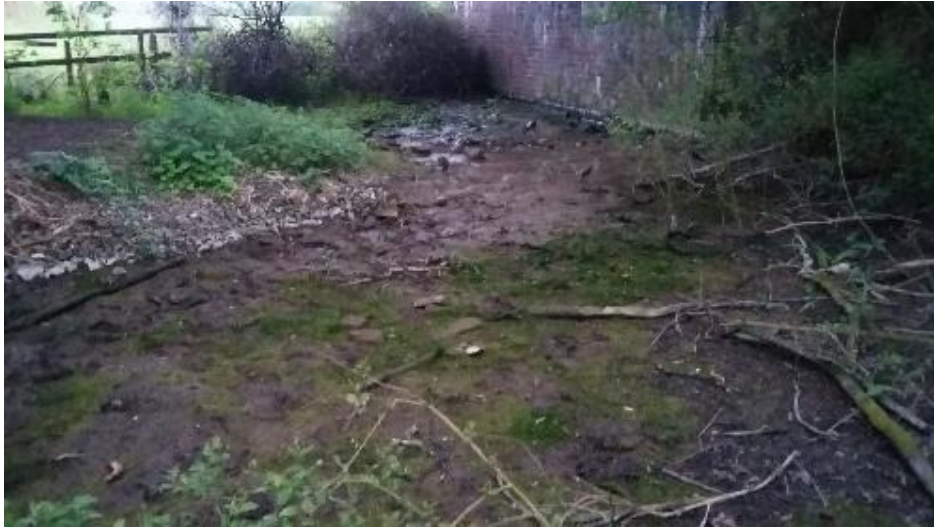
| Pond Number | Distance from structure (m) | Photograph and description |
|---|---|---|
| 1 | 0 | <p>Waterlogged area underneath structure which dries annually. Pasture field to the south and plantation woodland corridor to the north. Immediate habitat is scrub and bare ground with some grasses. Bottom is silty. Plenty of opportunities for hibernating newts in the surrounding habitat.</p> |

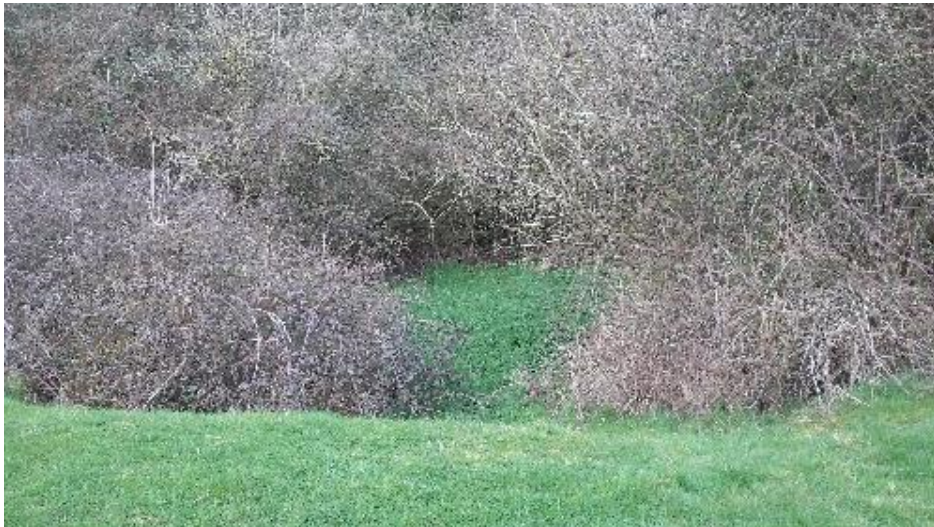
| Pond Number | Distance from structure (m) | Photograph and description |
|---|---|---|
| 2 | 75 | <p>Almost dry, depression in ground. Very shallow with grasses growing throughout. Bordered by scrub. Lies on western boundary of the southern field of Nant Holdings with woodland corridor running along the western edge which north to south down to the structure.</p> |

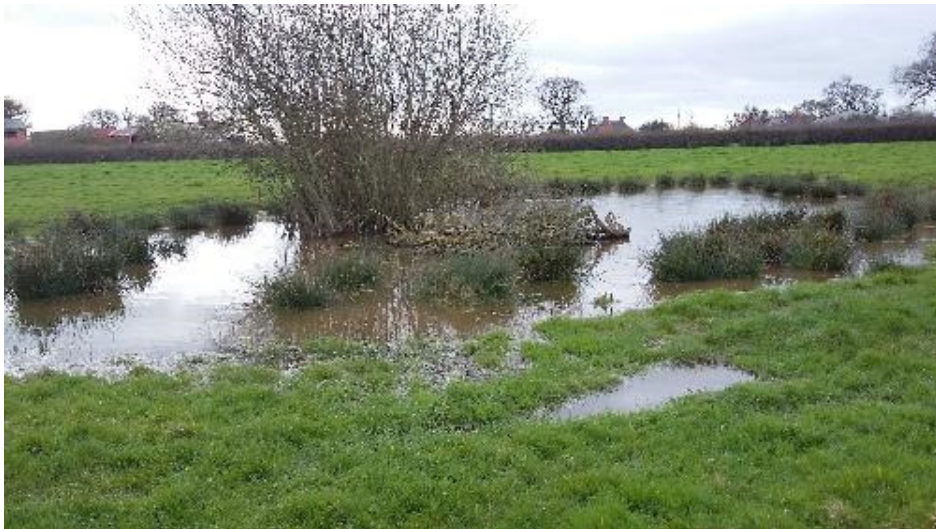
| Pond Number | Distance from structure (m) | Photograph and description |
|---|---|---|
| 3 | 150 | <p>Located in the middle of an agricultural field grazed by cows. <i>Juncus</i> sp. at the pond margins and willow scrub at the centre. Field is bounded by hedgerows.</p> |

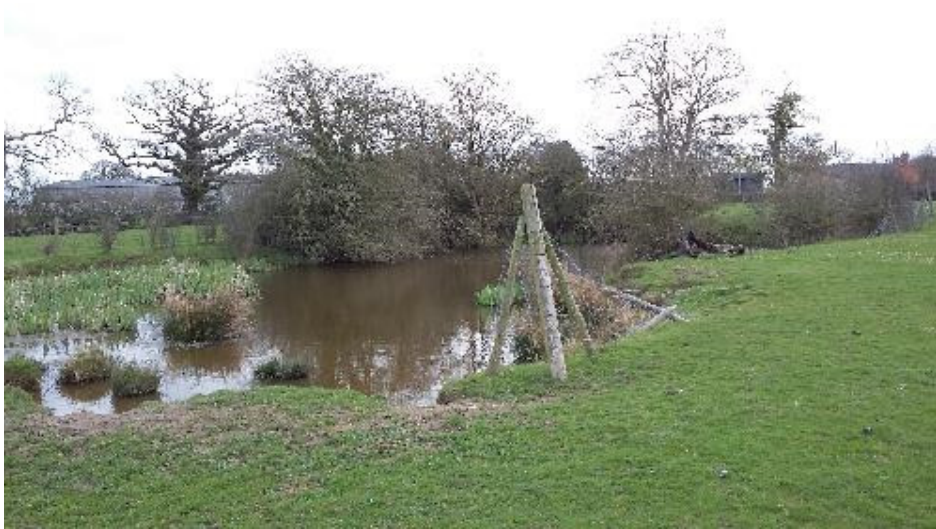
| Pond Number | Distance from structure (m) | Photograph and description |
|---|---|---|
| 4 | 230 | <p>Located at centre of agricultural field grazed by cows. Willow (<i>Salix</i> sp.), hawthorn (<i>Crataegus monogyna</i>) and blackthorn (<i>Prunus spinosa</i>) scrub and young trees. Bramble (<i>Rubus fruticosus</i> agg.), rose (<i>Rosa</i> sp.) and yellow flag iris (<i>Iris pseudacorus</i>) also present along the pond margin. Hedgerows along field margins. Evidence of poaching by cows.</p> |

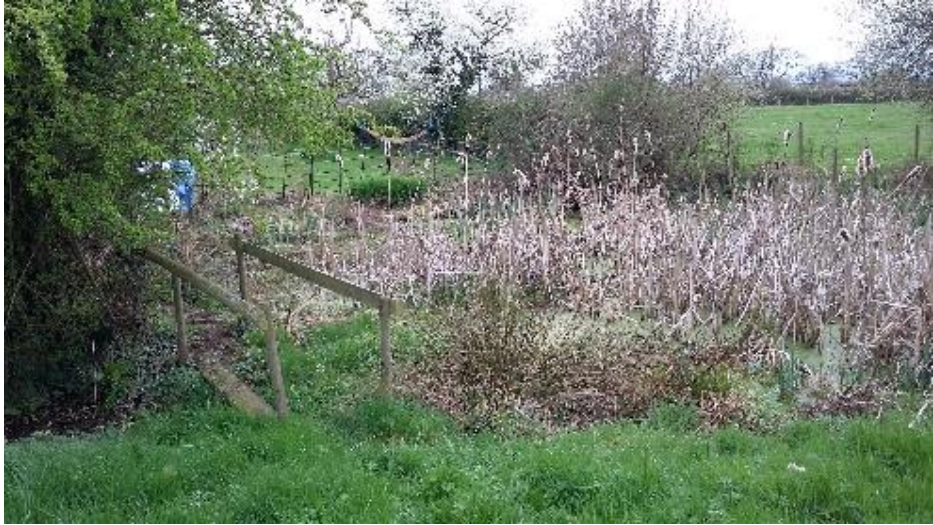
| Pond Number | Distance from structure (m) | Photograph and description |
|---|---|---|
| 5 | 125 | <p>Lots of emergent vegetation including grasses and yellow flag iris. Scrub and young trees along margins in some parts</p> |

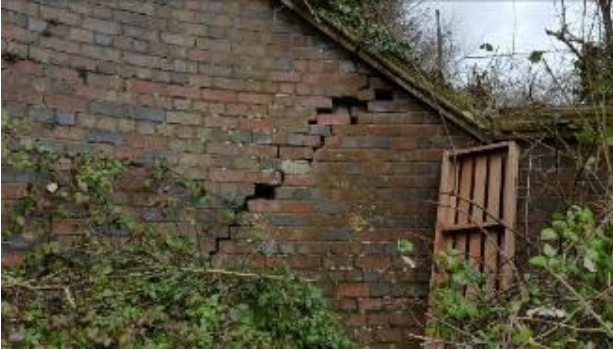
A large diagonal crack in the south east wing wall was identified as providing moderate potential for roosting bats.

| Aspect | Potential | Photograph |
|---|---|---|
| South- east Wing wall | <p>Missing brickwork and diagonal crack c. 0.5 m deep leading to multiple cavities within brickwork.</p> <p>No evidence of bat activity or hibernating bats identified, but feature is considered to have moderate potential for roosting bats</p> | |

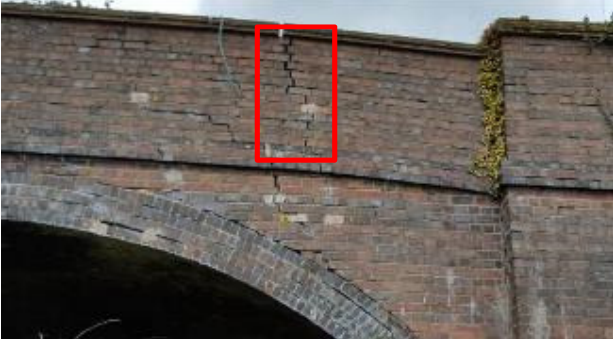
A confirmed hibernation roost of a single *Pipistrelle* species bat was found within a vertical crack in the south parapet which is in the same area as where a summer emergence was observed.

| Aspect | Potential | Photograph |
|---|---|---|
| South parapet | <p>Vertical crack c. 2 to 3 cm wide leading to multiple cavities within brickwork.</p> <p>Confirmed roost of single common pipistrelle c. 30 cm within cavity.</p> | |

The confirmed hibernation and day roost feature is within the parapet wall of the structure. This wall will be repaired and retained following the infill of the structure. Therefore, as an enhancement measure, part of the existing roost feature will be retained in this wall. The fracture will be repaired leaving a cavity suitable for roosting. The opening would be partially repointed to prevent water ingress but a suitable entry point retained.

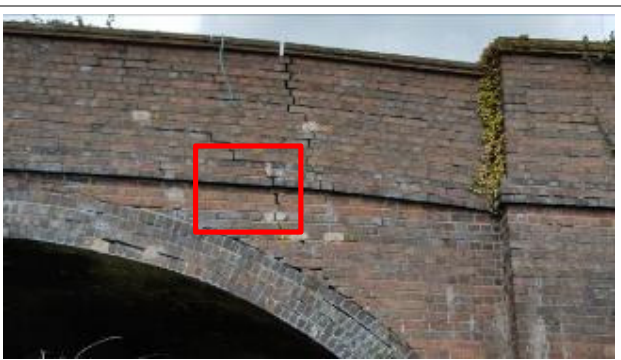
| Aspect | Potential | Photograph |
|---|---|---|
| South string course | <p>Diagonal crack passing through string course. Several cavities present up to 30 cm deep, but with much detritus and cobwebs.</p> <p>No evidence of bat activity or hibernating bats identified, but feature is considered to have low potential for roosting bats.</p> | |

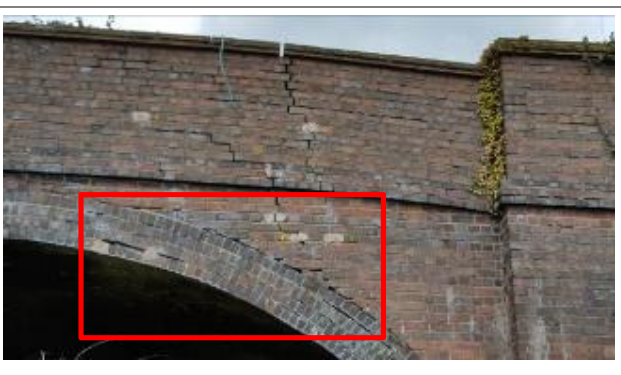
| Aspect | Potential | Photograph |
|---|---|---|
| South spandrel over arch | <p>Crack in arch and where spandrel joins arch. Loose bricks in spandrel over arch. Cracks superficial c. 2 cm deep to. Loose bricks carefully removed (and replaced) to reveal no cavities present.</p> <p>No evidence of bat activity or hibernating bats identified Feature is considered to have negligible potential for roosting bats.</p> | |

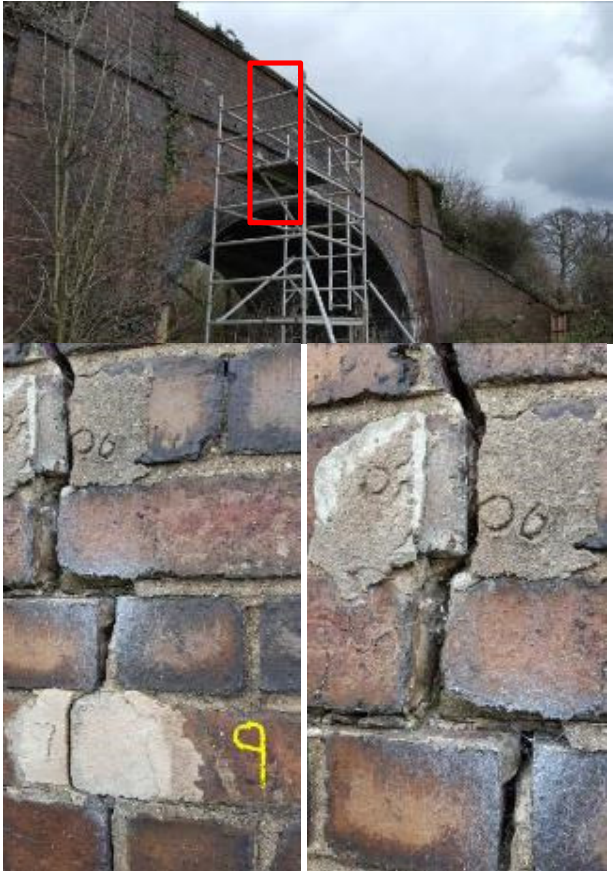
| Aspect | Potential | Photograph |
|---|---|---|
| <p>South spandrel, string course and parapet</p> | <p>Vertical crack passing through spandrel, string course and parapet. Cracks largely superficial or filled with loose mortar and cobwebs. Several wider gaps c. 1 to 2 cm extending into cavities.</p> <p>No evidence of bat activity or hibernating bats identified, but feature is considered to have low potential for roosting bats.</p> | |

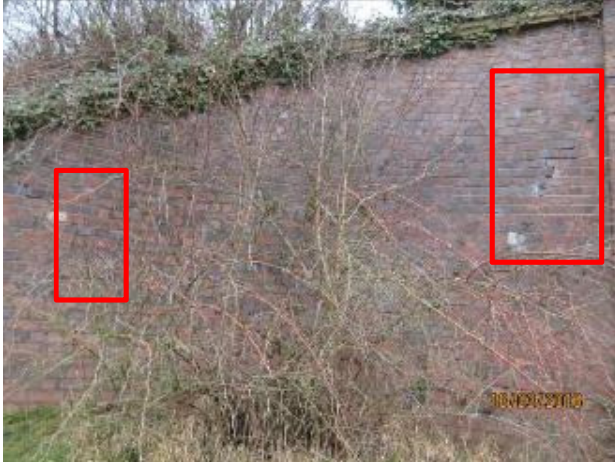
| Aspect | Potential | Photograph |
|---|---|---|
| <p>South-west wing wall</p> | <p>Two diagonal cracks in brickwork/masonry c. 1 cm wide. Relatively superficial with some areas leading into deeper cavities.</p> <p>No evidence of bat activity or hibernating bats identified, but feature is considered to have low potential for roosting bats.</p> | |

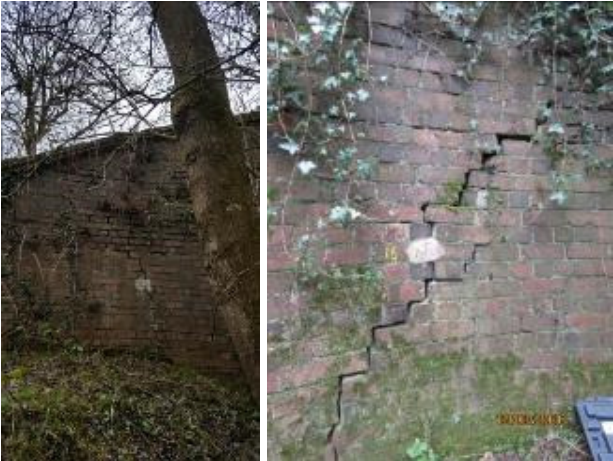
| Aspect | Potential | Photograph |
|---|---|---|
| North west and east wing walls | <p>Diagonal cracks c. 1 to 2 cm wide leading into cavities. Several areas within the cracks on both the west and east wing walls extending deeper into restricted cavities, with loose mortar, cobwebs and tree/shrub roots.</p> <p>No evidence of bat activity or hibernating bats identified, but feature is considered to have low potential for roosting bats.</p> | |

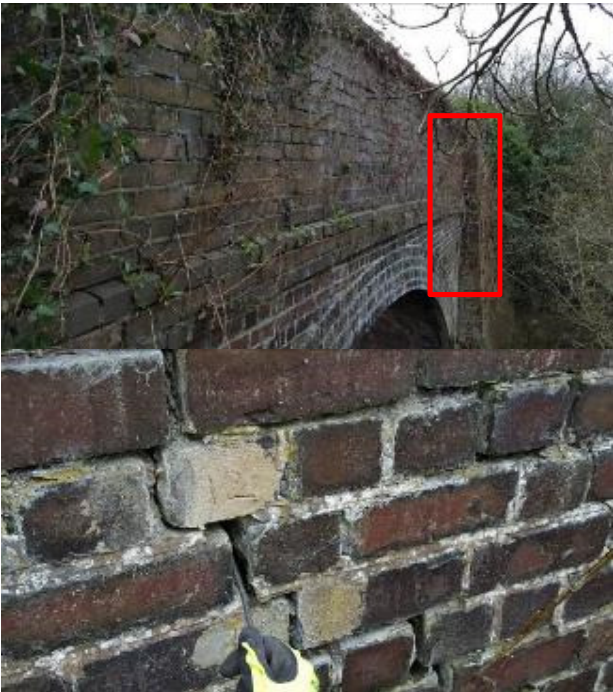
| Aspect | Potential | Photograph |
|---|---|---|
| North arch, spandrel and parapet | <p>Majority of cracks/missing mortar were identified at height as being largely superficial. A horizontal crack c. 1 to 2 cm wide passing through monitoring point twelve extended c. 30 cm into cavity was found to be largely restricted by loose mortar, cobwebs and bramble roots.</p> <p>No evidence of bat activity or hibernating bats identified, but feature is considered to have low potential for roosting bats.</p> | |

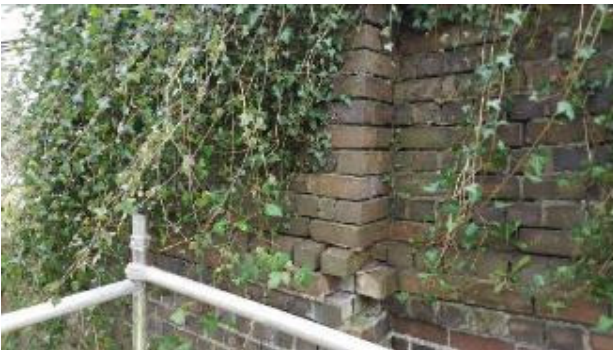
| Aspect | Potential | Photograph |
|---|---|---|
| North west pilaster | <p>Loose/missing brickwork and missing mortar found to be superficial, with no cavities identified.</p> <p>No evidence of bat activity or hibernating bats identified Feature is considered to have negligible potential for roosting bats.</p> | |
