# BAT SURVEY AND MITIGATION REPORT

BROAD OAK FARM BARNS, ROSSETT

19 OCTOBER 2018

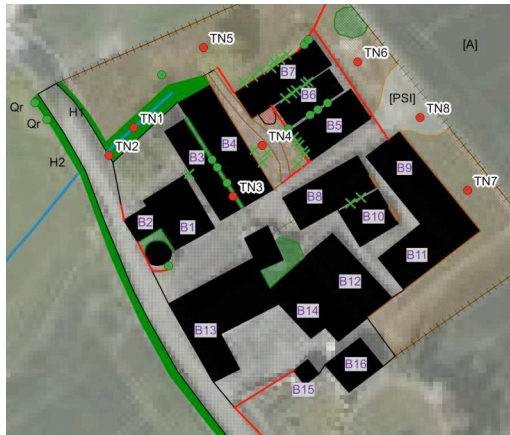
**Plate 1: Location of buildings**

3.4.3 Many of the buildings are attached to each other and so some of the buildings were surveyed collectively. Nevertheless, all of the external walls were covered by strategic positioning of the surveyors. Plate 1 below shows location of buildings (taken from Bowland Ecology Ecological Appraisal).
