# TABOR HILL, COEDPOETH

Geotechnical Design Report, Rev B  
September 2018

Job No: 15101

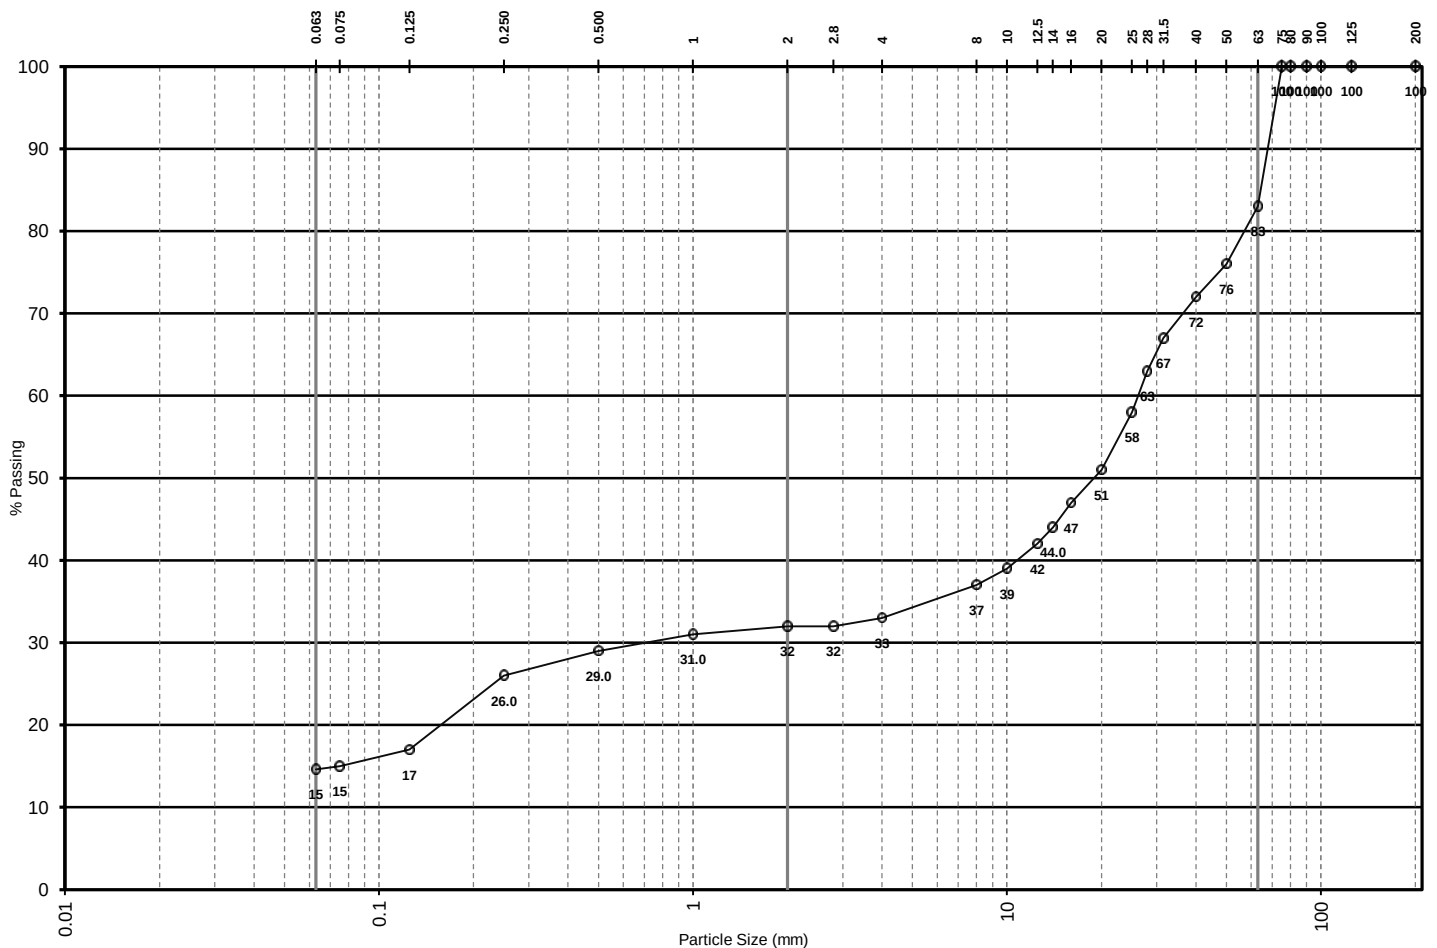
**MATERIAL DESCRIPTION**

Stoney Brown Clay

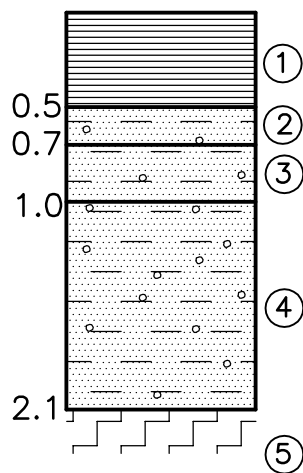
# TP1

SIDES STABLE  
NO GROUND WATER  
ENCOUNTERED

- ① loose FILL – building debris
- ② dark brown, firm, sandy, slightly gravelly CLAY
- ③ brown, firm, very sandy, slightly gravelly CLAY
- ④ orange/brown, firm, very sandy, slightly gravelly CLAY with angular cobbles
- ⑤ fractured BEDROCK with gravels and sand

The trial pit logs show that rock is present at 2.1m in TP1 and also the increase in angular cobbles would suggest that rock was near to the termination depth in the remain three trial pits (TP2-TP4).

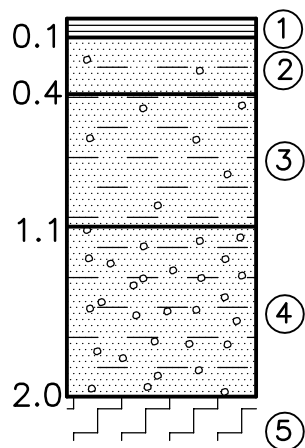
## TP2

SIDES STABLE  
NO GROUND WATER  
ENCOUNTERED

- ① BLACKTOP
- ② dark brown, firm, sandy, slightly gravelly CLAY
- ③ brown, firm, very sandy, slightly gravelly CLAY
- ④ medium dense, well graded, silty, sandy, clayey GRAVEL with cobbles
- ⑤ fractured BEDROCK with gravels and sand

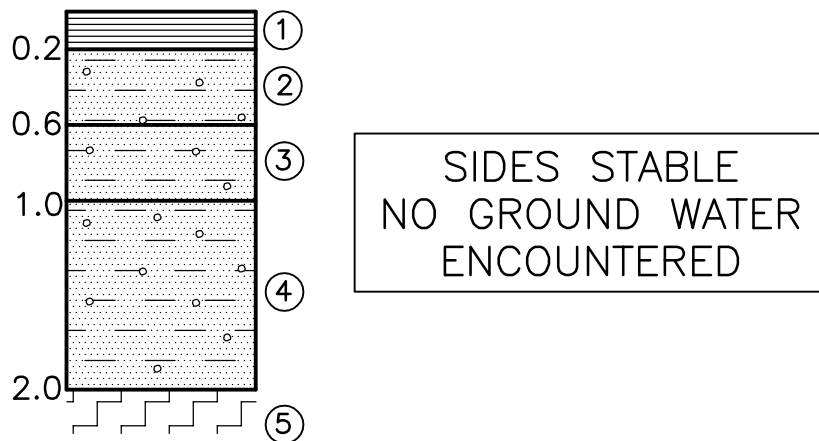
# TP3

- ① loose FILL – building debris
- ② dark brown, firm, sandy, slightly gravelly CLAY
- ③ brown, dense, very sandy, slightly gravelly CLAY with boulders
- ④ orange/brown, firm, very sandy, slightly gravelly CLAY with angular cobbles
- ⑤ fractured BEDROCK with gravels and sand

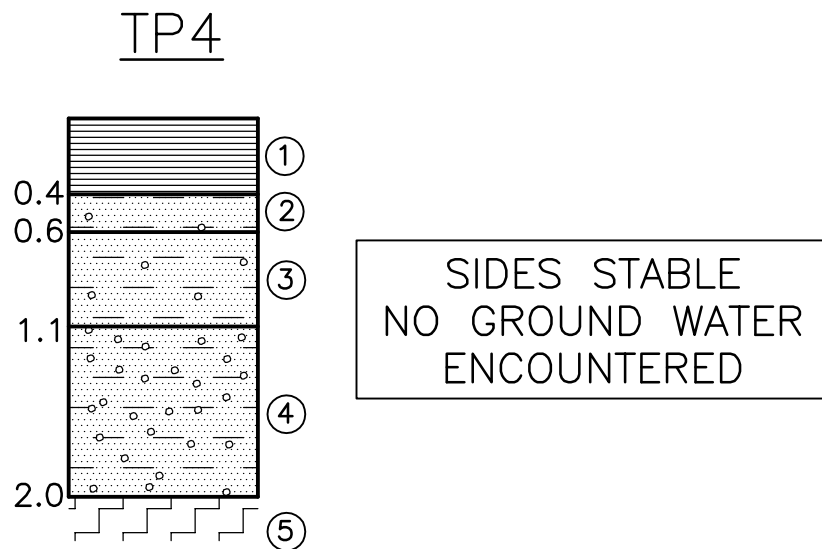
- ① dense FILL – building debris
- ② dark brown, firm, sandy, slightly gravelly CLAY
- ③ brown, firm, very sandy, slightly gravelly CLAY
- ④ medium dense, well graded, silty, sandy, clayey GRAVEL with boulders
- ⑤ fractured BEDROCK with gravels and sand
