Our ref: 2752-CAU-XX-XX-RP-C-0301.A0-C1

**Re: Infiltration Testing at the former Gredington Arms Public House, Wrexham**

Caulmert Ltd was commissioned by TACP Architects Ltd (TACP) to undertake an infiltration investigation of soils in accordance with Building Research Establishment Digest (BRE) 365 Soak Away Design:2016 [1] at the former Gredington Arms, Llan-y-Pwll (the Site). This letter presents details of works undertaken and the results obtained, and specifically addresses point three of the officer's comments regarding disposal of surface waters. Points one and two are being dealt with under separate correspondence and are not considered as part of this report.

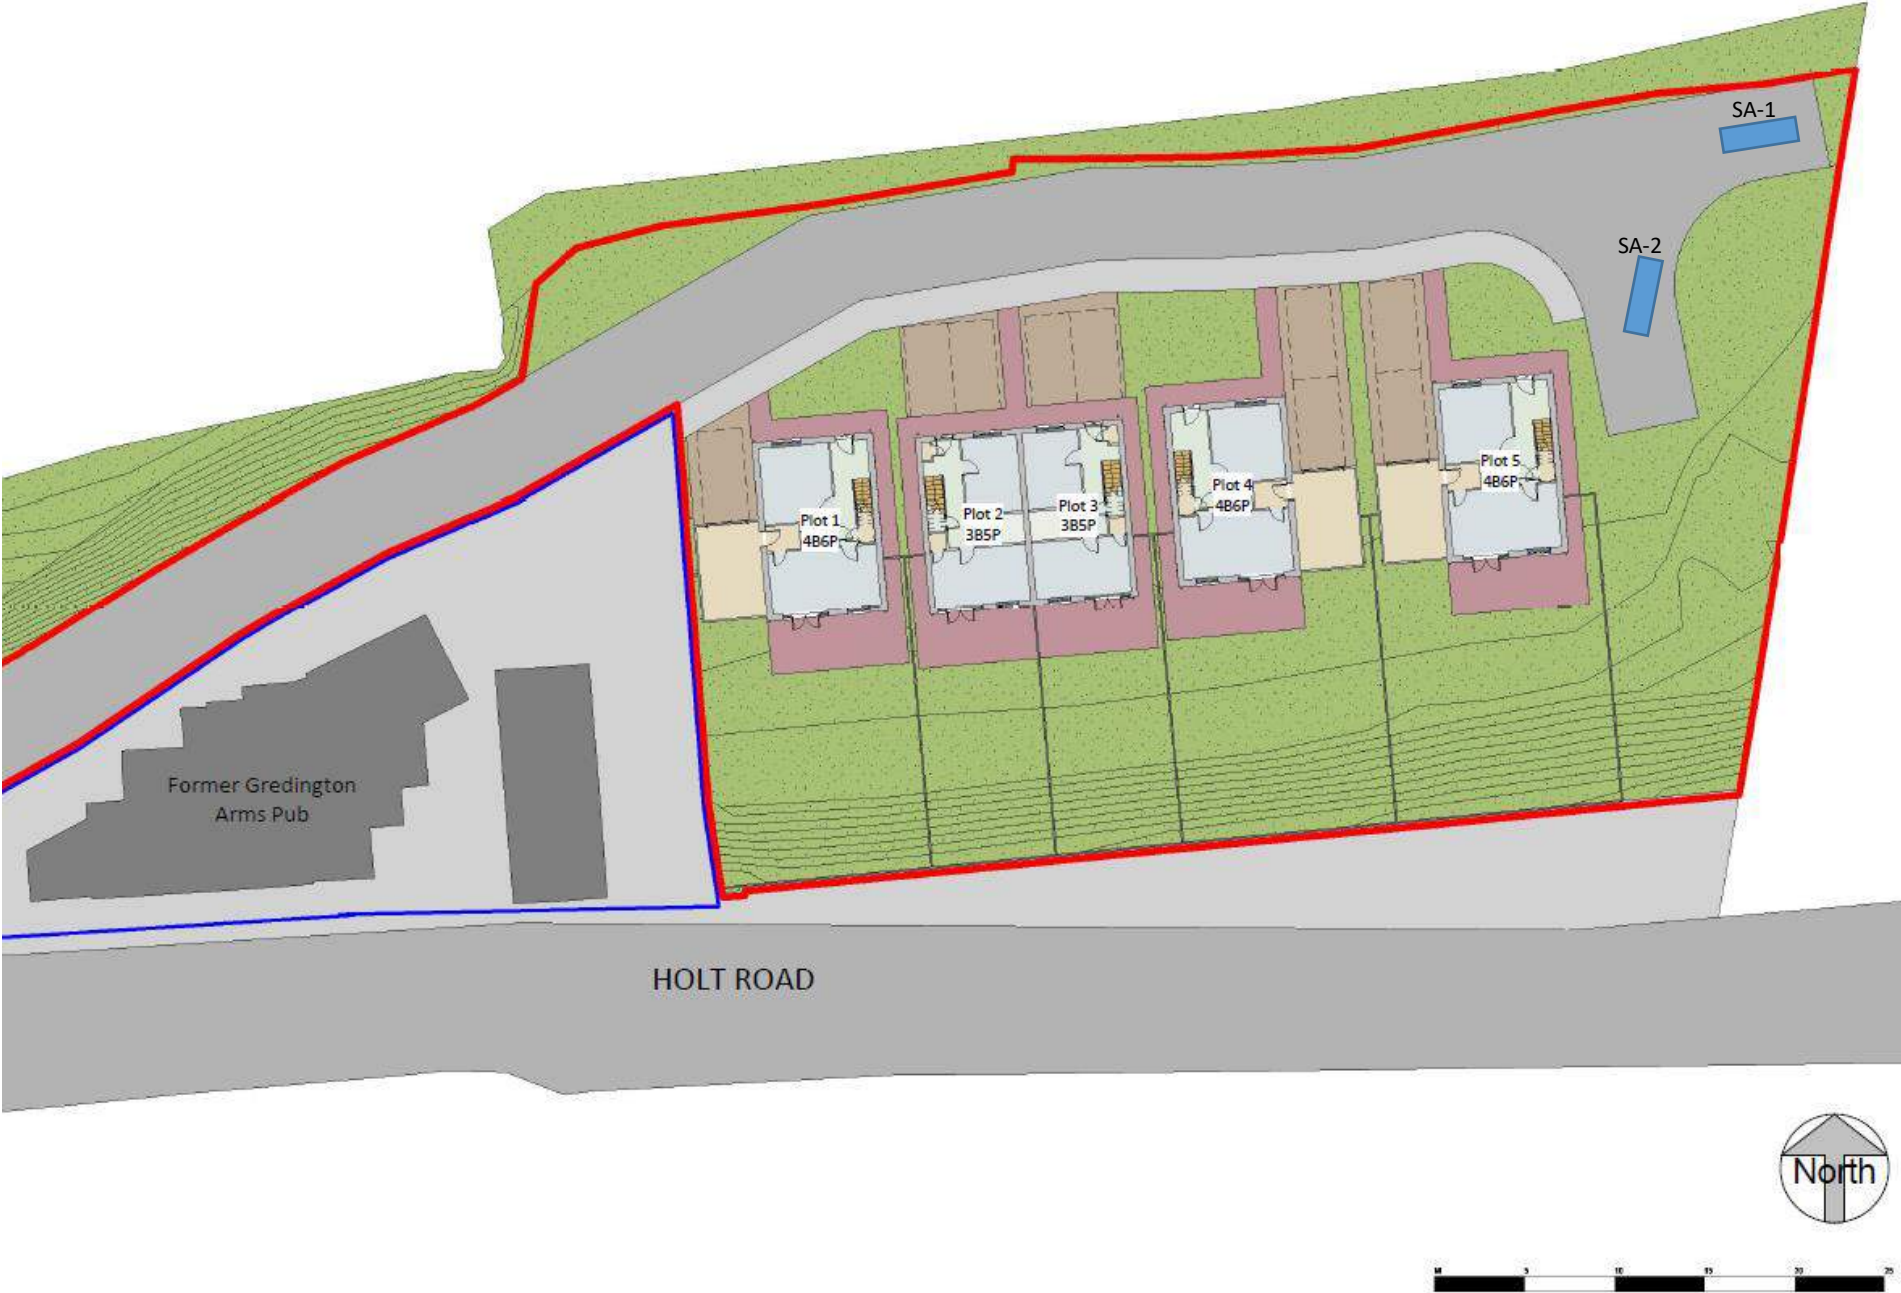
Figure 1 - Exploratory Hole Layout Plan

The infiltration testing was undertaken at the eastern end of the Site in an area that will comprise soft landscaping. The site layout and the location of the trial pits is shown on Figure 2.

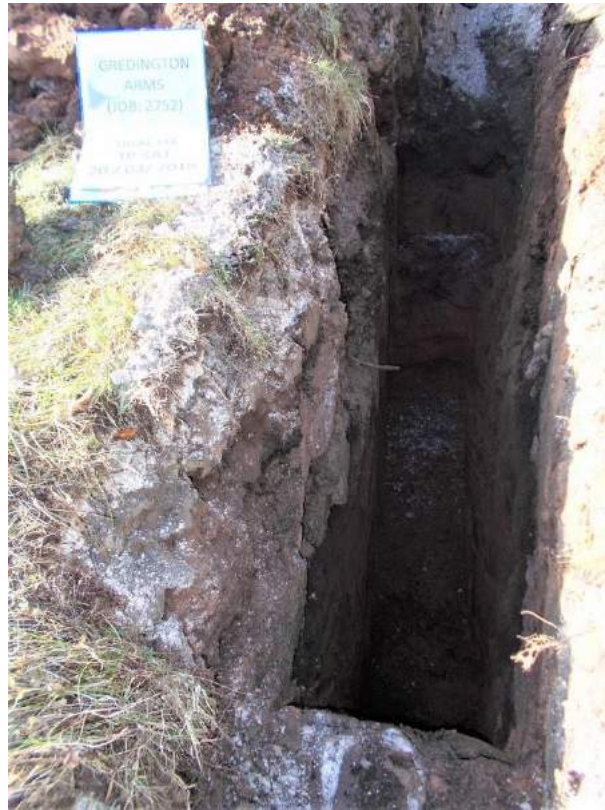
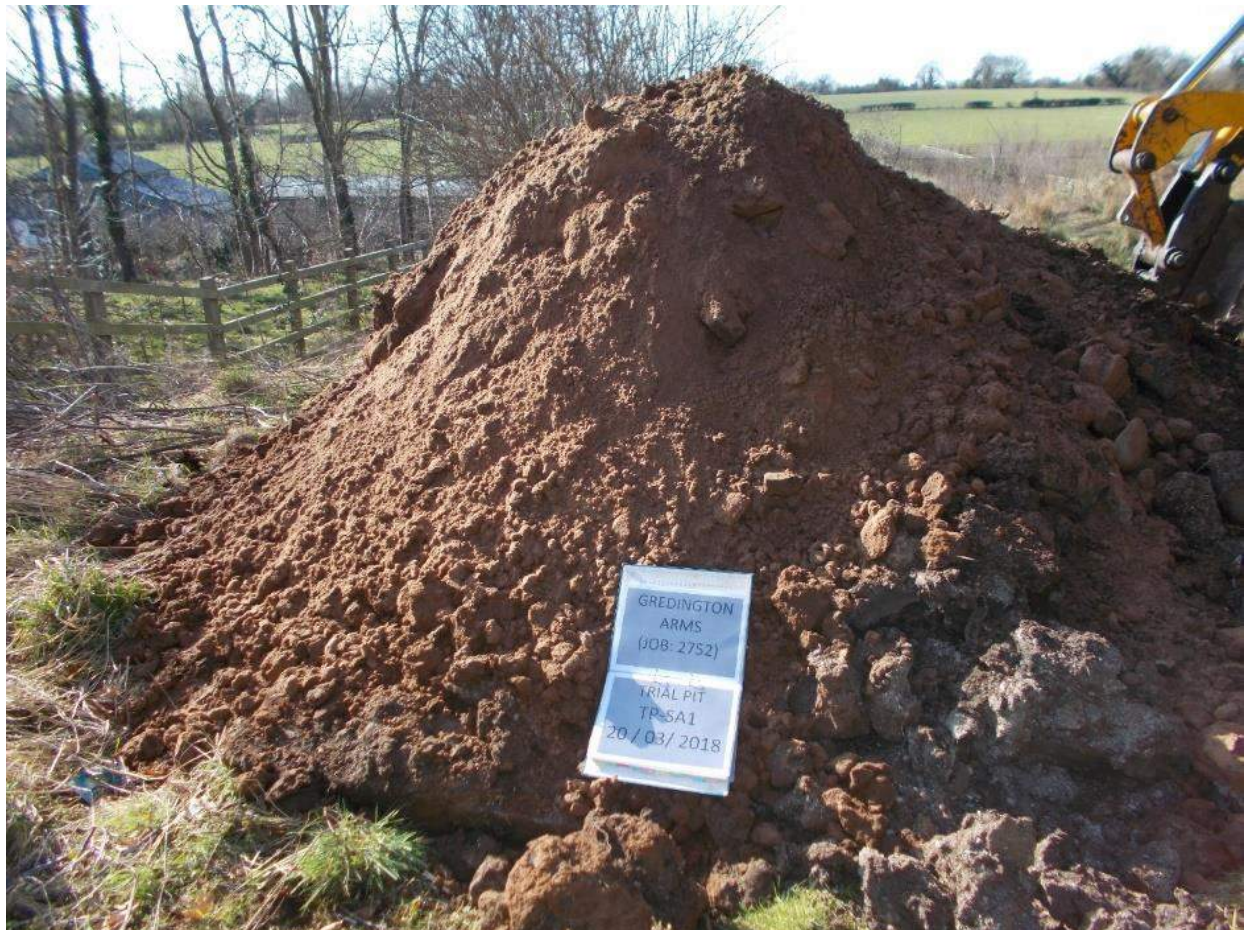
**Trial Pit Photographs**

| 0.00 | 0.25 | Medium dense grey silty sandy fine to coarse angular to sub-angular aggregate of limestone (MOT type 1 sub-base). With many rootlets in top 5cm (MADE GROUND). | | | None taken |
| 0.25 | 1.10 | Firm to stiff reddish-brown silty slightly sandy slightly gravelly CLAY. Gravel is fine to coarse angular to rounded including brick, slate, tile, limestone and mixed natural lithologies. Occasional large cobble (kerb-stone) and part and whole bricks. Concrete or sandstone obstruction on face B, possible kerb-stone. With occasional layers and pockets of orange-brown sand (MADE GROUND). | | | |
| 1.10 | 2.00 | Medium dense dark brown silty clayey fine and medium SAND with occasional rootlets. Rare fine to coarse sub-rounded to rounded gravel of mixed lithology and one piece of pottery. Damp (POSSIBLE MADE GROUND). | | | |
| 2.00 | 3.25 | Dark orange-brown becoming light orange-brown silty fine and medium SAND. Rare fine to coarse sub-rounded to rounded gravel of mixed lithology. Damp (MADE GROUND). | | | |
| <b>Excavated by</b> – JCB 3CX wheeled backhoe loader.<br><b>Plan Dimensions of Pit</b> – 3.00 x 0.70 x 3.25m (L:W:D).<br><b>Groundwater</b> – Damp below 1.10m.<br><b>Stability</b> – Sides stable during excavation except in made ground where large cobbles encountered.<br><b>Contamination</b> – None observed. | | | | | |

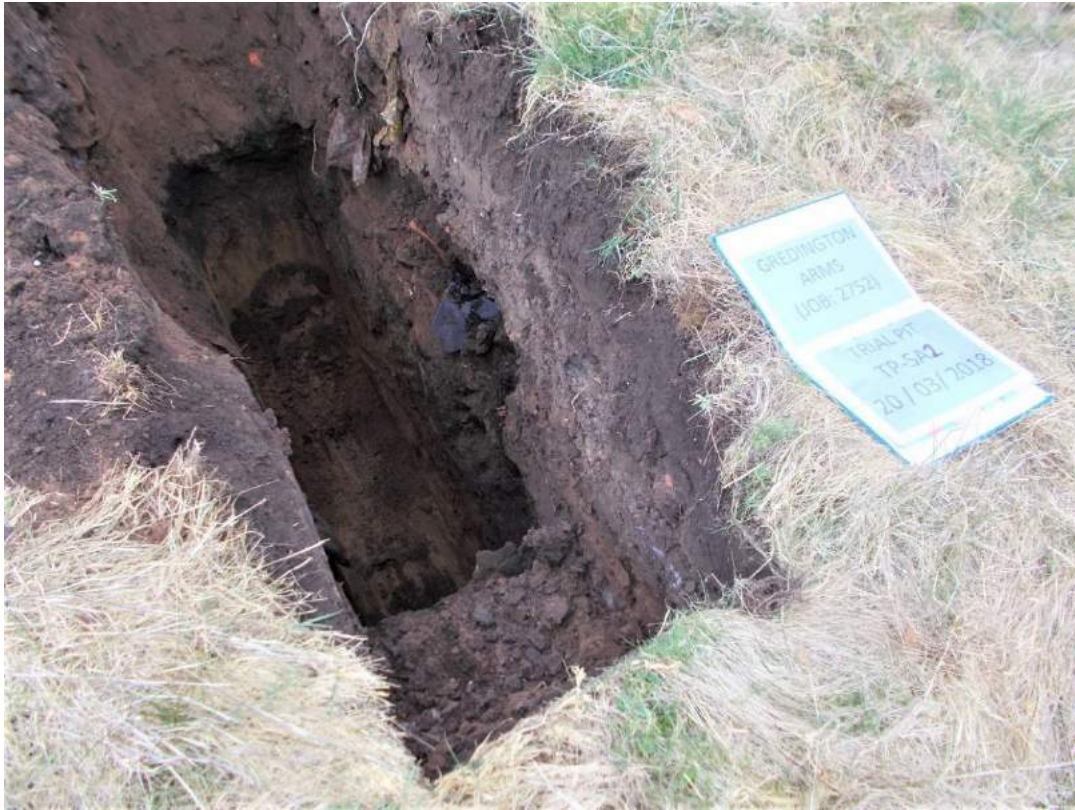
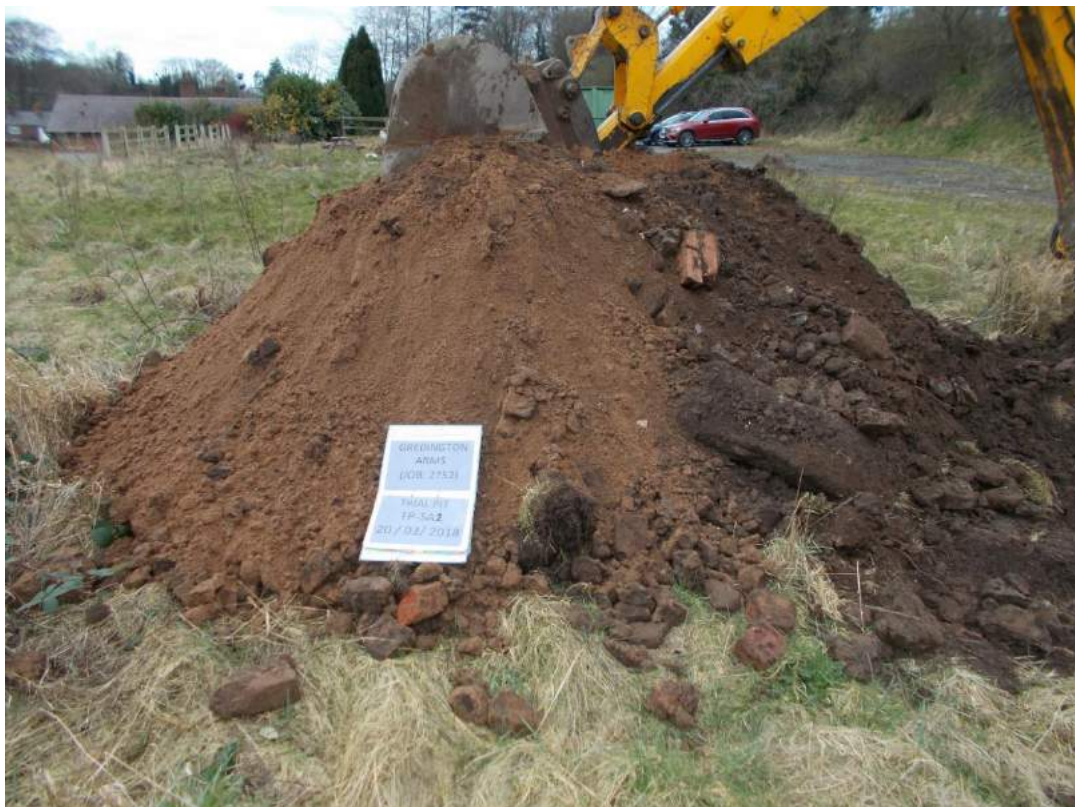
**Trial Pit Photographs:**

| | | Project:<br><br><b>Gredington Arms, Wrexham</b> | | Trial Pit:<br><br><b>SA-2</b> | |
|---|---|---|--|---|--|
| 0.00 | 0.35 | Tall grass over soft dark brown silty sandy slightly gravelly Clay with many rootlets. Gravel is fine to coarse angular to rounded including brick, metal, plastic and mixed natural lithology (MADE GROUND - TOPSOIL). | | None taken. | |
| 0.35 | 2.00 | Firm to stiff reddish-brown silty slightly sandy slightly gravelly CLAY with frequent cobbles of brick, slate, concrete and metal. Gravel is fine to coarse angular to rounded including brick, slate, tile, limestone and mixed natural lithologies (MADE GROUND). | | | |
| 2.00 | 2.95 | Orange-brown slightly silty fine and medium SAND. | | | |
| Stability – Sides spalling to 2.00m during excavation due to presence of large cobbles and bricks. | | | | | |
