## **Structure ELW/12, Cae Dyah Lane, Overton**

### **Ecological Survey Report**

## Structure ELW/12, Cae Dyah Lane, Overton

Project No: B28280BE  
 Document Title: Ecological Survey Report  
 Document No.: 1  
 Revision: Final Revision 1  
 Date: 25 July 2018  
 Client Name: HE Historical Railways Estate  
 Client No: ELW/12  
 Project Manager: Nigel Robson  
 Author: Amy Davies

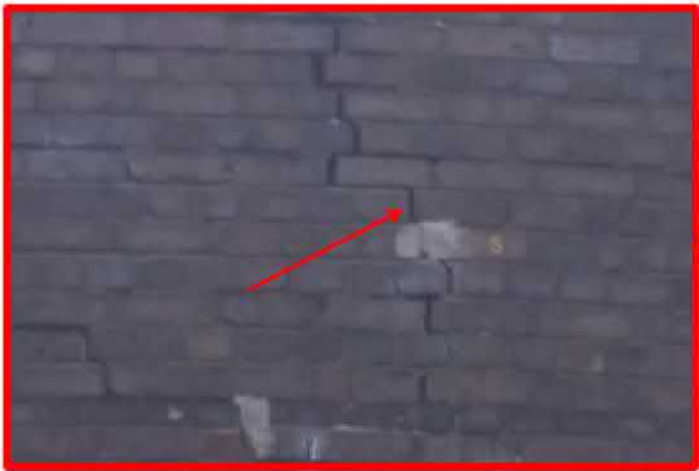
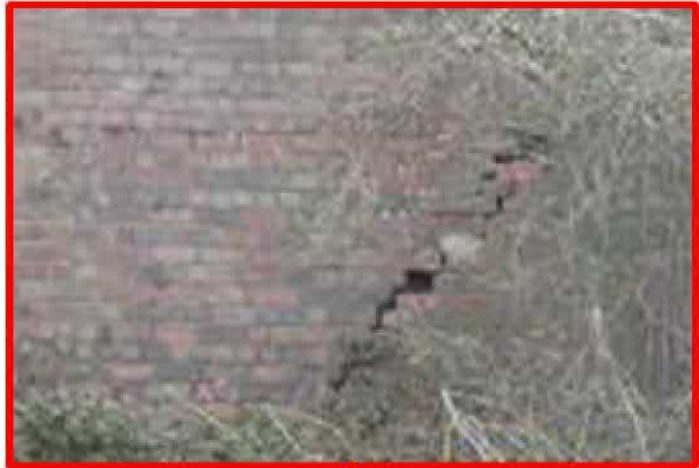
FIGURE 4

Most of the activity was observed on the south side; mainly foraging activity by pipistrelle and *Myotis* bat species, with some passes underneath the structure. The bat activity observed during the dusk emergence and dawn re-entry surveys, including locations of the emergence and re-entry described above, are shown in **Error! Reference source not found.**4, Appendix A.

Dawn re-entry on 24/08/2016

Possible emergence on 12/07/2016

Foraging activity

A common pipistrelle (*Pipistrellus pipistrellus*), which had been foraging around the bridge throughout the majority of the dawn re-entry survey on 24 August 2016, was observed re-entering a cavity on the south side of the structure at about 15 minutes before sunrise.

There was also a possible emergence from the south of the structure during the second dusk emergence survey on 12 July 2016. Calls from two species were recorded at the time of emergence; common pipistrelle and a *Myotis* species. The area of the structure that the bat was observed flying from was obscured by dense vegetation but there were crevices extending into the structure here.

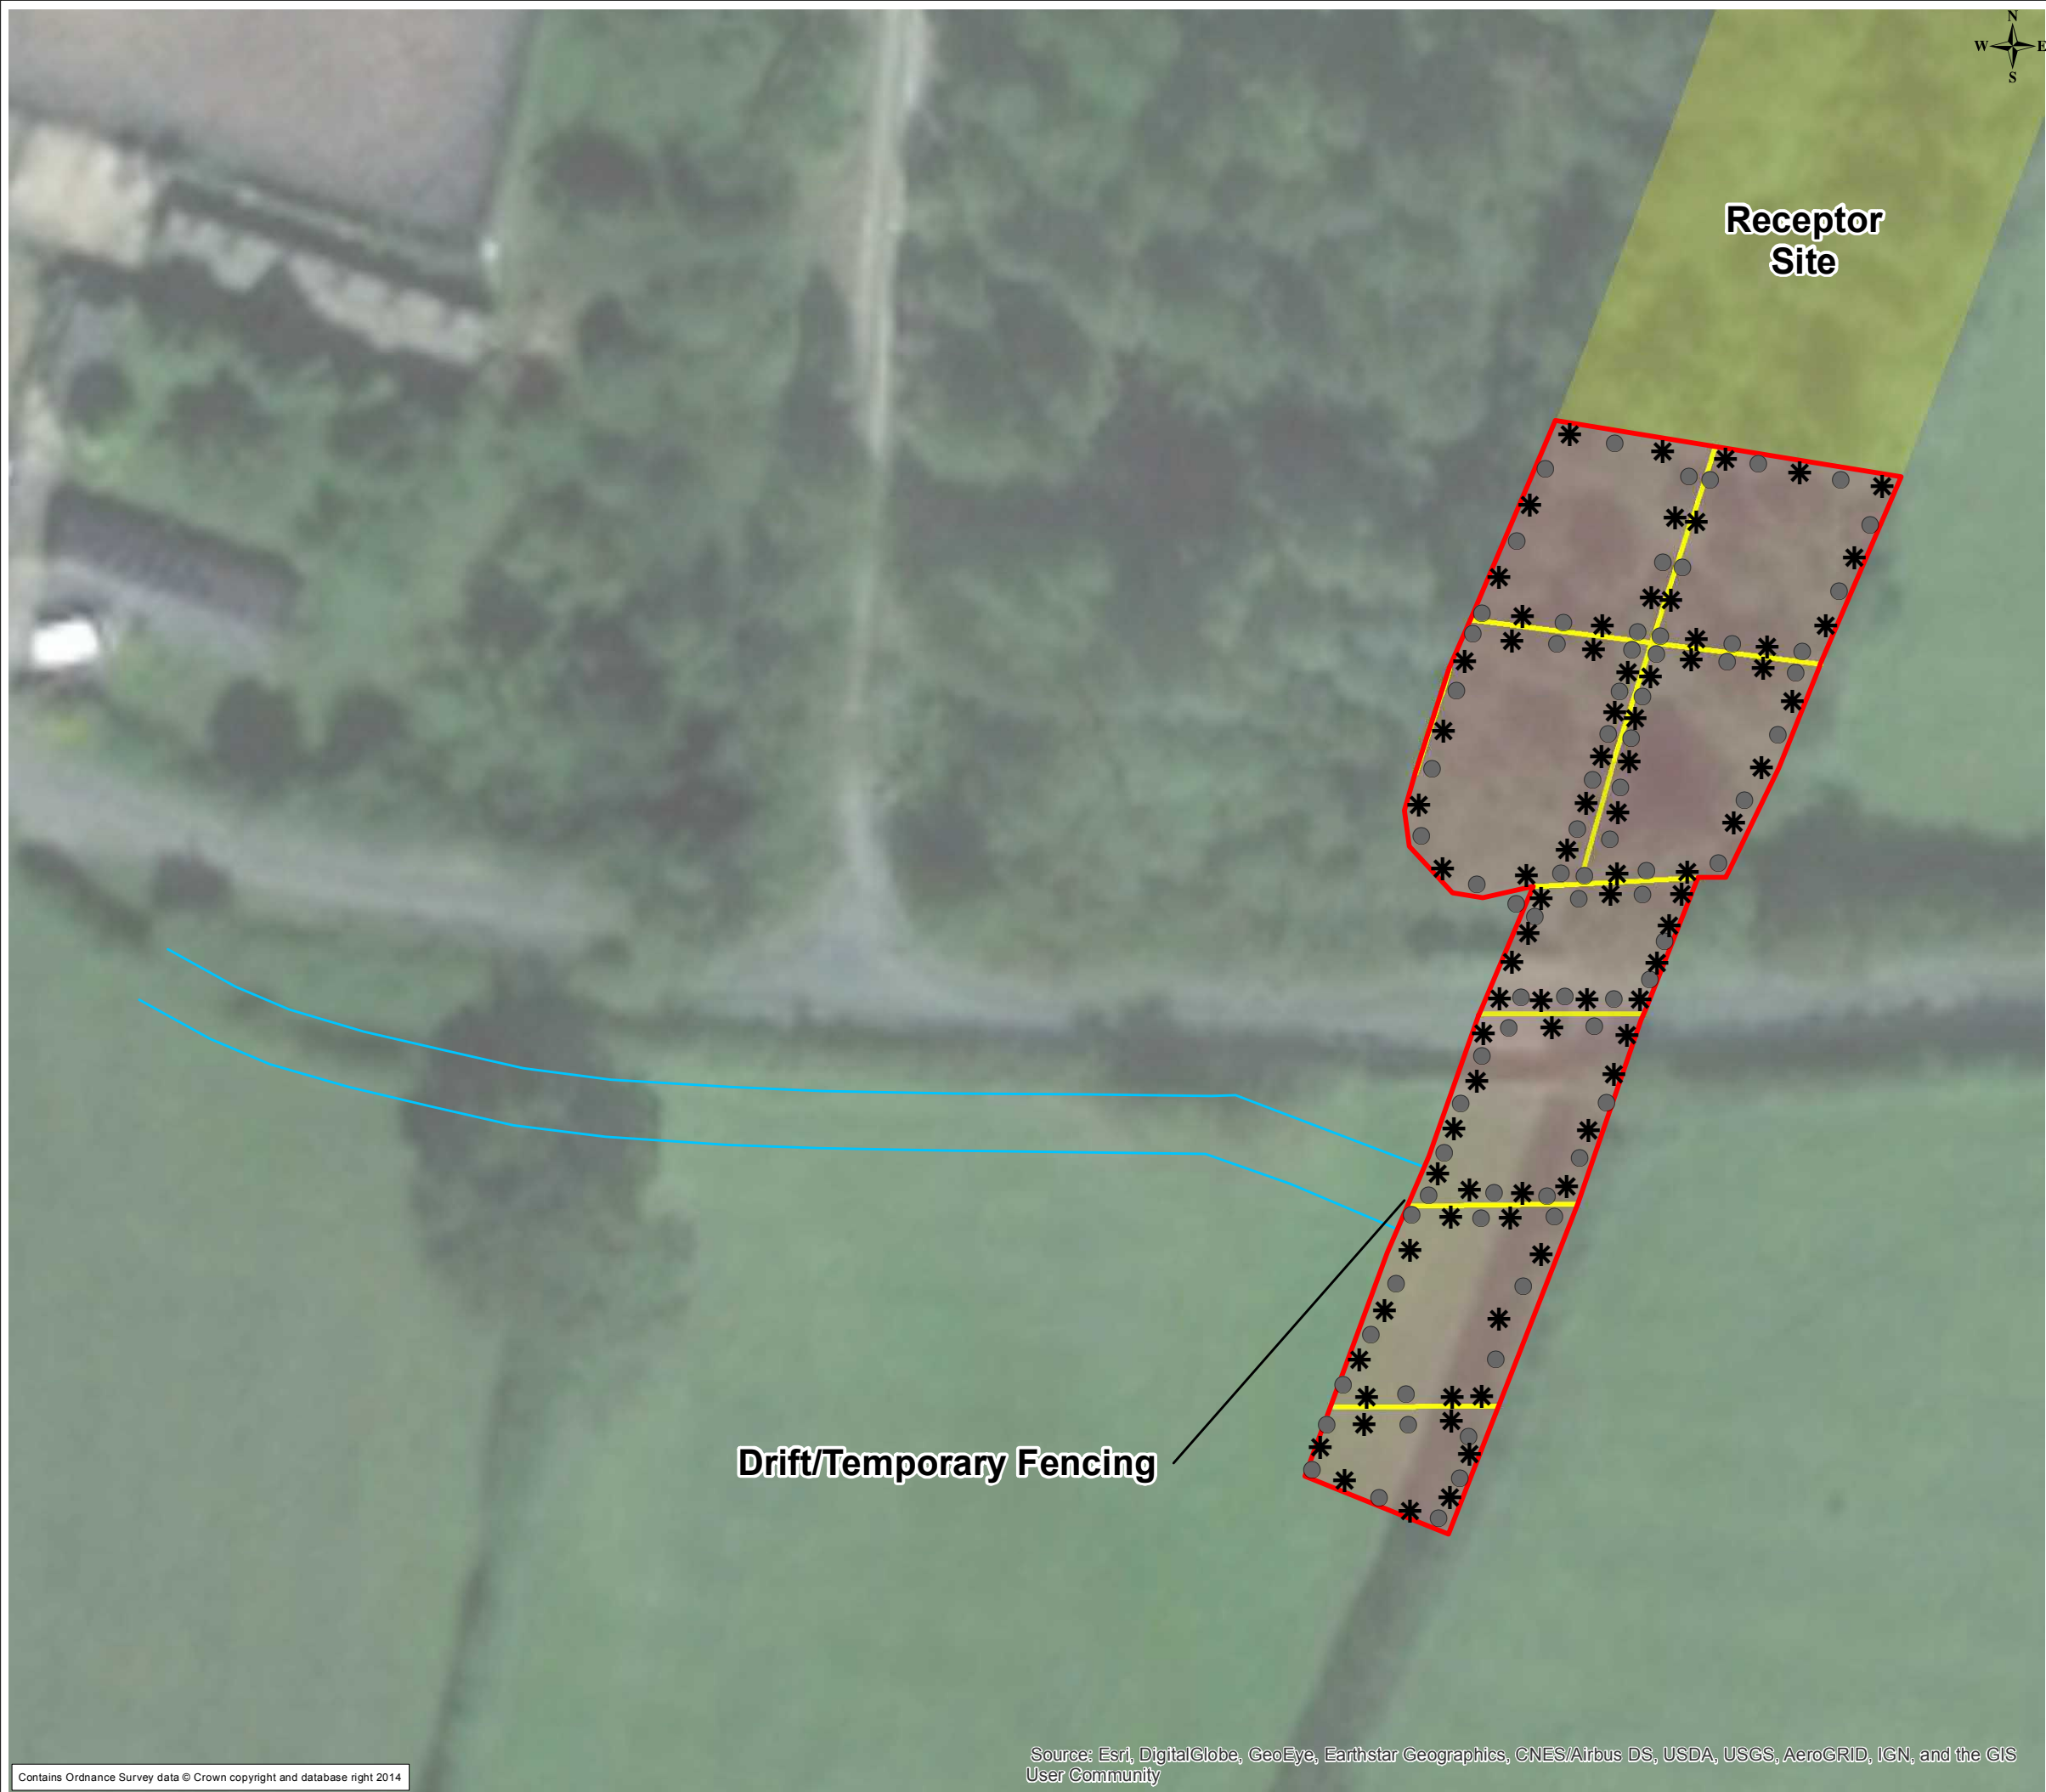
Figure 5

Figure 5: Example of potential GCN fence and pitfall trap layout

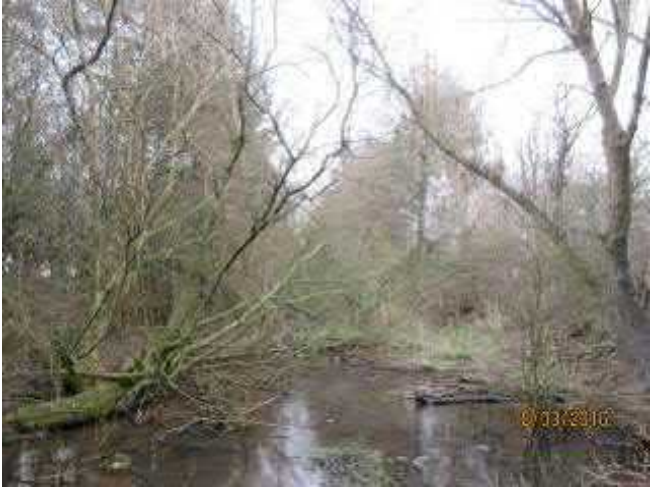
| Target Note Number | Description | |
|---|---|---|
| TN1 | Ephemeral pond underneath structure extending from under the bridge along the track bed. | |

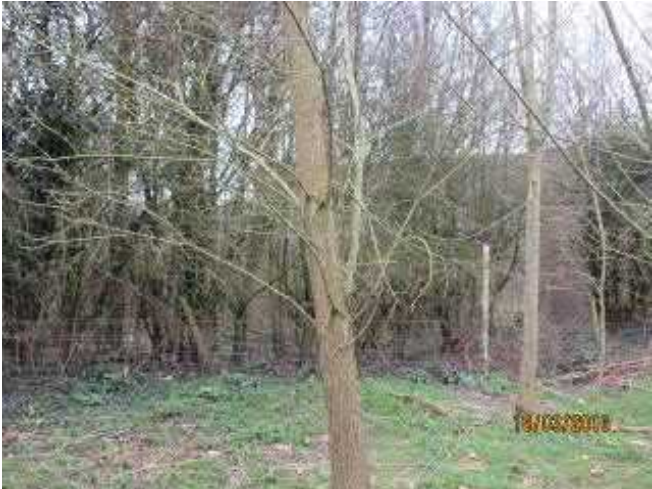
| Target Note Number | Description | |
|---|---|---|
| | Remnant hedgerow boundary on embankments | |

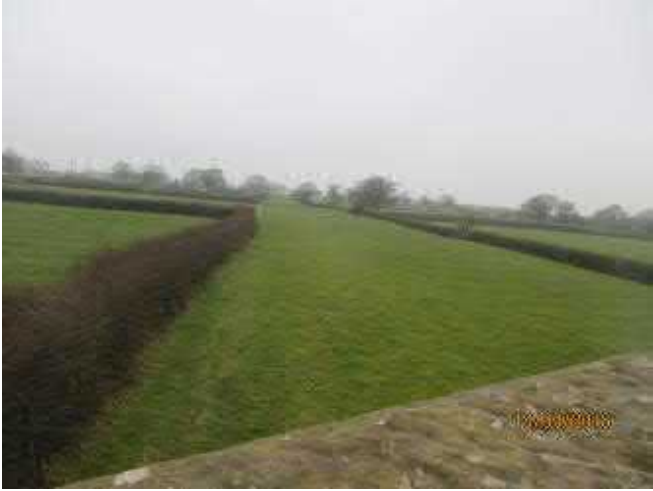
| Target Note Number | Description | |
|---|---|---|
| | Improved grassland in field to the south | |

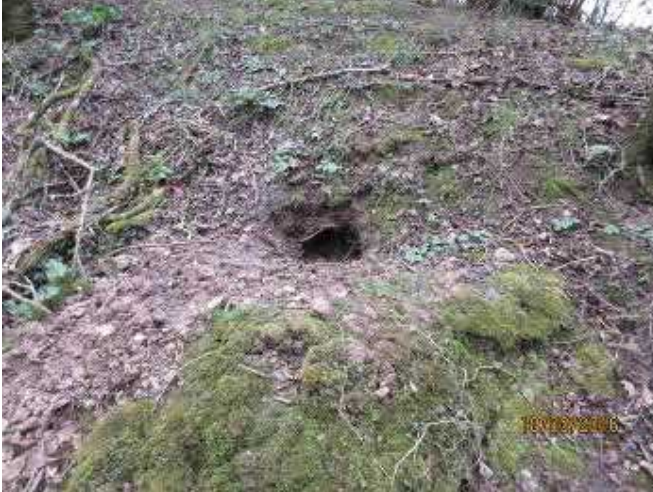
| Target Note Number | Description | |
|---|---|---|
| TN2 | Outlier single hole sett. Potentially still used by badgers. | |

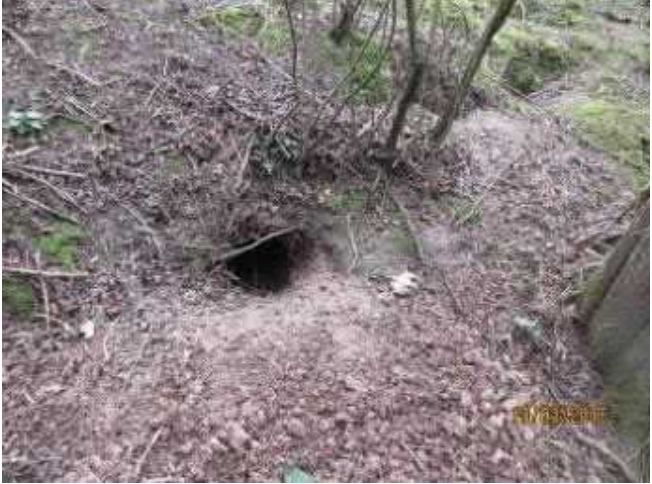
| Target Note Number | Description | |
|---|---|---|
| TN4 | Two hole outlier sett considered to be in use by badgers. | |

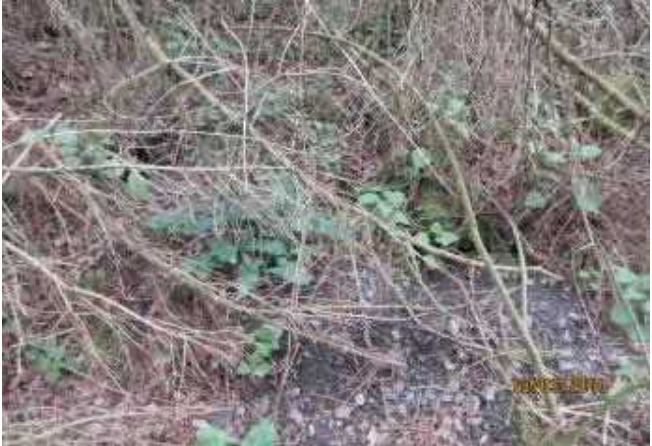
| Target Note Number | Description | |
|---|---|---|
| TN5 | Mammal signs, two collapsed badger holes used by rabbit. | |

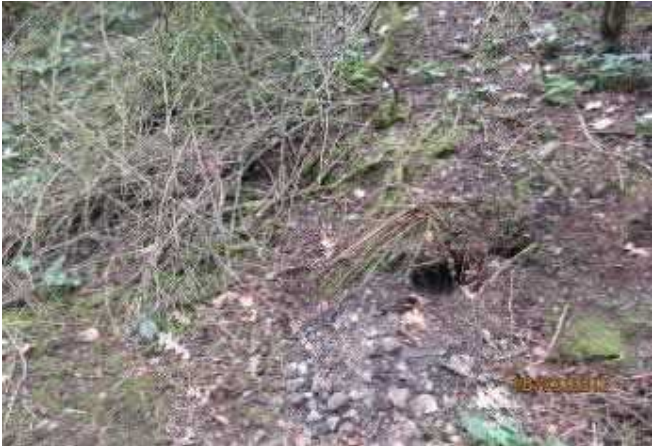
| Target Note Number | Description | |
|---|---|---|
| TN6 | Badger signs, likely to be foraging hole. | |

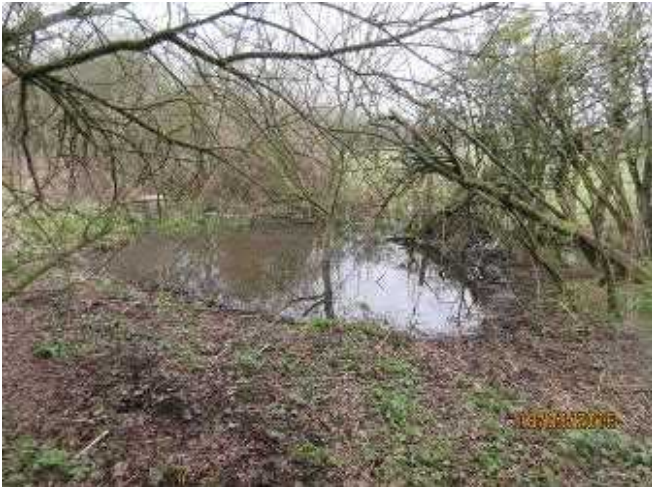
| Target Note Number | Description | |
|---|---|---|
| TN9 | Small pond, dries annually. Potential habitat for GCN. | |

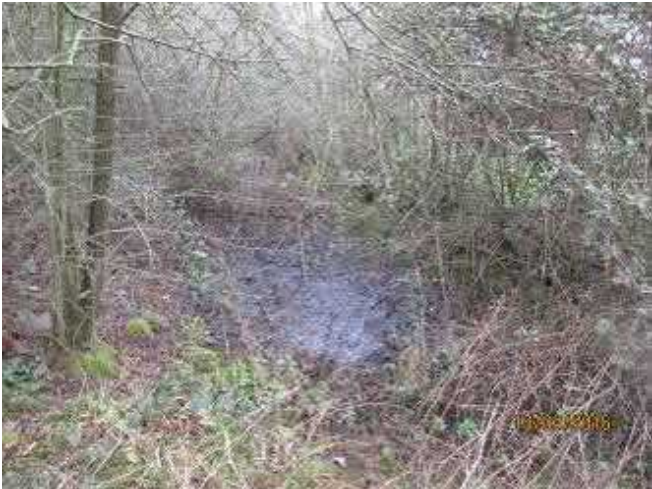
| Target Note Number | Description | |
|---|---|---|
| TN10 | Small pond, dries annually. Potential habitat for GCN. | |

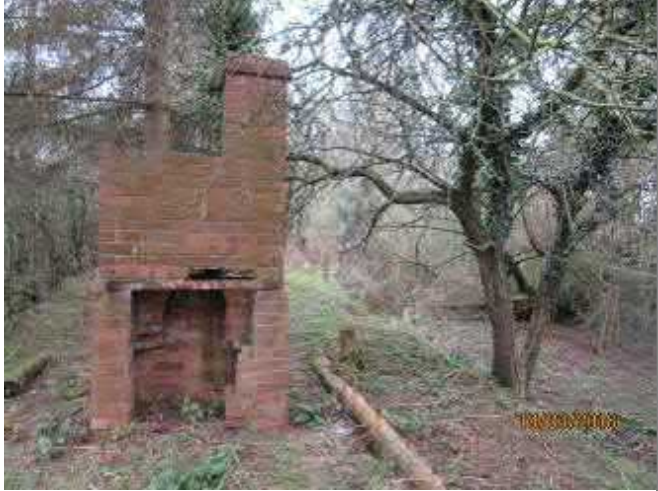
| Target Note Number | Description | |
|---|---|---|
| TN11 | Remnant chimney stack located along the track bed approximately 200m to the north of structure ELW/12. No evidence of bat roosting observed. | A photograph showing a remnant brick chimney stack in a wooded area. The stack is made of red bricks and has a large opening at the base. It is surrounded by trees and vegetation. A fallen log lies on the ground in the foreground. |

A small structure to the north of the bridge, approximately 200 m along the track bed, was found to be a remnant chimney stack forming part of a collapsed building (TN 11).

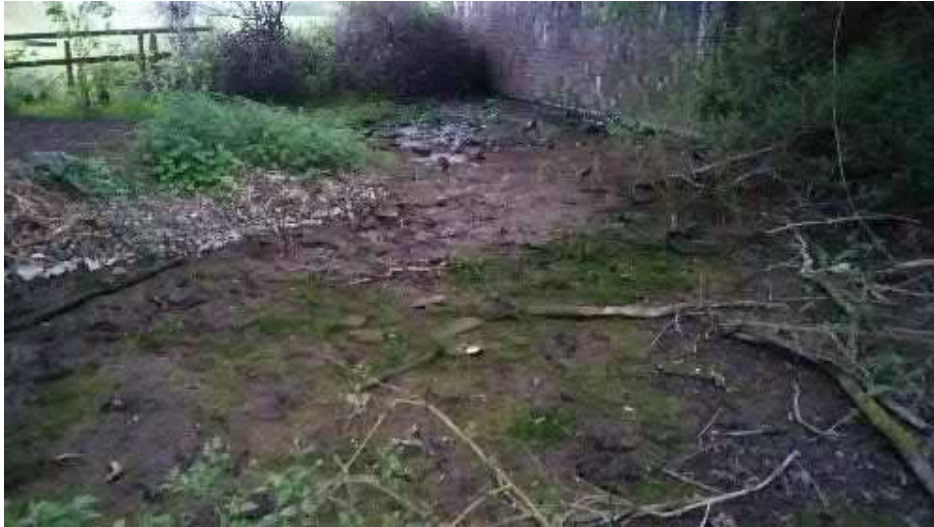
| Pond Number | Distance from structure (m) | Photograph and description |
|---|---|---|
| 1 | 0 | <p>Waterlogged area underneath structure which dries annually. Pasture field to the south and plantation woodland corridor to the north. Immediate habitat is scrub and bare ground with some grasses. Bottom is silty. Plenty of opportunities for hibernating newts in the surrounding habitat.</p> |

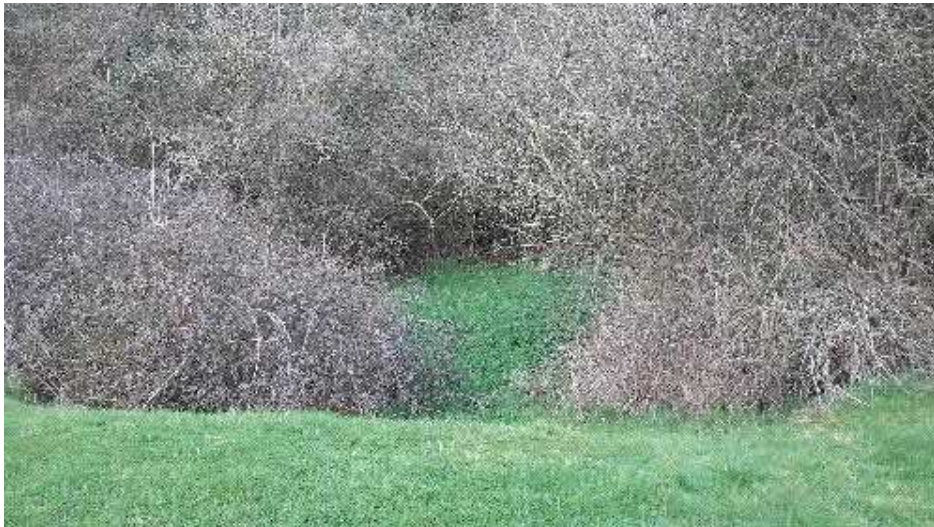
| Pond Number | Distance from structure (m) | Photograph and description |
|---|---|---|
| 2 | 75 | <p>Almost dry, depression in ground. Very shallow with grasses growing throughout. Bordered by scrub. Lies on western boundary of the southern field of Nant Holdings with woodland corridor running along the western edge which north to south down to the structure.</p> |

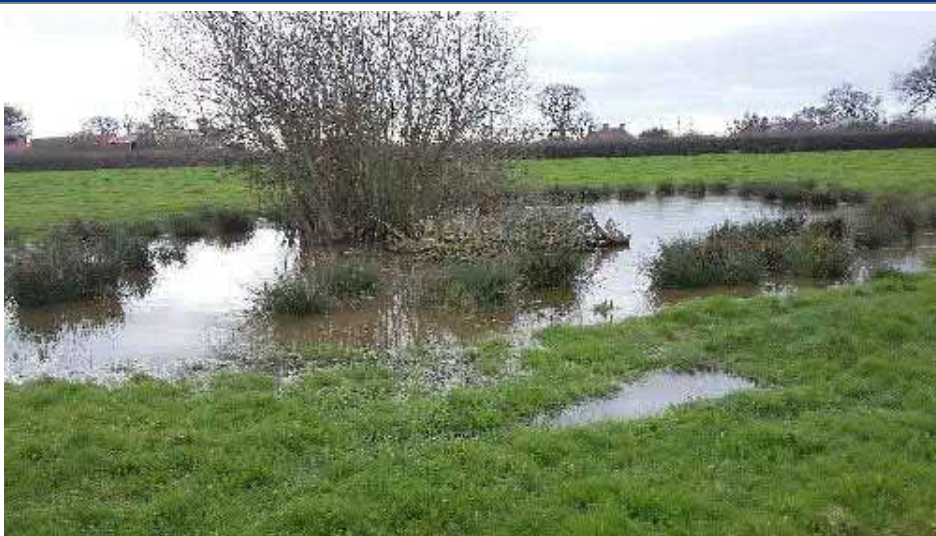
| Pond Number | Distance from structure (m) | Photograph and description |
|---|---|---|
| 3 | 150 | <p>Located in the middle of an agricultural field grazed by cows. <i>Juncus</i> sp. at the pond margins and willow scrub at the centre. Field is bounded by hedgerows.</p> |

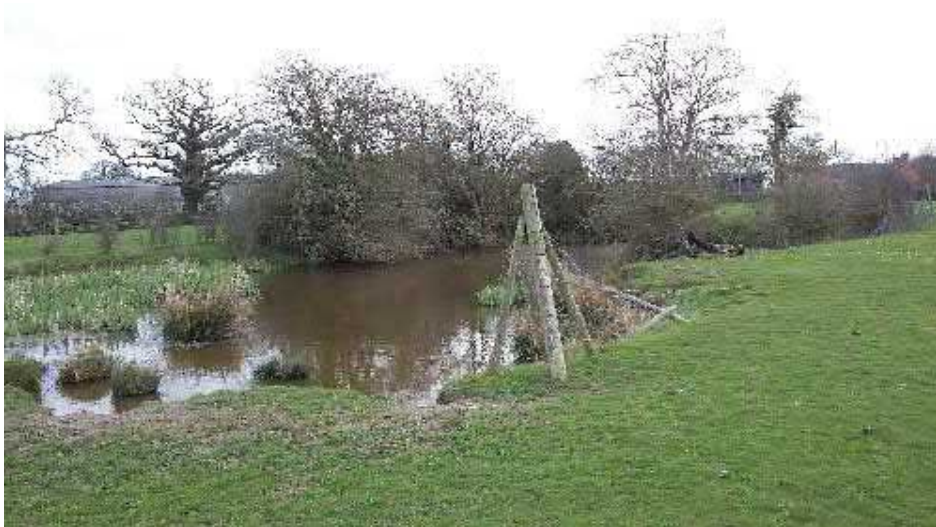
| Pond Number | Distance from structure (m) | Photograph and description |
|---|---|---|
| 4 | 230 | <p>Located at centre of agricultural field grazed by cows. Willow (<i>Salix</i> sp.), hawthorn (<i>Crataegus monogyna</i>) and blackthorn (<i>Prunus spinosa</i>) scrub and young trees. Bramble (<i>Rubus fruticosus</i> agg.), rose (<i>Rosa</i> sp.) and yellow flag iris (<i>Iris pseudacorus</i>) also present along the pond margin. Hedgerows along field margins. Evidence of poaching by cows.</p> |

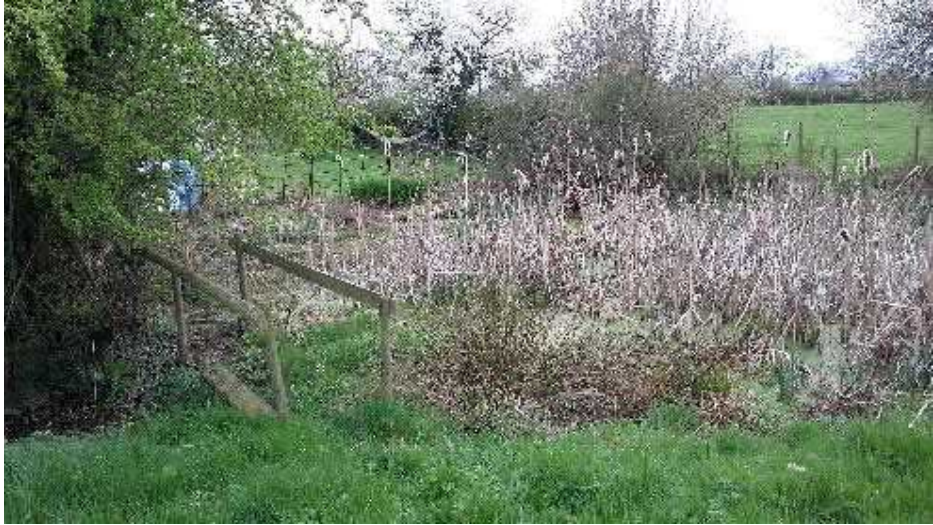
| Pond Number | Distance from structure (m) | Photograph and description |
|---|---|---|
| 5 | 125 | <p>Lots of emergent vegetation including grasses and yellow flag iris. Scrub and young trees along margins in some parts</p> |

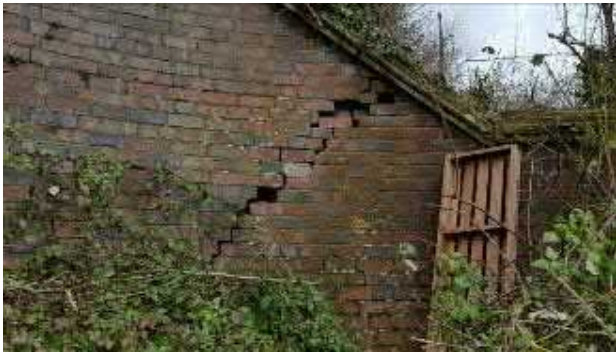
A large diagonal crack in the south east wing wall was identified as providing moderate potential for roosting bats.

| Aspect | Potential | Photograph |
|---|---|---|
| South- east Wing wall | <p>Missing brickwork and diagonal crack c. 0.5 m deep leading to multiple cavities within brickwork.</p> <p>No evidence of bat activity or hibernating bats identified, but feature is considered to have moderate potential for roosting bats</p> | |

The winter inspection, undertaken from a tower scaffold height, confirmed a single pipistrelle hibernation roost in the same feature used as a day roost. The diagonal fracture in the south east wing wall, where there was a possible emergence of a pipistrelle or myotis during the summer emergence surveys, was assessed to have moderate potential. All other features were of low or negligible potential. The comprehensive nature of the winter inspection superseded the initial roost assessment.

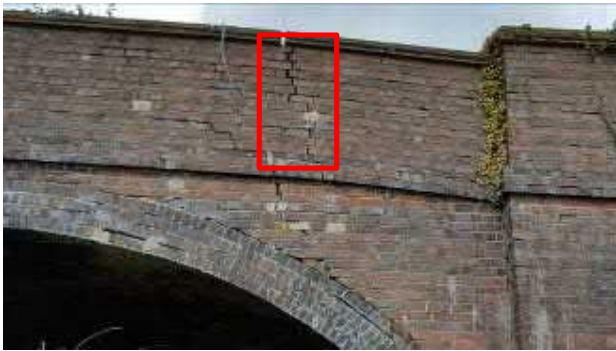
A confirmed hibernation roost of a single *Pipistrelle* species bat was found within a vertical crack in the south parapet which is in the same area as where a summer emergence was observed.

| Aspect | Potential | Photograph |
|---|---|---|
| South parapet | <p>Vertical crack c. 2 to 3 cm wide leading to multiple cavities within brickwork.</p> <p>Confirmed roost of single common pipistrelle c. 30 cm within cavity.</p> | |

Prior to the works to the bridge, under the bat licence all suitable features would be inspected and where the features can be fully inspected, they will be filled to prevent any bat entry. Where features cannot be fully examined, a one-way excluder will be fitted to allow any bat out of sight to leave but not re-enter the feature. This will be undertaken during the bat active season under suitable conditions and will ensure no roosting bats are present at the time of the works. Prior to works commencing the licenced bat ecologist would provide a toolbox talk to all site staff to discuss the potential presence of bats, measures to minimise impacts on bats and the action to be taken in the event that bats are discovered during the works.

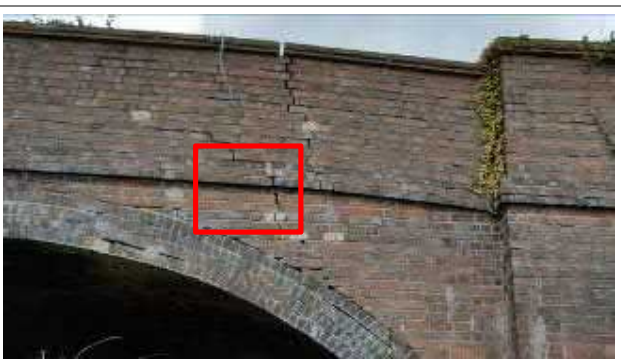
| Aspect | Potential | Photograph |
|---|---|---|
| South string course | <p>Diagonal crack passing through string course. Several cavities present up to 30 cm deep, but with much detritus and cobwebs.</p> <p>No evidence of bat activity or hibernating bats identified, but feature is considered to have low potential for roosting bats.</p> | |

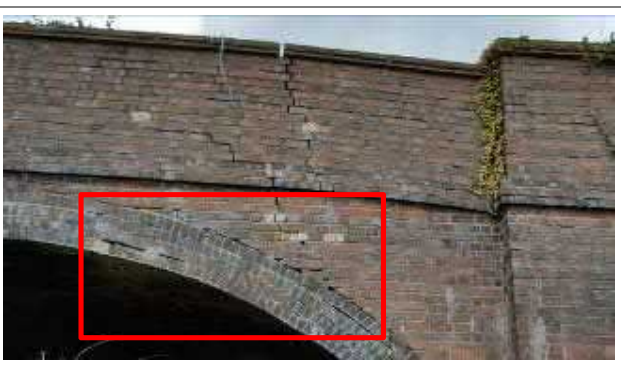
| Aspect | Potential | Photograph |
|---|---|---|
| South spandrel over arch | <p>Crack in arch and where spandrel joins arch. Loose bricks in spandrel over arch. Cracks superficial c. 2 cm deep to. Loose bricks carefully removed (and replaced) to reveal no cavities present.</p> <p>No evidence of bat activity or hibernating bats identified. Feature is considered to have negligible potential for roosting bats.</p> | |

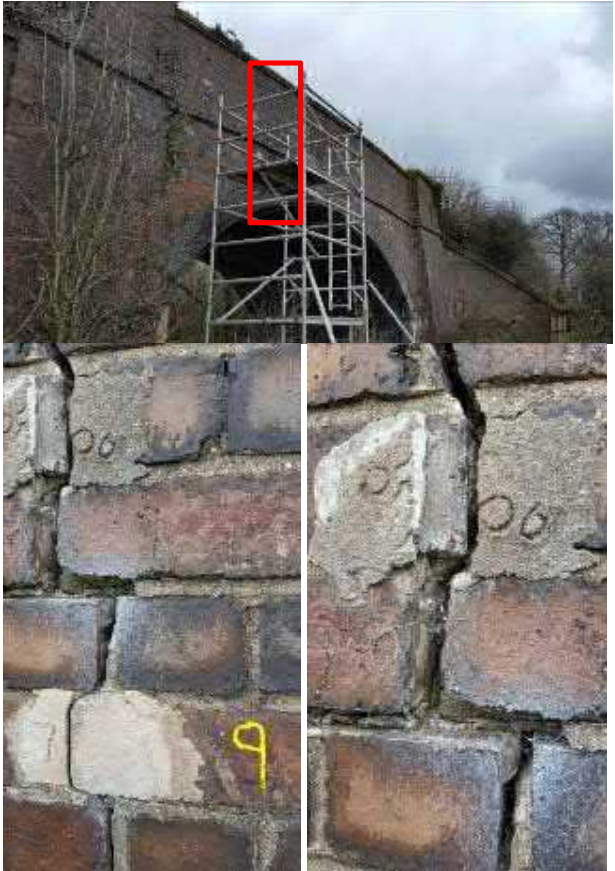
| Aspect | Potential | Photograph |
|---|---|---|
| <p>South spandrel, string course and parapet</p> | <p>Vertical crack passing through spandrel, string course and parapet. Cracks largely superficial or filled with loose mortar and cobwebs. Several wider gaps c. 1 to 2 cm extending into cavities.</p> <p>No evidence of bat activity or hibernating bats identified, but feature is considered to have low potential for roosting bats.</p> | |

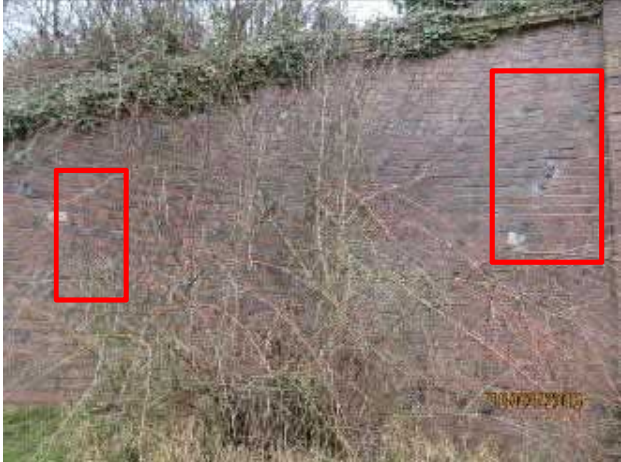
| Aspect | Potential | Photograph |
|---|---|---|
| <p>South-west wing wall</p> | <p>Two diagonal cracks in brickwork/masonry c. 1 cm wide. Relatively superficial with some areas leading into deeper cavities.</p> <p>No evidence of bat activity or hibernating bats identified, but feature is considered to have low potential for roosting bats.</p> | |

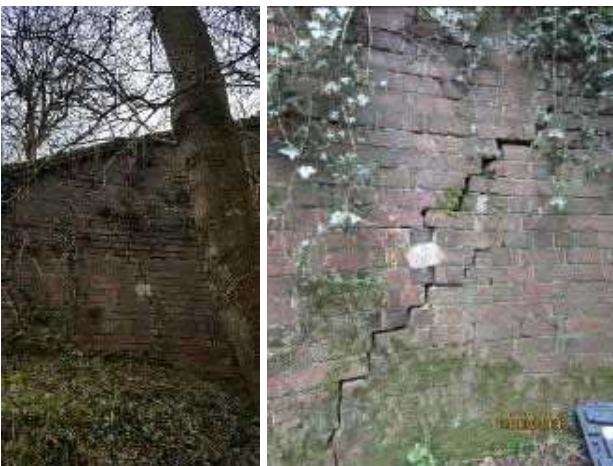
| Aspect | Potential | Photograph |
|---|---|---|
| North west and east wing walls | <p>Diagonal cracks c. 1 to 2 cm wide leading into cavities. Several areas within the cracks on both the west and east wing walls extending deeper into restricted cavities, with loose mortar, cobwebs and tree/shrub roots.</p> <p>No evidence of bat activity or hibernating bats identified, but feature is considered to have low potential for roosting bats.</p> | |

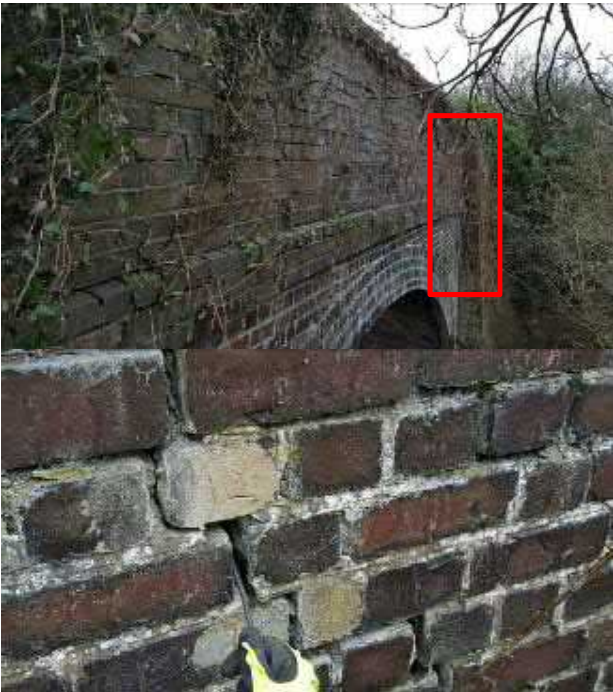
| Aspect | Potential | Photograph |
|---|---|---|
| North arch, spandrel and parapet | <p>Majority of cracks/missing mortar were identified at height as being largely superficial. A horizontal crack c. 1 to 2 cm wide passing through monitoring point twelve extended c. 30 cm into cavity was found to be largely restricted by loose mortar, cobwebs and bramble roots.</p> <p>No evidence of bat activity or hibernating bats identified, but feature is considered to have low potential for roosting bats.</p> | |

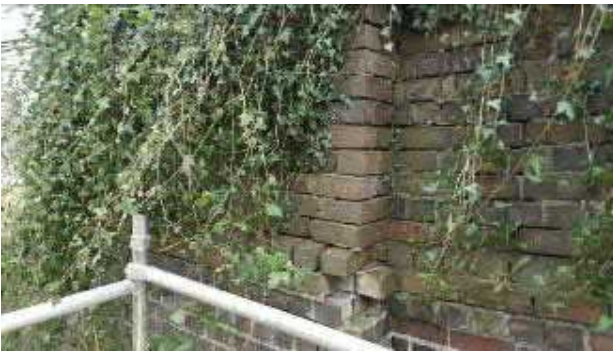
| Aspect | Potential | Photograph |
|---|---|---|
| North west pilaster | <p>Loose/missing brickwork and missing mortar found to be superficial, with no cavities identified.</p> <p>No evidence of bat activity or hibernating bats identified Feature is considered to have negligible potential for roosting bats.</p> | |
