# **GWERSYLLT COMMUNITY PRIMARY, DODDS LANE, GWERSYLLT, LL11 4NT PRELIMINARY ECOLOGICAL APPRAISAL AND PRELIMINARY BAT ROOST ASSESSMENT AND NESTING BIRD SURVEY**

Report Ref EE.421.18.SJ

- 1.1 Enfys Ecology Limited were commissioned by TACP on behalf of Read Construction, to undertake a Preliminary Ecological Appraisal and Preliminary Bat Roost Assessment and nesting bird survey of Gwersyllt Community Primary School.

- 1.2 The proposed project works include an extension to the main school building, and the demolition of the Dodds Lane Student Centre building to the southeast of the site.

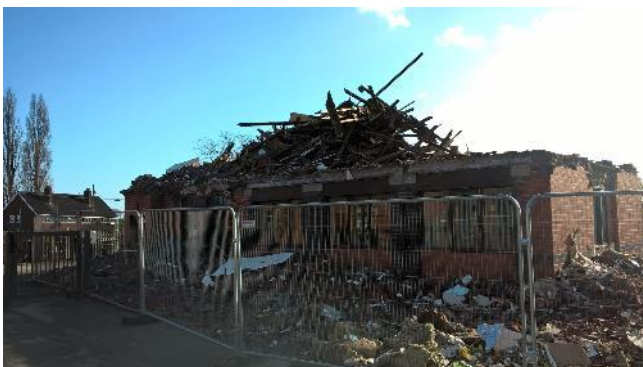
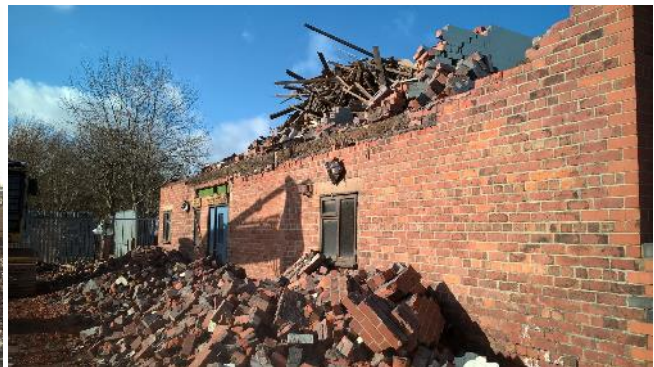
**PICTURES 3 AND 4. BUILDING 2, PARTLY DEMOLISHED.**

- 4.2.1 This building was brick built, however it had been demolished above the ground floor ceiling height and was therefore not surveyed.

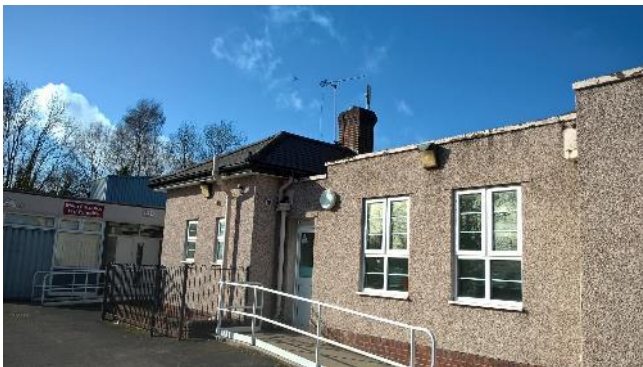
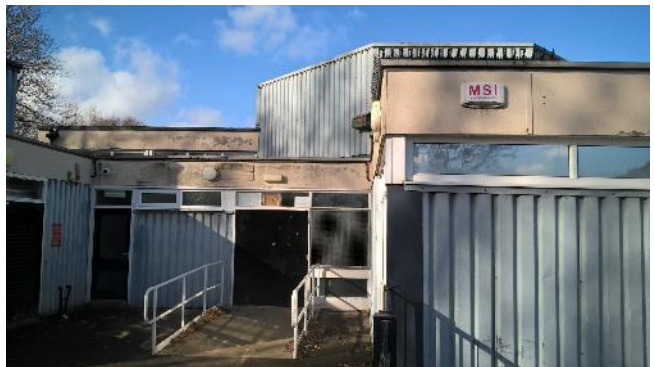
**PICTURES 5 AND 6. THE DODD'S LANE STUDENT CENTRE BUILDING. NOTE RENDERED BRICK AND PREFABRICATED METAL CONSTRUCTION.**

4.4.1 Building 4 is mainly flat roofed, with two small pitched roof sections facing north east. Most of the building is rendered and pebble-dashed over brick, however the rear (south-western) 40% (approx.) of the building has been constructed from wood and corrugated metal sheeting, possibly prefabricated, all sections had felted flat roofs, bar two small raised sections with pitched slate roofs, and a raised metal roof.

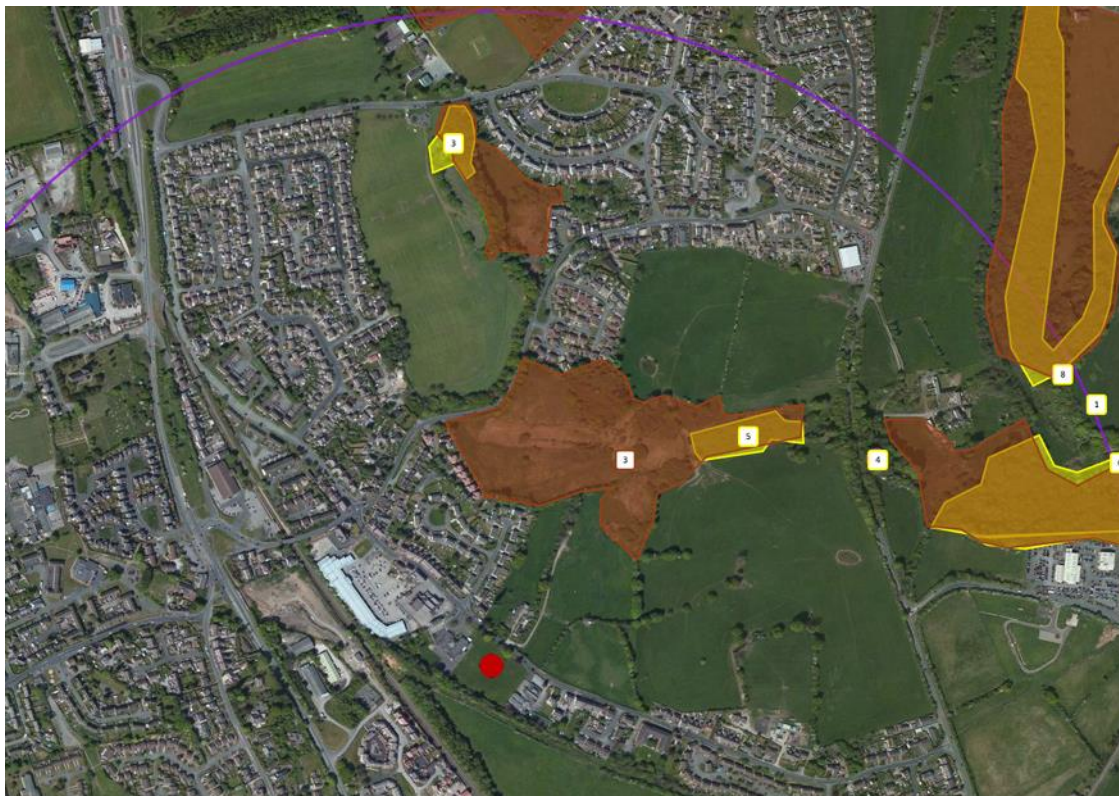
**FIGURE 5.1. CENTROID OF SURVEY AREA (RED) OVERLAID WITH LOCAL WILDLIFE SITES (BROWN), AND ANCIENT WOODLANDS (YELLOW). IMAGE TAKEN FROM COFNOD DATA SEARCH. IMAGE © COFNOD 2018.**

- 5.1.1 No statutory nature conservation sites are found within 1km of the survey area boundary.
- 5.1.2 There are three non-statutory Local Wildlife Sites (LWS) within 1km of the site, the closest is Woodlands and Fishpond Wood, 251m to the north (Figure 5.1).
- 5.1.3 There are eight ancient semi natural woodland sites found within 1km of the survey boundary, the closest of which approx. 449m to the northeast of the site.

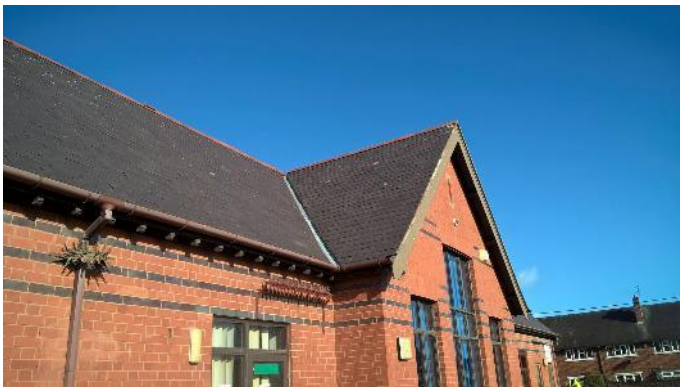
**PICTURE 7. SOUTH ELEVATION OF BUILDING 1.**

The area of the building which will be most affected by the proposed works is the south-eastern front elevation, where the extension is proposed. The roofs here are in generally good condition, with few gaps, (notably better than some other parts of the building). There were some lifted slates, with slight gaps. The ridge tiles were intact, but there are vents in some tiles (possibly meshed). The Soffits were generally intact all along this section, a ventilation gap running along the base of the soffit boxes is sealed with a mesh insect screen.

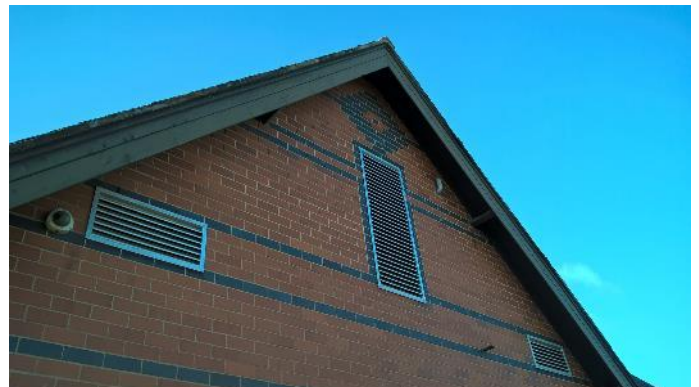
**PICTURE 8. VENTS ON THE SOUTHWEST GABLE, BUILDING 1.**

The pitched roof on this south-eastern elevation runs from gable ends to the southwest-northeast, with a small sub pitch, with a gable end projecting to the southeast. There was a small gap at the northern gable end where mortar has fallen out under the end of the slates. Large vents at all gable ends appeared to be meshed behind the events and sealed, though how well sealed these are inside is not known except where obvious holes are present (see below). There are also a few small gaps in the brickwork, though these are probably shallow.

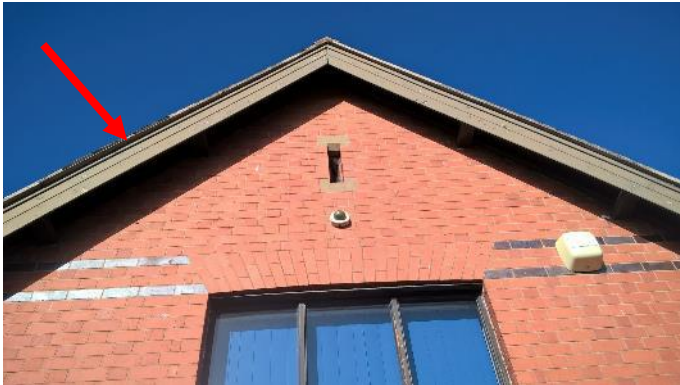
**PICTURE 9. THE SOUTHERN GABLE. THE ARROW INDICATES GAPS WHERE MORTAR HAS FALLEN FROM UNDER SLATES.**

The central gable end (hereafter Mid-gable) is sealed, with all, windows, soffits and fittings sealed, but the mesh covering the large vent has peeled back, revealing a gap. There are also many gaps where mortar has fallen out from under the roof tiles at the gable.

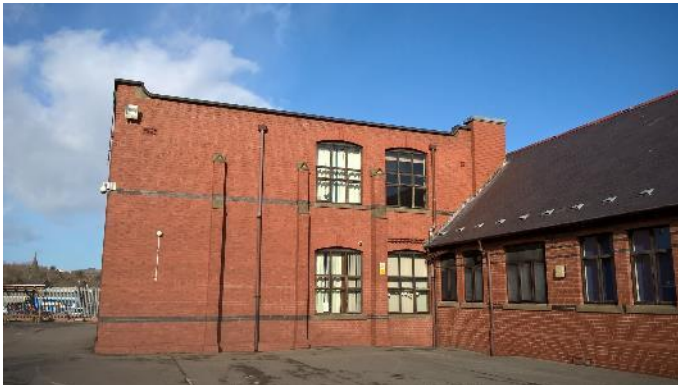
**PICTURE 11. THE WESTERN TWO STOREY EXTENSION.**

To the west is a large two story flat roofed brick extension. The roof was completely sealed but there is a large gap in the soffit on the western side where a panel is broken.

On the south western side there was one other large gap under the lead flashing on a small tower. As on other areas of the roof there are some gaps under slates, and vents on the ridge tiles. There was a large gap along the entire south-western eaves between the brick wall and the soffit board above.

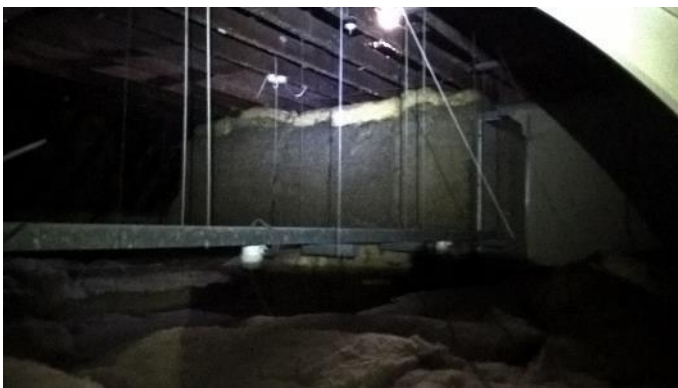
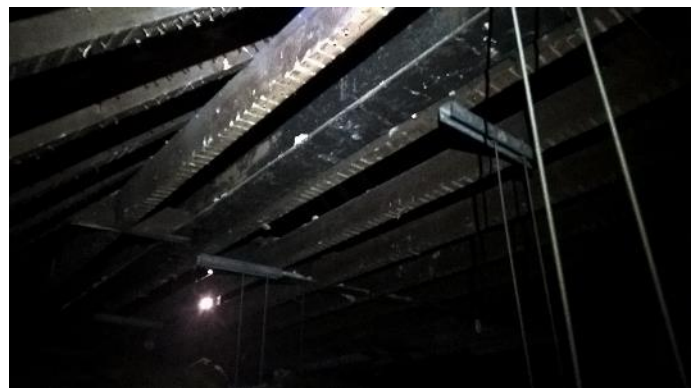
**PICTURES 13 AND 14. LOFT SPACE INTERIOR, PITCHED ROOFS ON THE SOUTHWEST OF BUILDING 1.**

The majority of the building is single storey, with high open roof frames, divided from the teaching space below by suspended ceiling tiles. These roof spaces were large with an open frame and many timber beams. In places it appeared that there might have been a ceiling and an upper floor in the past. The roof is lined with bitumen felt that appears to be intact, though this could only be assessed at a distance by looking through various ceiling tiles. The ceiling of the main hall had a very high ceiling so this roof space could not be assessed.

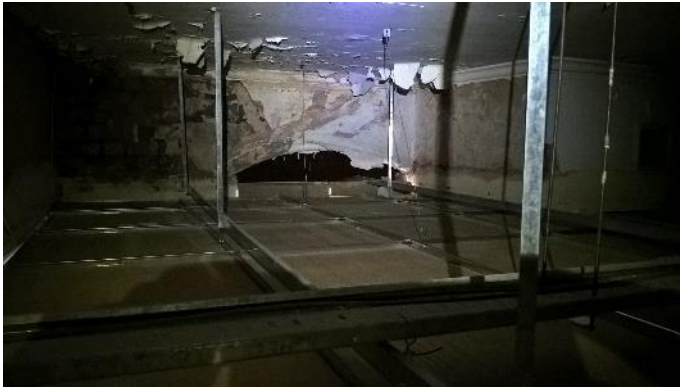
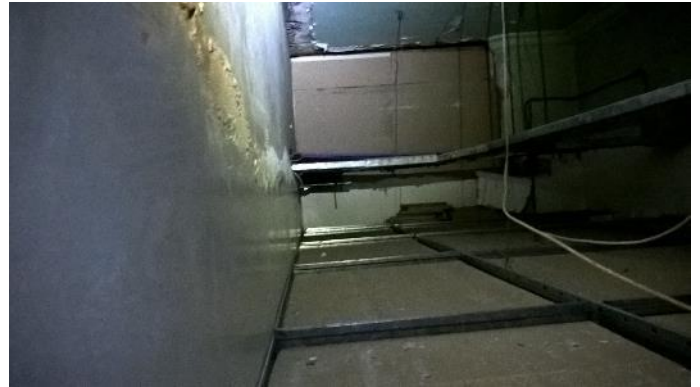
**PICTURES 15 AND 16. INSIDE THE SPACE UNDER THE FLAT ROOFS, BUILDING 1.**

The flat roofed two storey extension has a similar suspended ceiling, which was only spaced about 50cm from the concrete underside of the roof. These roofs were all totally sealed with no potential bat access.

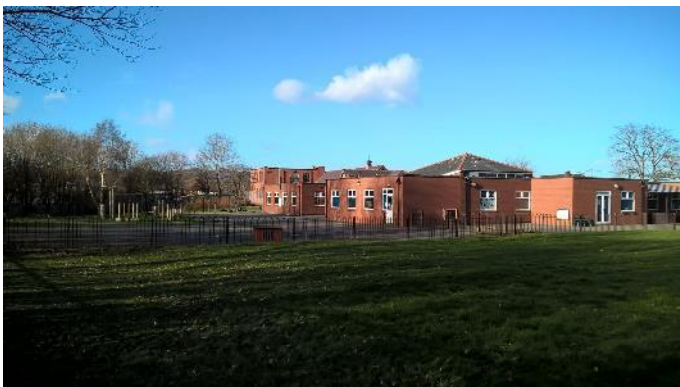
**PICTURE 17. BUILDING 3.**

Building 3 is a brick building with largely flat roofs. Appearing to be well sealed at the eaves, it has very few features useable by bats. This building will not be affected by the proposed works, and so only the exterior was assessed. The only significant features were some minor gaps in the brickwork that appeared to be shallow, and some small gaps in the slates on the small pitched roof section.

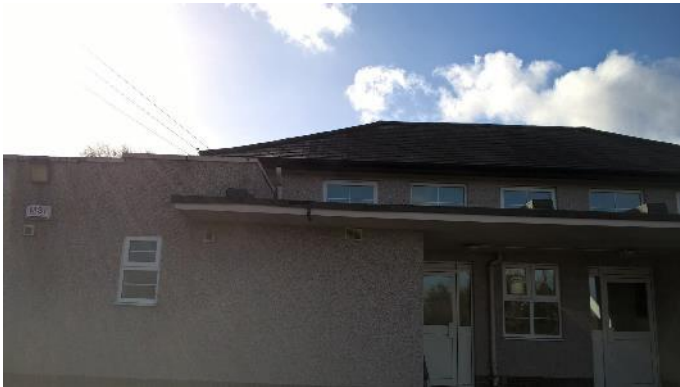
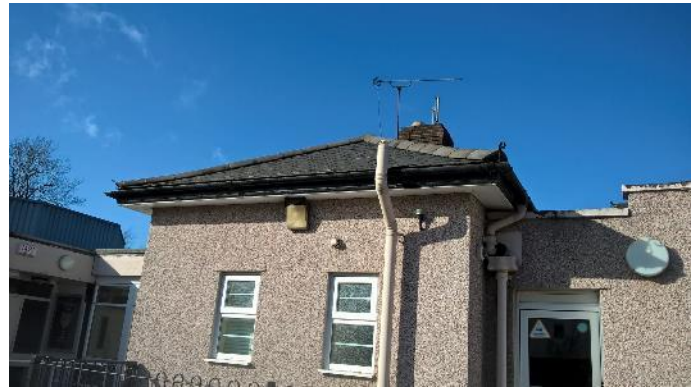
**PICTURES 19 AND 20. BUILDING 4, RENDERED SECTIONS ON THE NORTH EAST AND SOUTH EAST SIDES OF THE BUILDING**

This building is in two parts, the front (north-eastern) part towards the road, which was rendered brick and a predominantly corrugated metal section to the rear. The front elevation by the road appears well sealed, with low potential for bat entry.

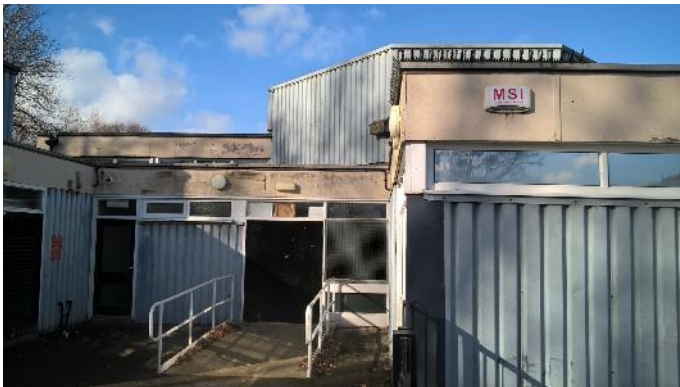
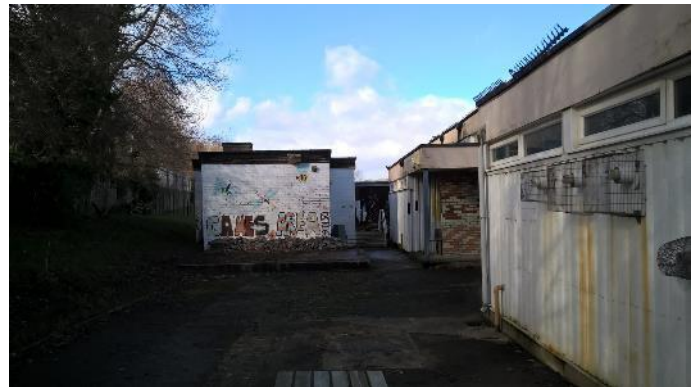
**PICTURES 21 AND 22. BUILDING 4, PREFABRICATED CORRUGATED SHEETS AND WOOD TO THE SOUTH.**

There are gaps around the fascia boards over almost the entire rear section of the building, which are probably shallow, leading only to a small crack behind the board, but in some places this may lead into a larger space behind the boards. There is a gap in the soffit board on the corner south west of the basement access. Other than this the building was well sealed, including the roofs, the only other notable gap where a large pipe extends out from the back of the main building which has a gap all the way around.

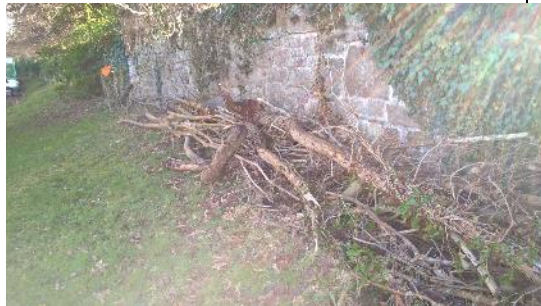
| Target Number | Description | Picture |
|---|---|---|
| 1 | A large pile of brash, wood and rubble. This may contain hedgehogs, amphibians and other overwintering animals and should be left in place. If it must be removed this should be done by hand in appropriate conditions. | |

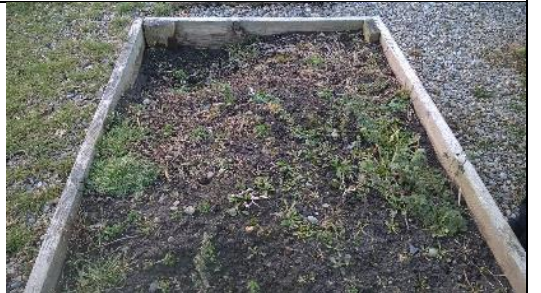
| Target Number | Description | Picture |
|---|---|---|
| 2 | Several raised beds here are dominated by common field speedwell. (See habitat descriptions for more information). | |

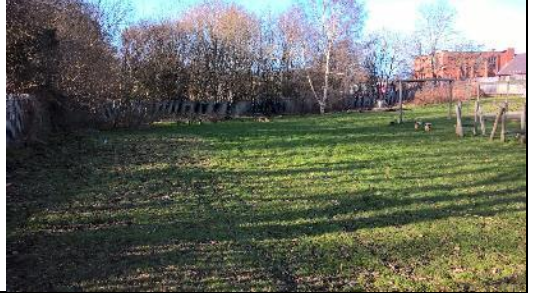
| Target Number | Description | Picture |
|---|---|---|
| 3 | This area has been planted with trees, broadleaved species including ash, beech, and oak and cherry, however they have been largely destroyed by mowing, and so is currently grassland. | |

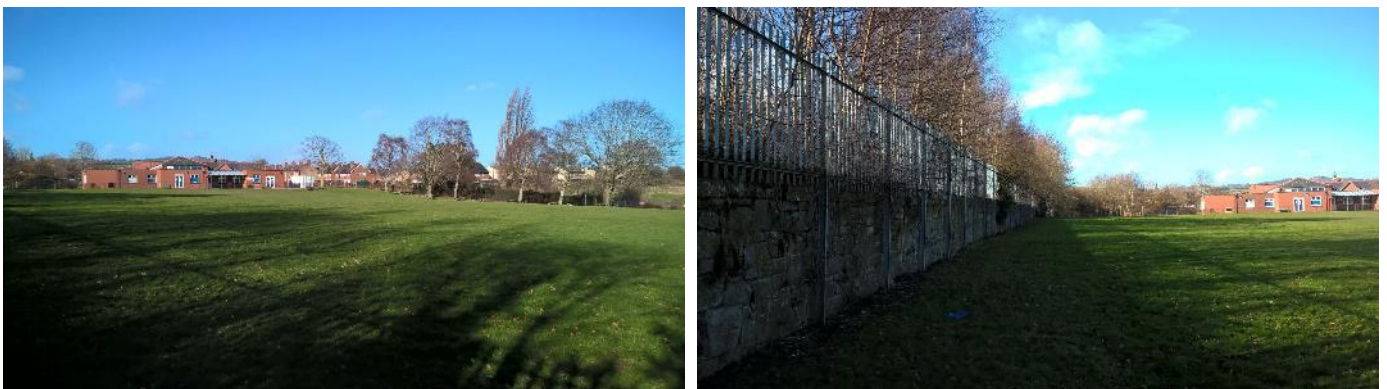
- 6.4.2 The main central field comprised short mown grassland (under 5cm over most of the area). The sward was relatively species poor; mostly grasses including cocks foot and perennial rye grass (others were probably present but were not identified due to the lack of seed heads and very short sward), with abundant mosses, ribwort plantain, dandelion and common daisy, creeping thistle, common ragwort were frequent, and meadow buttercup, chickweed, and a spurge species were occasional. The remains of umbellifers and curled dock were present on the margins. Daffodils had been planted in places around the margins, and very rarely, common dog violet was found on the edge of the grassland by the hardstanding.

**PICTURES 25 AND 26. THE CENTRAL (AMENITY GRASSLAND) FIELD.**

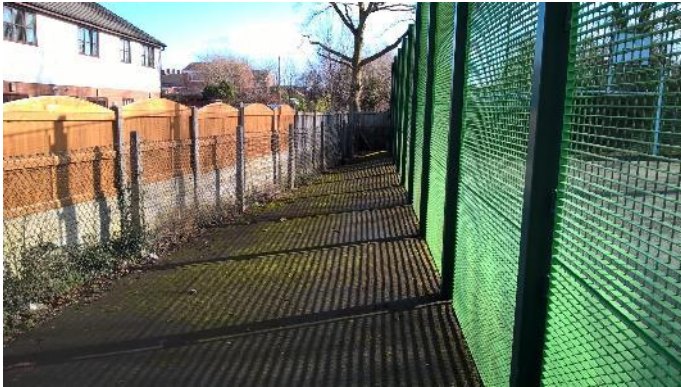
- 6.4.5 The area around the buildings (in both north and south of the site) is mostly hardstanding. To the north, around buildings 1 and 2, the ground was almost entirely intact hardstanding, with only limited vegetation including moss, groundsel, ragwort and thistles in a few cracks. Building 3 was surrounded by similar hardstanding with an outer ring of metal fences, vegetation was very limited. Building 4 (Dodd's lane) was also surrounded by hardstanding, however here there were a few areas of amenity grassland to the north, similar to the field, and some introduced shrubs to the south. The hardstanding contained vegetation around

**PICTURE 27. HARDSTANDING IN THE FAR SOUTHEAST. PICTURE 28. THE SMALL GRAVEL ‘GARDEN’, BUILDING 4.**

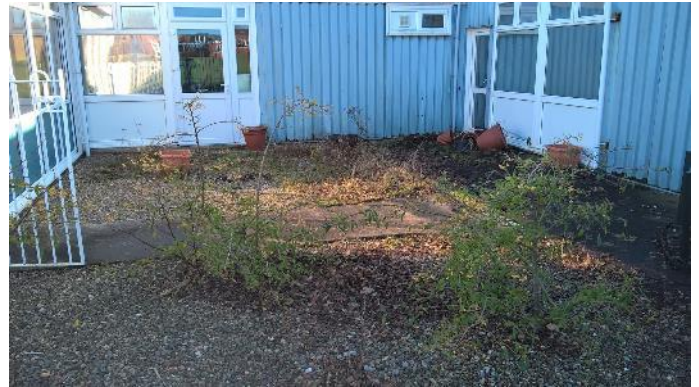
the margins including greater stitchwort, curled dock, common nettle, plantain, daisy, ragwort, ivy, herb Robert, red fescue, common field speedwell, ground ivy and groundsel, all occasional. A small garden area on the northwest side of the building was mostly gravel, but contained shrubs including cotoneasters and buddleia, plus dogwood, and several birch saplings. There was also rosebay willowherb, curled dock, grasses, yarrow, umbellifers remains and creeping thistle. A large elm stands northeast of the building.

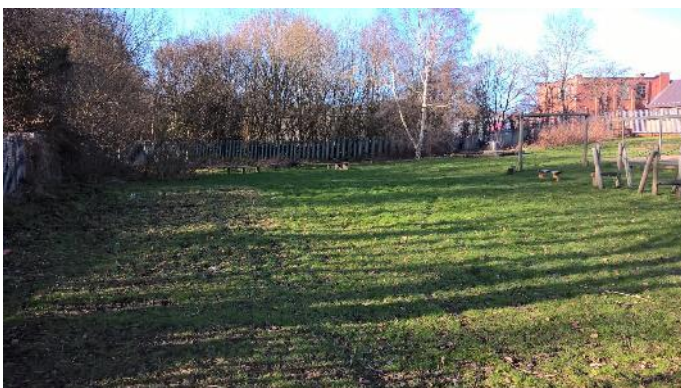
- 6.4.7 The grassland area contained some benches and was clearly used as amenity, however a large part of the area had also been planted with small trees, in lines. Most of these however appear to have been damaged or killed by subsequent mowing, none were more than 1m tall, most under 50 cm, and with most side branches removed there was little more than a narrow single stem in many cases. Species included oak, birch, cherry and probably hazel and alder. Otherwise the grassland sward was similar to the larger field, but with red clover, and more abundant buttercup. Common bird’s foot trefoil was also occasionally present. The sward was longer than the field, but still generally under 10cm in length.

**PICTURE 29. GARDEN AREA (AMENITY GRASSLAND) IN THE WEST OF THE SITE. PICTURE 30. THE SMALL WOODLAND IN THE WEST OF THE SITE.**

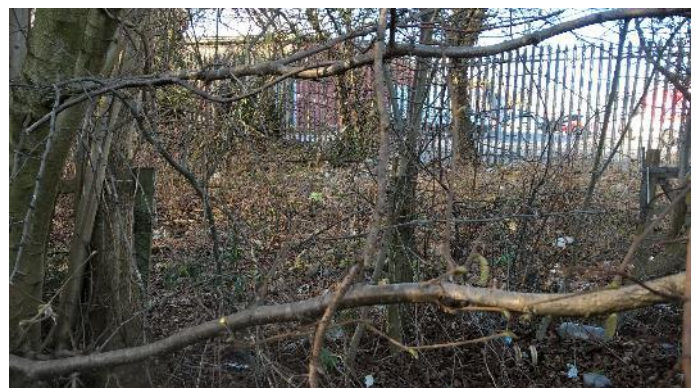
6.4.8 Behind this was a small woodland and scrub area behind a fence. This was dominated by willows, with occasional larger oak and ash, but there were no large mature trees over a few metres in height. The ground flora was open and most of the ground visible, dominated by icy, nettle, with abundant lords and ladies, daffodils, snowdrops, and meadow buttercup. The central area was dominated by the tall remains of rosebay willowherb, nettles and umbellifers, and some bramble.

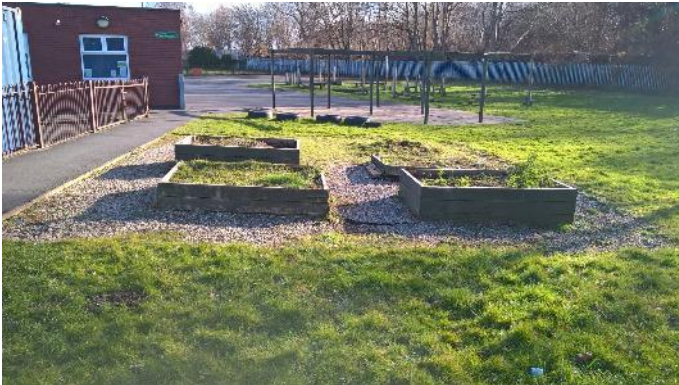
**PICTURE 31. RAISED BEDS NEAR BUILDING 3.**

6.4.9 Near to building 3, are several raised beds with wooden plank sides. These were all partly empty apart from low growing vegetation including common field speedwell, dominant in some beds plus, hedge mustard, fat hen, common mouse ear, dandelion, chickweed, ribwort plantain, nettles and thistles.

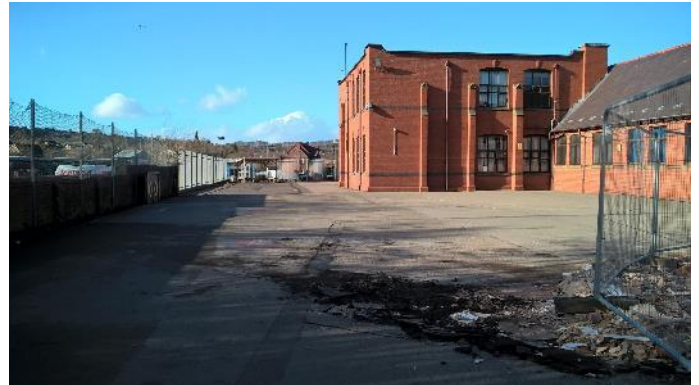
**PICTURE 28. HARDSTANDING AROUND BUILDING 1**
