Llangwryd Uchaf.

Llwynmawr, Llangollen, LL20 7BD.

**Bat Survey Report**

July 2018

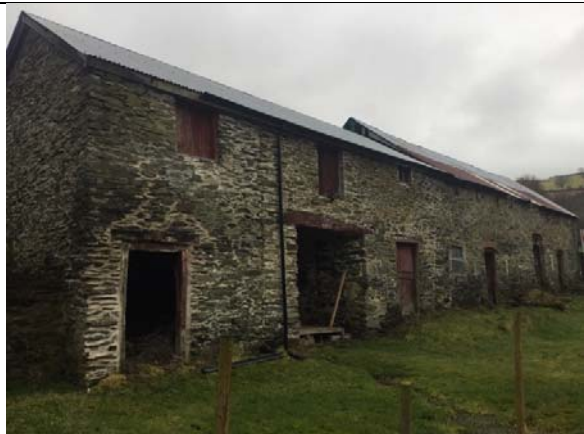
Plate 1: Front of barn

- 4.3.1 Activity on this evening was low level. Two common pipistrelles were seen emerging from the front of the barn (from open doorway in Section 2 at 21:07 and from a hole towards the top of the wall next to the drain pipe near Section 2 at 21:11, see Plate 1). Bat droppings were observed on the floor of Section 2, at the base of an internal wall containing a large crevice. Two or three common and soprano pipistrelles were recorded and observed foraging and socialising intermittently throughout the evening with two passes by brown long-eared bats

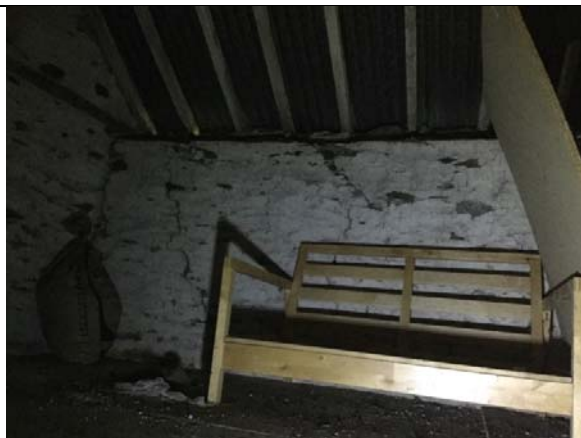
Plate 9: Section 3 upper floor

| Section | Brief Description | Evidence of bats |
|---|---|---|
| 3 | Livestock stalls, part upper floor comprising tree | 2 droppings on upper floor. |

| | trunks. Walk way at back leading through to Section 4. | Singe butterfly wind caught on cobweb underneath beam. |

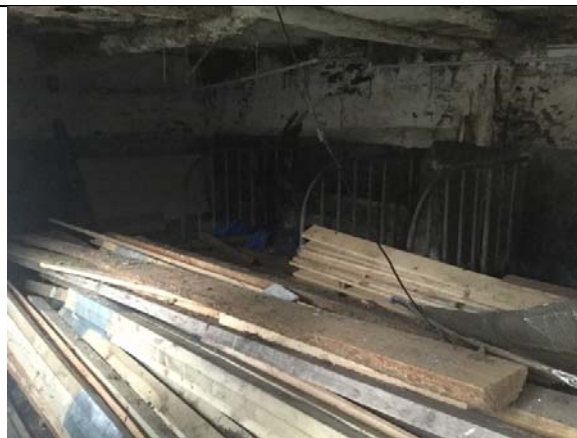
Plate 10: Section 4

| 4 | Feed room, no upper floor so rises into apex. Upper 'floor' of section 3 was accessed from this section. | 2 droppings on piece of furniture. |

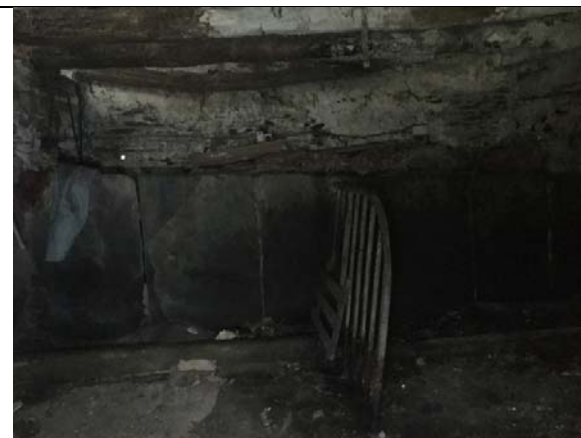
- 4.4.3 Currently, bats are using the barn, including the stone walls of the barn as roost spaces. The barn will be converted into living accommodation. The holes in walls where mortar has dislodged will require infilling in order to prevent further degradation and ultimately dilapidation of the stone walls. The roof will also be replaced and therefore the potential for roosting bats to enter the building will be further reduced. It is therefore necessary to provide an alternative roost space which will be sufficient to provide a like for like replacement roost

Plate 15: Holes in back wall

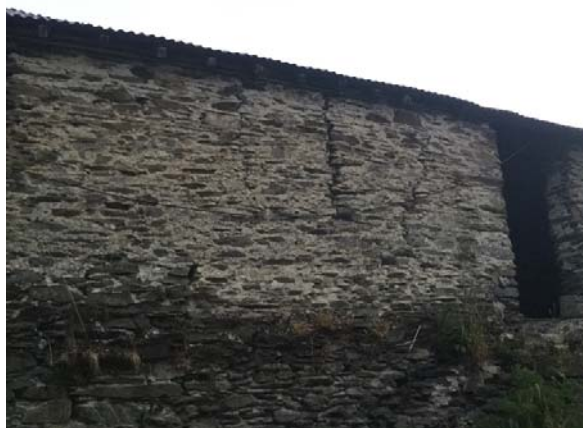
Plate 16: Large crack in wall where pipistrelle entered

- 4.3.3 A similar amount of activity to the previous dawn survey was recorded. In the main, activity was attributed to pipistrelle bats (mainly common), with foraging and commuting activity in low numbers throughout the survey. No bats were seen entering the front of the barn but a single pipistrelle was seen to enter the building through gaps in the southern gable end at 03:33 (see Plate 3). At the back of the building, common pipistrelle and myotis were again recorded flying in and out of the large upper window in Section 3 starting at 03:22. At 03:51, a single common pipistrelle was observed landing on the wall of the barn and going into a large crack in the stonework in Section 2 (see Plate 16). Foraging within the barn continued until around 04:30. A single noctule was recorded flying at height overhead at 04:28.
