**CO-OP PETROL STATION, HIGH  
STREET, COEDPOETH, WREXHAM**

**PRELIMINARY BAT ROOST  
ASSESSMENT**

Report No: RT-MME-127752-03

Date: April 2018

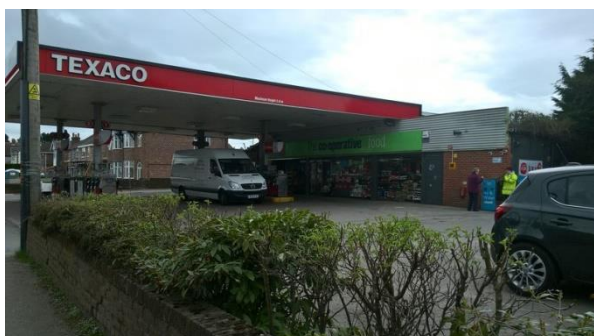
The attached petrol forecourt canopy was constructed from corrugated plastic and metal (see Plate 4.1) and was concluded to hold negligible bat roost potential.

**Plate 4.1: B1 - North-Eastern Elevation, Showing Foodstore and Forecourt Canopy**

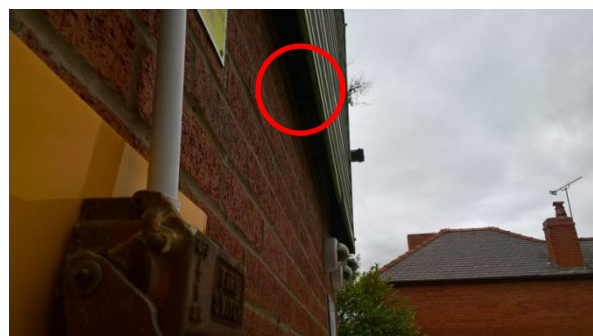
**Plate 4.2: B1 – North-Eastern Elevation, Gap Between Wall and Metal Frontage**

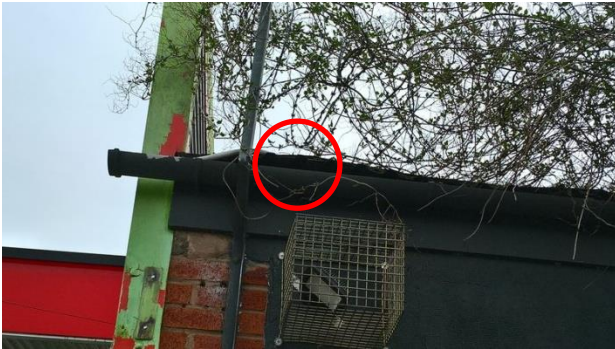
**Plate 4.3: B1 – North-Western Elevation  
Showing Gaps Under Corrugations**

On the north-western side of the building felt was present over a corrugated metal roof which had a shallow pitch. Gaps were present under the corrugations and these may provide access to the void above the suspended ceiling of the food store.

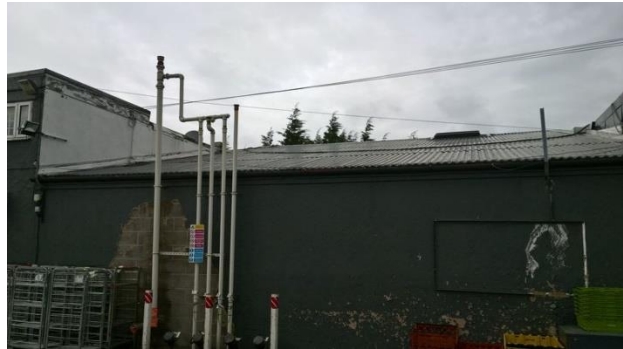
**Plate 4.4: B1 – South-Eastern Elevation**

The south-eastern elevation of the building (Plate 4.4) was constructed of breeze blocks covered with peeling render. No potential roost features were recorded associated with the walls. The roof of this elevation comprised corrugated metal with a shallow pitch and again no potential roost features were recorded associated with this.

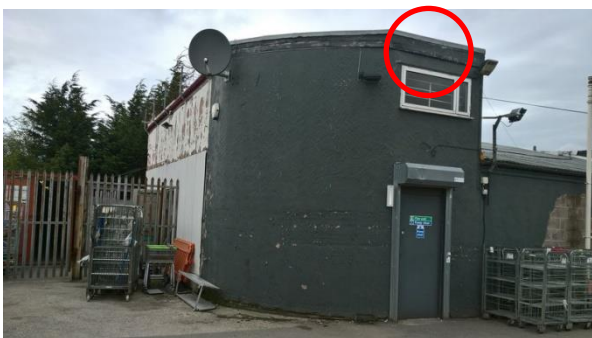
The rear (south-western) elevation comprised the two-storey office section with a flat roof (Plates 4.5 and 4.6). This was again constructed of breeze block and render, which was generally in good condition with no potential roost features recorded. At the southern corner some sections of barge board were present at the top of the wall (see Plate 4.5) and gaps were present under these, however they were fully inspected and were found to be cobwebbed, and showed no evidence of use by roosting bats.

**Plate 4.5: B1 – South-Western Elevation,  
Southern Corner, Showing Barge Board**

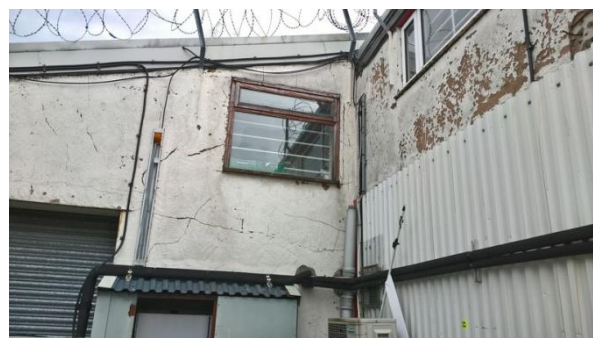
**Plate 4.6: B1 – South-Western Elevation,  
Northern Corner**

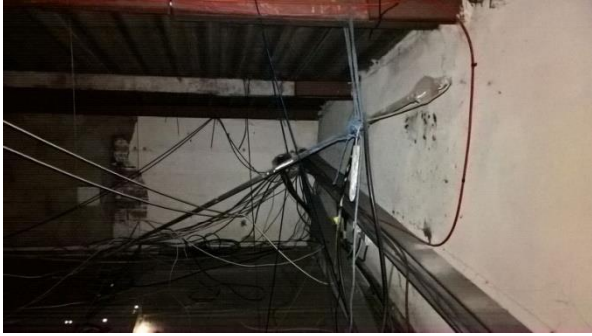
Internally, doors were present to the roof space (Plates 4.7 and 4.8), which comprised a metal corrugated roof over a metal frame, half of which was under-laid with boarding. At the rear of the building the roof was comprised of asbestos-type corrugated material over the same metal frame, with a suspended ceiling below. Corrugated metal was present over the top of the asbestos roof and a slight gap was present between the layers. The gap and the roofspace were inspected and noted to be clear, with no evidence of bat droppings. No light was visible at the eaves suggesting no access points from the outside were present.

Plate 4.7: B1 – Roof Space

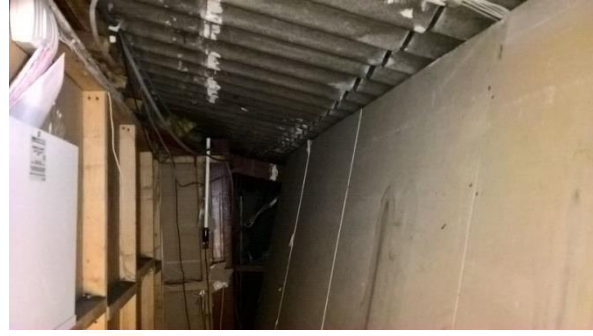
Plate 4.8: B1 – Further View of Roof Space

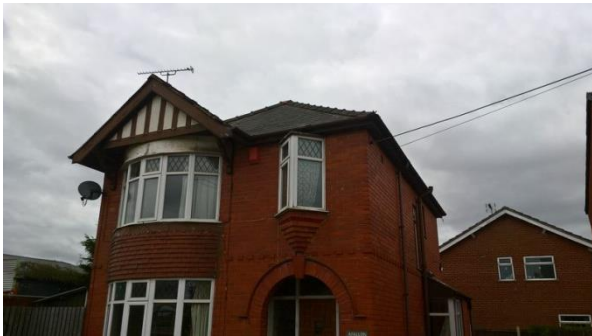
Afallon was a two-storey brick built residential property with a pitched and hipped clay-tiled roof (Plate 4.9).

Plate 4.9: B2 – North-Eastern Elevation

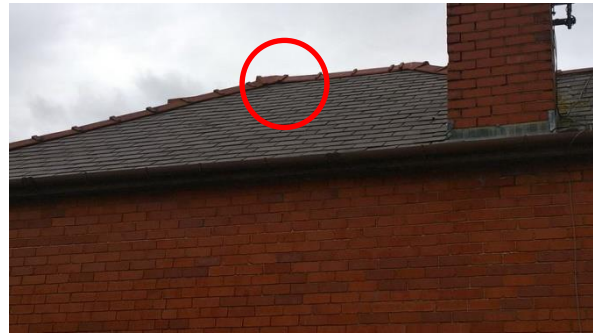
Plate 4.10: B2 – Gaps Under Ridge Tiles

The ridge and roof tiles were flat to the roof and generally in good condition and well-sealed, with no missing, broken or lifted tiles; however some gaps were present below the ridge tiles (Plate 4.10) which could not be inspected due to the height at which they were located. It was considered unlikely that the gaps would provide access into the loft space however they could provide crevice roosting opportunities. Gaps were also present below the hip tiles and some verge mortar was missing at the northern corner. Again, these features could not be fully inspected due to the height at which they were located.

This building has been identified as having high potential to support roosting bats. Bat Surveys: Good Practice Guidelines published by the Bat Conservation Trust (Collins, 2016) recommends that for structures with high bat roosting potential at least three dusk emergence and/or dawn re-entry surveys be undertaken during the bat emergence/re-entry survey season to determine the presence/absence of roosting bats within the structure. The bat emergence/re-entry survey season extends from May to September. At least two of the surveys should be undertaken during the peak season for emergence/re-entry surveys between May and August and one of the three surveys should be a dawn re-entry survey. If a roost is discovered during these surveys, a Natural England licence application may be required.

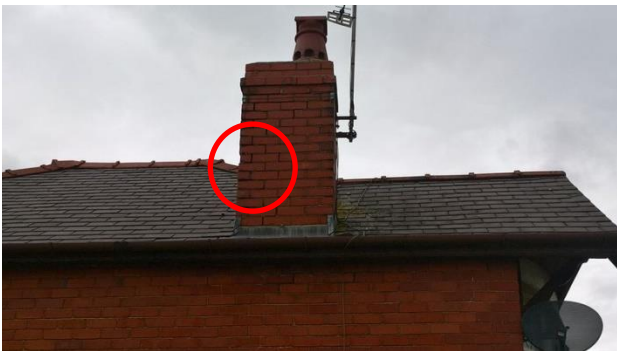
A chimney stack was present on the south-eastern roof pitch. Some mortar was missing between the bricks of the chimney (Plate 4.11) however most of the gaps did not appear to extend into the brickwork.

Plate 4.11: B2 – Missing Mortar on Chimney

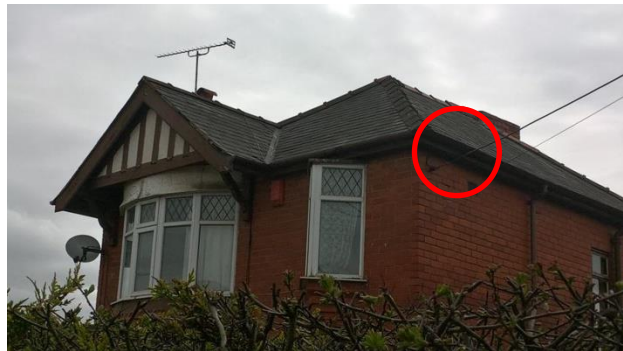
Plate 4.12: B2 – Boxed Eaves and Gable Feature

The eaves of the roof were boxed (Plate 4.12) and a gap was noted between the boxing and the wall on the rear (south-western) elevation. Again this could not be fully inspected due to the height at which it was located.

On the front (north-eastern) elevation of the house a small gable roof with a mock tudor gable end was present over the first floor bow window (see Plate 4.12). House sparrows were recorded to be nesting within this feature and slight gaps were noted between the boards.

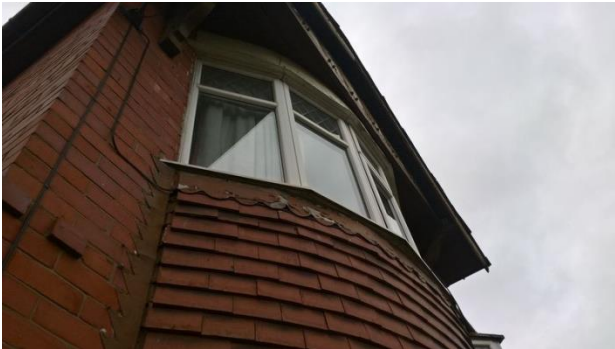
**Plate 4.13: B2 – Hanging Tiles Between Bay Windows**

Hanging tiles were present between the bow windows on the ground floor and first floor (Plate 4.13). These were well-sealed, with only very narrow gaps present at the base.

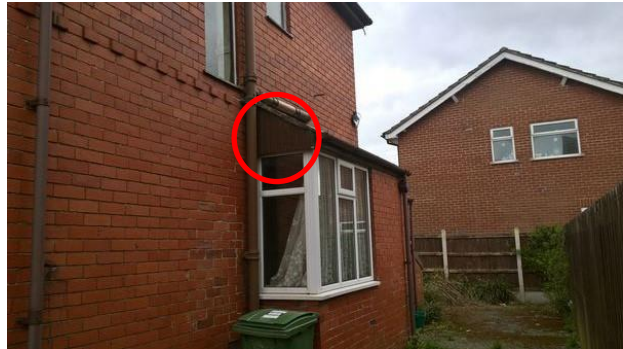
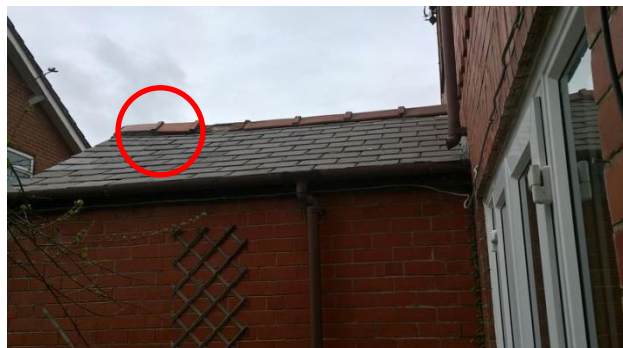
**Plate 4.14: B2 – North-Western Extension With Barge Boards**

A small, single-storey linear extension was present on the north-western elevation of the building (Plate 4.14). This had a half-pitched roof of slate tiles which were lined internally. The roof was generally in good condition however one tile was noted to be slightly lifted, creating a potential access point below the tile. Wooden barge boards were also present on the north-eastern gable end of the extension (see Plate 4.14) however they were tight to the wall.

**Plate 4.16: B2 – North-Western Extension With Barge Boards**

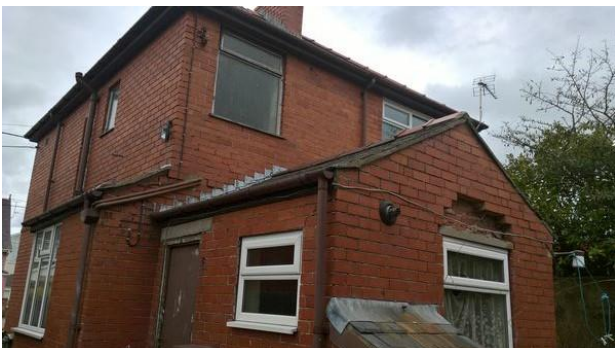
A single storey kitchen extension was present on the south-western elevation of the building (Plate 4.15). This had a pitched roof with a brick gable end, overlapping clay ridge tiles and slate roof tiles. Gaps were present below some of the ridge tiles (Plate 4.16) and under a couple of the slates. These could be inspected using a ladder and torch and most of the gaps did not extend very far however a few went right into the ridge and may provide access to crevice roosting opportunities or into the loft space within. No evidence of bats was recorded within the gaps under the ridge tiles however a single bat dropping, considered to be from a pipistrelle species of bat, was recorded on the northern pitch of the roof.

**Plate 4.15: B2 – Kitchen Extension**

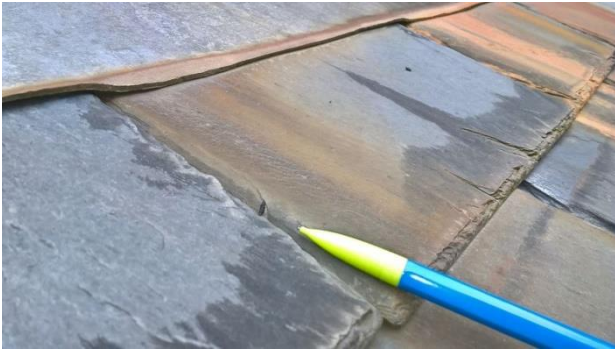
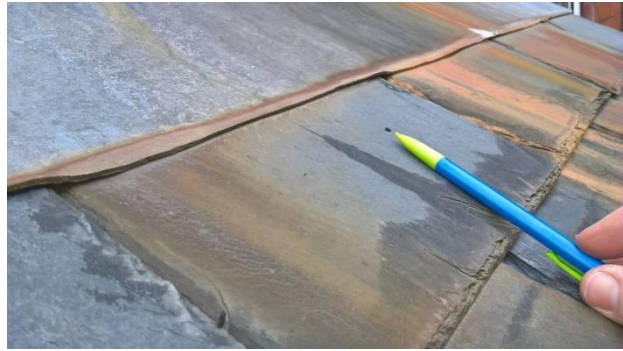
**Plate 4.17: B2 – Bat Dropping on Coal Store**

**4.18: B2 – Second Bat Dropping on Coal Store**

A coal store was attached to the kitchen extension and two further pipistrelle-type droppings were recorded on top of this (Plates 4.17 and 4.18).

However, as three bat droppings were recorded on the tiles of the rear extension and external coal store of Building B2 and a number of potential roost features were identified on the building, B2 was concluded to hold high bat roost potential. The proposed demolition of this building, therefore, has the potential to disturb or destroy any roosts present within the features identified and potentially injure or kill any bats present at the time, in contravention of the legislation relating to bats, as detailed in Appendix 1. Recommendations for further surveys to assess whether bats are indeed present and inform any mitigation required to avoid adverse impacts on bats are therefore made in Chapter 6.

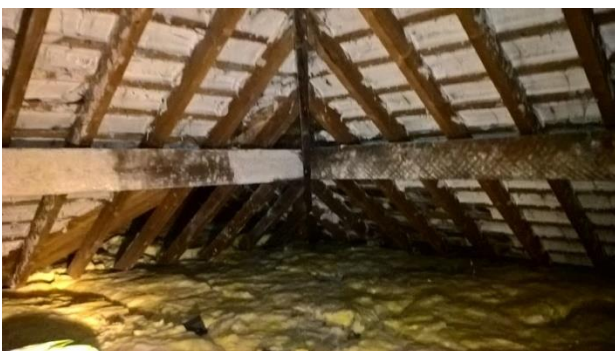
Internally, the main roof was supported on a wooden frame with rafters and purlins (Plate 4.19). The space was uncluttered but small, with a floor to apex height of 2.5 metres and an area measuring approximately 10 metres by 8 metres.

**Plate 4.19: B2 – Internal Roof Space, Showing Plaster on Tiles and Insulation on Floor**

The tiles were unlined but were backed with a type of insulating white plaster (see Plate 4.19). A small amount of light was visible at the eastern side where some of the plaster was missing behind the tiles near the eaves however not large gaps or potential entry points were recorded.

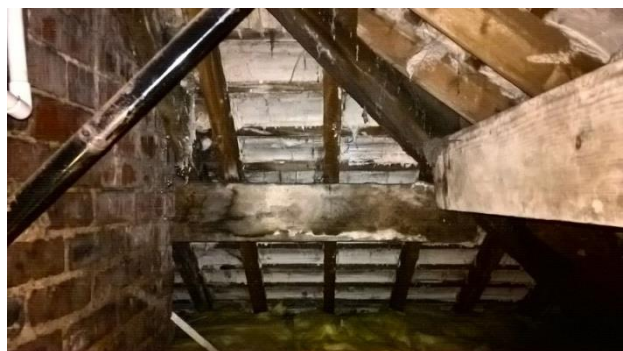
**Plate 4.20: B2 – Brickwork of Chimney Stack**

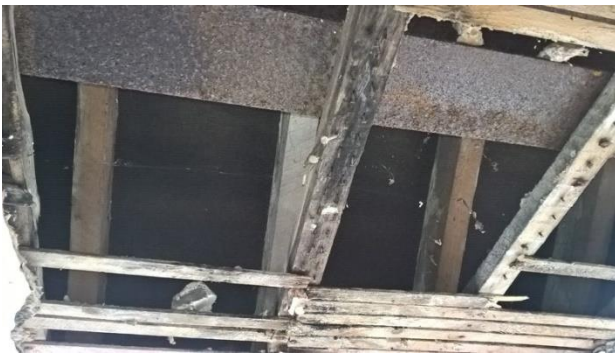
Within the single-storey pitched extension on the north-west elevation of the building the ceiling was broken, giving views into the small roof space (Plate 4.21). The underside of the roof tiles was lined with felt sarking and this was intact, with no light showing from the outside. No evidence of bats was recorded within the roof space.

**Plate 4.21: B2 – Internal Roof Space of Extension, Showing Felt Sarking**

It was not possible to fully inspect all features within the loft space e.g. the area between the felt sarking and roof tiles within the north-western extension and as such the bat roosting potential of this area could not be determined. Whilst no evidence of bats, e.g. droppings, urine staining, feeding remains or scratch marks, was recorded during the internal inspection of the building, not all areas could be fully assessed.
