**ECOLOGICAL APPRAISAL**

**BUILDING TO REAR OF  
HAFOD ADAMS  
LLANARMON-DYFFRYN-CEIRIOG  
LLANGOLLEN  
LL20 7LB**

**MAY 2018**

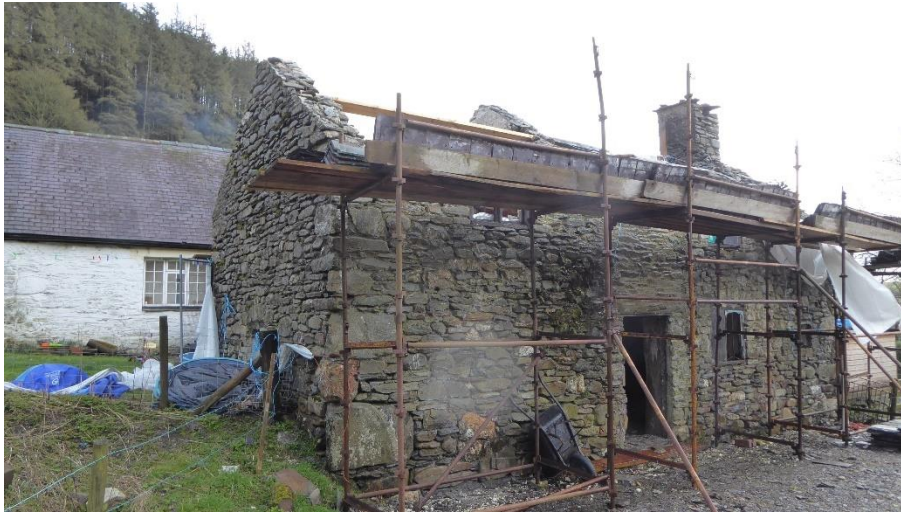
**Figure 4.2. The building**

The building to be renovated is a typical welsh borders dwelling comprising double-skin stonework. At the time of survey it had no roof at all.

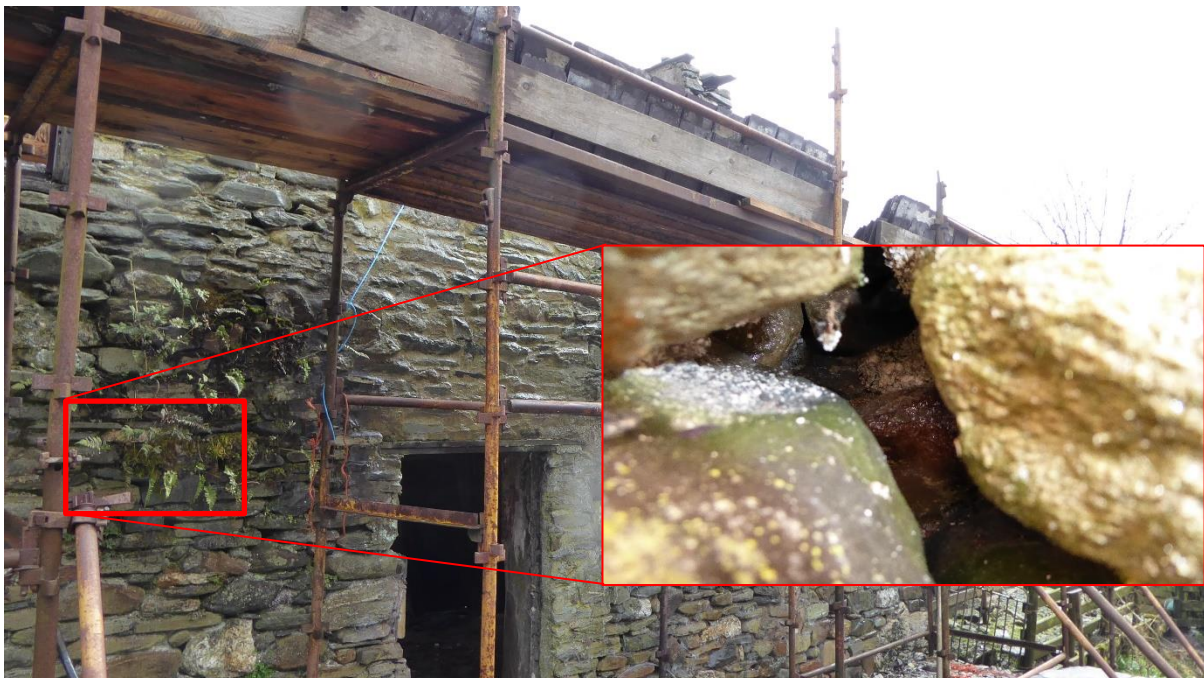
**Figure 4.3. Gap shown in brickwork**

The stonework has several mortar gaps which lead into large cavities behind the outer stonework, these could be used by individual bats in the summer, though no evidence was found during this survey. These gaps are currently not impacting the structural integrity or weatherproofing of the rooms inside, and so it is not an urgent job to re-point. Some of the major gaps are located in areas planned for removal to create new windows, such as that shown below.

It is recommended that work on repairing the stone walls and creation of a new window be conducted between the end of September and March to minimise the risk to individual bats that might use the gaps as a transitory roost.

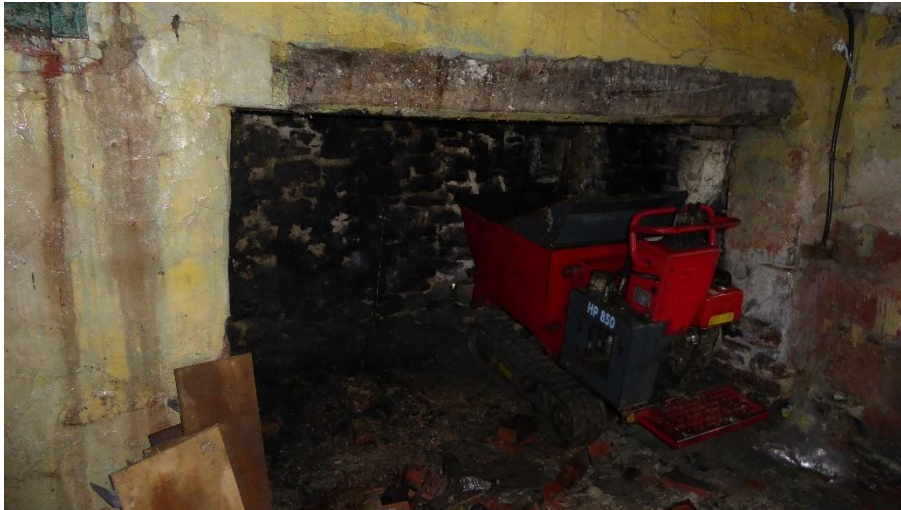
**Figure 4.4. Fireplace**

The building was thoroughly searched internally for evidence of bats but none was found. This is likely due to the highly open nature of the building owing to the lack of roof. There is a very large fireplace and chimney on the southeast gable. This chimney was checked for bats and none found.

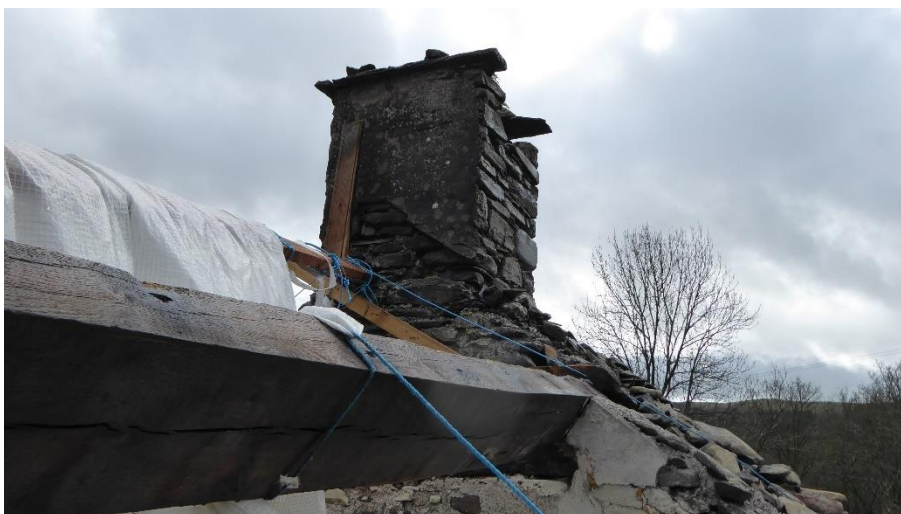
**Figure 4.6. Chimney exterior**

The exterior of the chimney is much the same as the rest of the building – constructed of stone with significant mortar gaps which might offer refuge for individual bats.

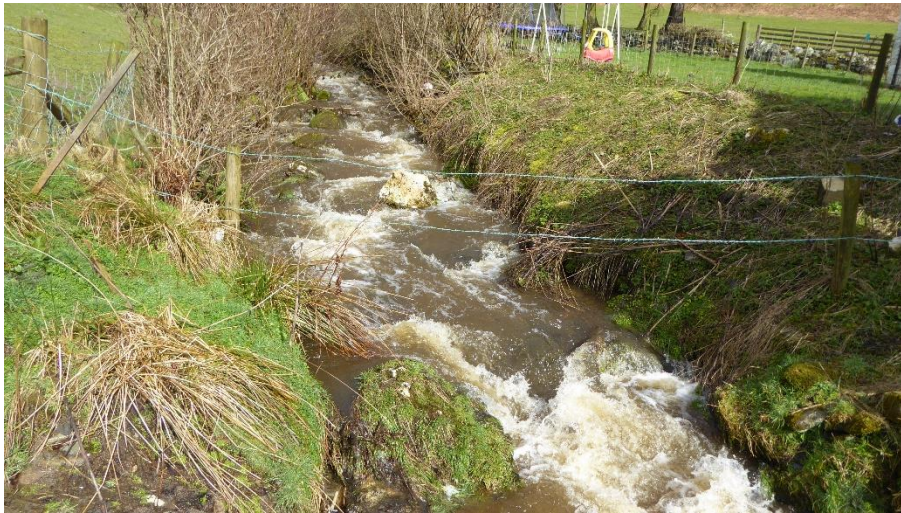
**Figure 4.7. Fast-flowing stream**

The stream running along the house was very fast flowing at the time of survey, most likely due to recent snow melt. The banks were checked for evidence of species such as water vole, but no evidence was found and the water course is generally unsuitable for the species. The water is always flowing and so is considered unsuitable for species such as great crested newts.

Clearance of site and the development work itself might result in increased dust and silt contaminating the stream toward the river and this would cause a minor negative impact on the protected species recorded in this area. Careful working practices and a simple method statement will be utilised to prevent contamination.

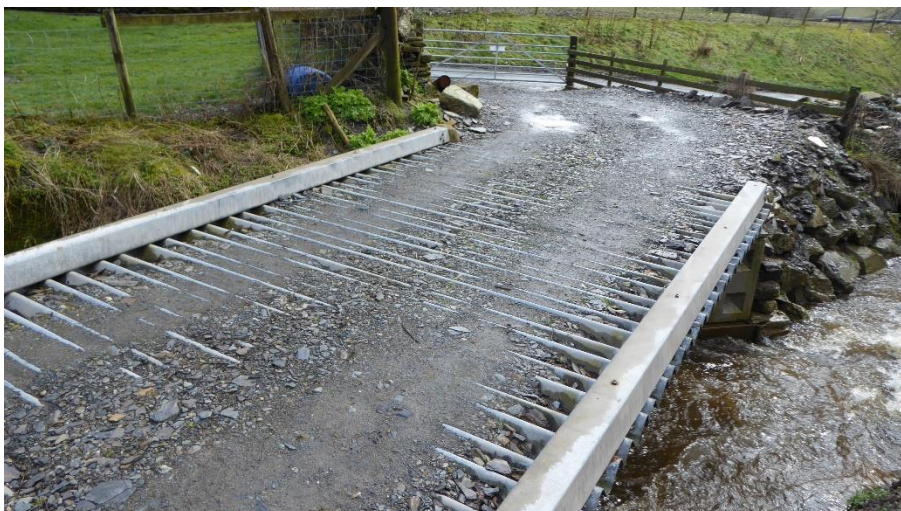
**Figure 4.8. Bridges**

Two bridges have already been constructed over this stream, allowing vehicular access to the land west of the building, and will be used as the private access once the conversion is complete. These bridges are corrugated metal concreted in to the banks on either side. The only further amendment regarding these bridges will be railings along the sides, which will have no impact on the biodiversity of the area.

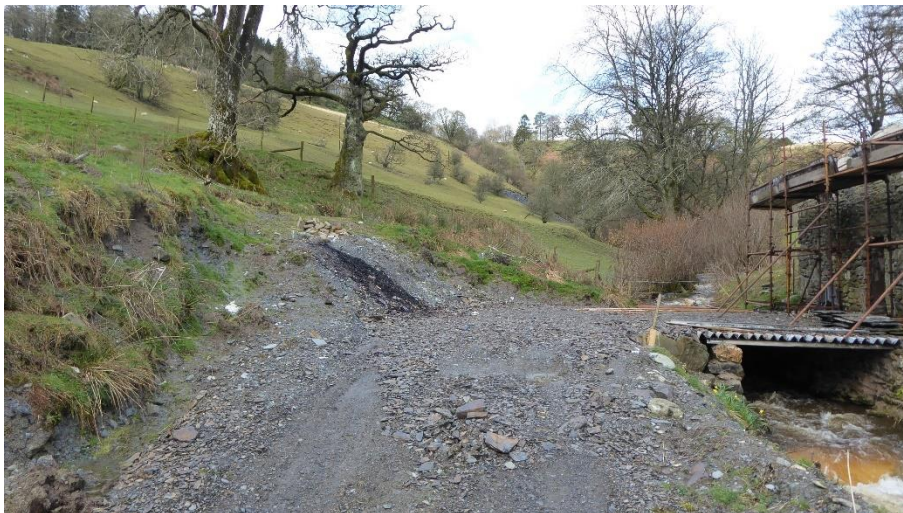
**Figure 4.10. Stone driveway leading to a bridge**

The stone driveway is not planned for alterations.

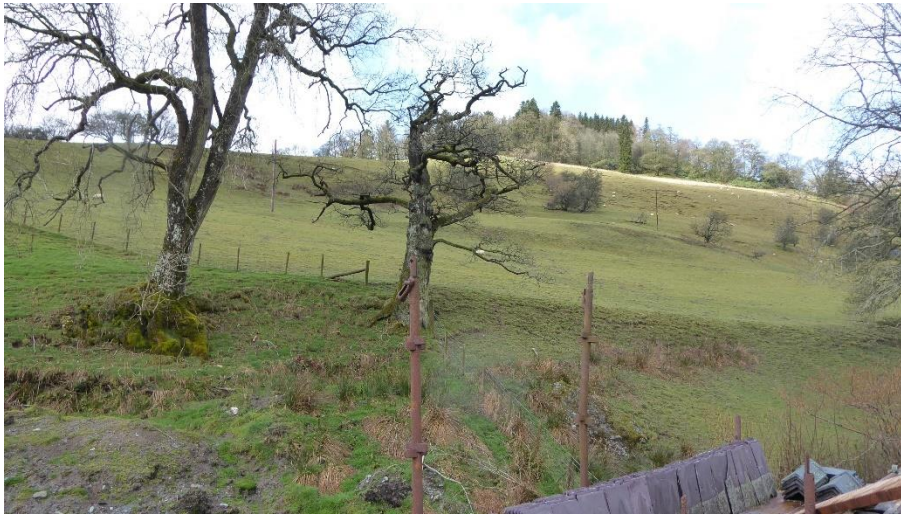
**Figure 4.11. Land to the west**

The site is surrounded on all sides by the Berwyn Valley. This is comprised of grazed pasture and blocks of woodland on rolling hills. There are three trees to the immediate west of the site, these are located to the north of the existing driveway and have some potential for roosting bats. There is limited ecological value in the lands immediately around the development.

No evidence of species such as badger was seen in the immediate surrounds.

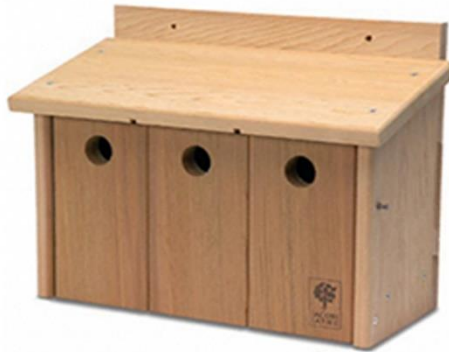
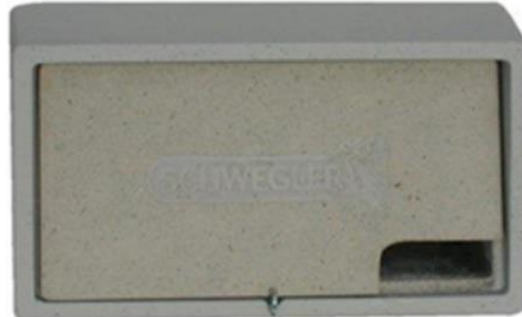
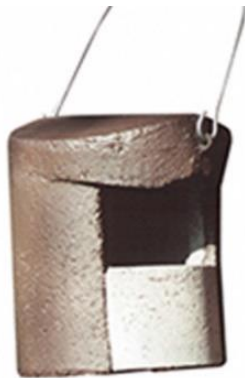
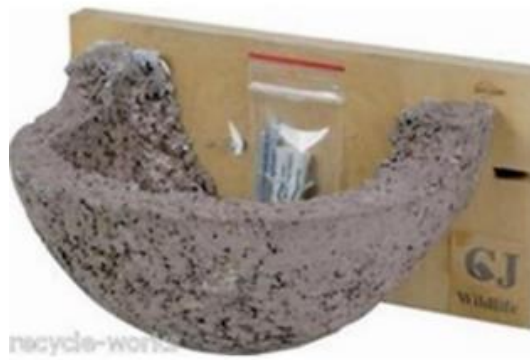
**Figure 6.3: Provision for bird boxes**

Cedarwood Sparrow Terrace

Schwegler 16S Integral  
Swift Box

Schwegler 2H Robin Box

Swallow Nest Cup

1. It is recommended that a range of artificial woodcrete boxes are erected around the site to provide an enhancement for passerine birds. A selection of the following nest boxes is recommended.
