# BAT SURVEY REPORT

BROAD OAK FARM BARNs, ROSSETT

SITE 2

| Report Reference | BRO_R002 |

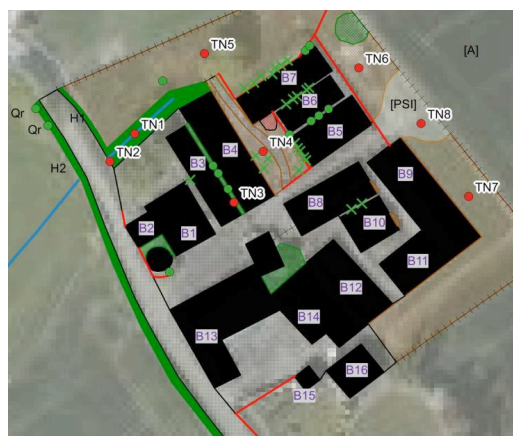
**Plate 1: Location of buildings**

- 3.3.1 Plate 1 below shows location of buildings (taken from Bowland Ecology Ecological Appraisal).

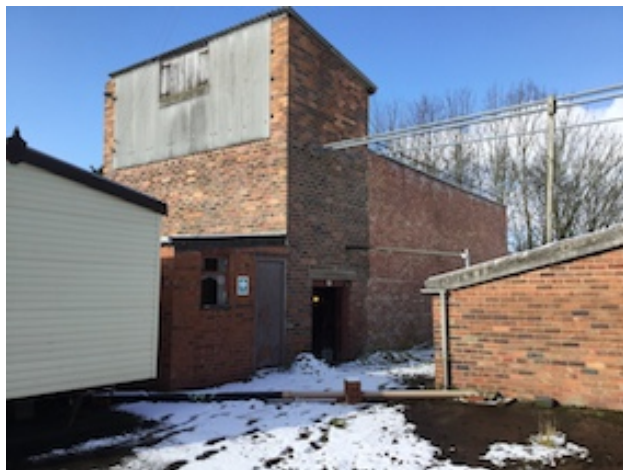
Building 1

| Building ref | Brief description | Potential to support bats | Comments |
|---|---|---|---|
| 1 | Two storey red brick building with corrugated fibre cement roof with single storey monopitch tiled roof extension on northern aspect. | Low | None |

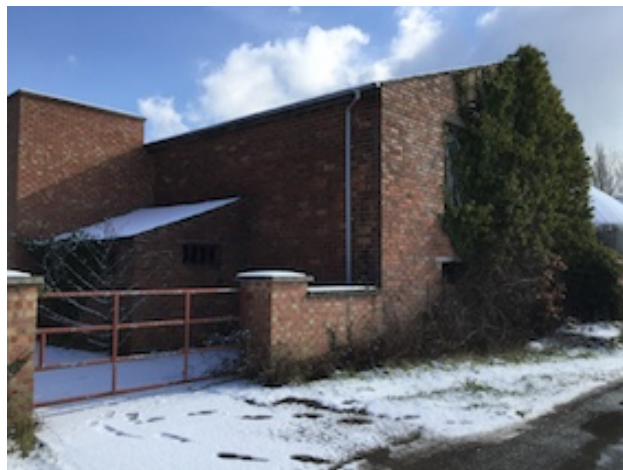
Building 2

- 4.1.2 The 2016 survey identified building 2 as medium/high potential, however, the upper floor was not accessed and so a thorough survey could not be achieved. In 2018, the upper floor of the building was comprehensively surveyed and it was found that the building offered little potential for bats and with the exception of a single butterfly wing (which could be present coincidentally), no evidence of bats was identified. The building does not offer good roosting potential for crevice dwelling species, given the limited suitable features. Any loose or raised tiles may support individuals but are not substantial enough to support colonies. The ivy on the side of the building has good leaf foliage but the stem structure is not dense and so unlikely to support bat colonies. Void dwelling species such as brown long-eared would unlikely access the building since the only main upper level entrance point is covered by ivy. It is possible they could access the building through lower ground windows and fly up through the small loft hatch but there was no evidence in the form of droppings etc to support this. The timbers within the roof structure are relatively new (possibly within 30 years) and therefore unlikely to attract this species.

| Building ref | Brief description | Potential to support bats | Comments |
|---|---|---|---|
| 2 | Two storey red brick building with pitched slate roof, ridge tiles, roof lights on northern and southern elevations. Internally, solid floors on ground, upper floor, access via loft hatch comprises intact floor boards, open to roof, no roof membrane present, broken gable window which is ivy covered which would block free flight into building, gaps at eaves. | Low | Single butterfly wing |

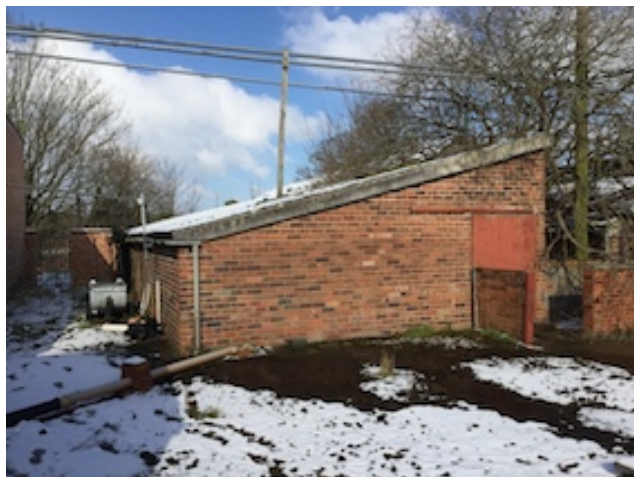
Building 3

| Building ref | Brief description | Potential to support bats | Comments |
|---|---|---|---|
| 3 | Single storey red brick barn, fibre cement roof in poor condition. Roof part lined internally with fibreboard in poor state of repair. | Low | None |

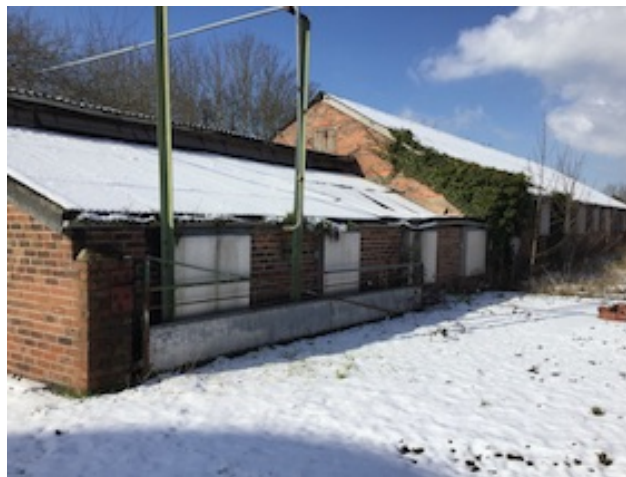
Building 4

| Building ref | Brief description | Potential to support bats | Comments |
|---|---|---|---|
| 4 | Single storey red brick barn, fibre cement roof in poor condition. Roof part lined internally with fibreboard in poor state of repair. | Low | None |

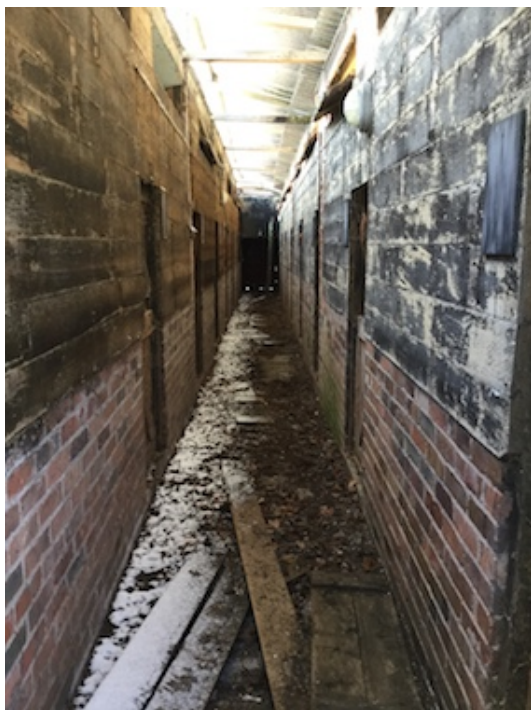
Building 5

| Building ref | Brief description | Potential to support bats | Comments |
|---|---|---|---|
| 5 | Single storey red brick barn, fibre cement roof in poor condition. Roof part lined internally with fibreboard in poor state of repair. | Low | None |

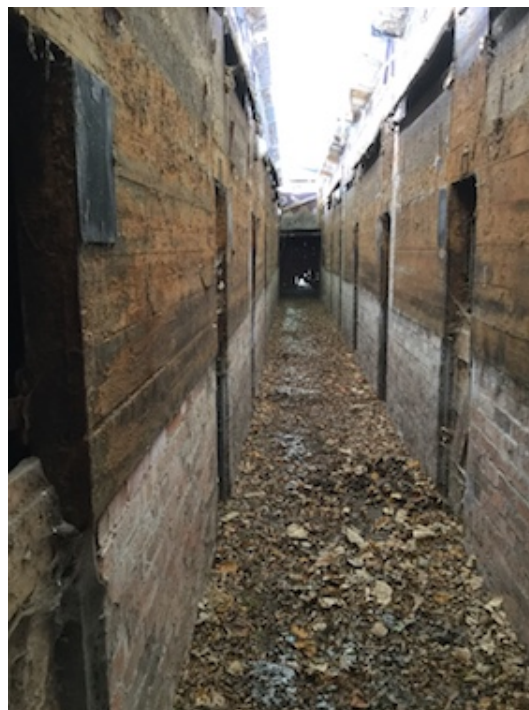
Building 6

| 6 | Single storey red brick barn, fibre cement roof in poor condition. Roof part lined internally with fibreboard in poor state of repair. | Low | Occasional butterfly wing |

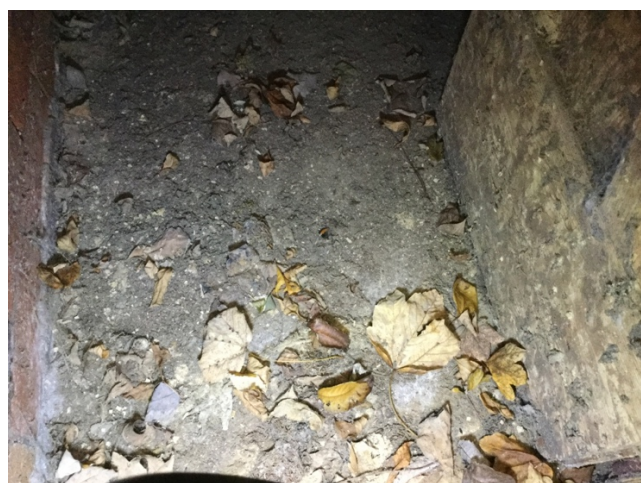
- 4.1.3 The occasional presence of butterfly wings could be coincidental, particularly given a live, hibernating adult peacock *Aglais io* butterfly was recorded in building 7. However, it is possible it may indicate that some of the barns may be used as feeding roosts by bats on a transient basis.

Building 6 (wing centre of photo)

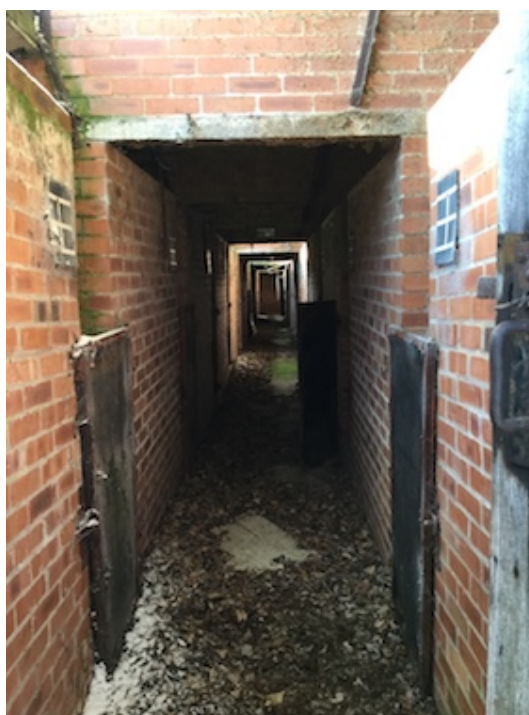
Building 7

| 7 | Single storey red brick long barn, fibre cement roof in poor condition. Roof part lined internally with fibreboard in poor state of repair. | Low | Occasional butterfly wing |
