**PROPOSED RESIDENTIAL DEVELOPMENT  
MAESTEG,  
GWYNFRYN, WREXHAM  
FOR  
WALES & WEST HOUSING ASSOCIATION**

**NOVEMBER 2013**

**PHASE II GEO-ENVIRONMENTAL INVESTIGATION REPORT  
13057**

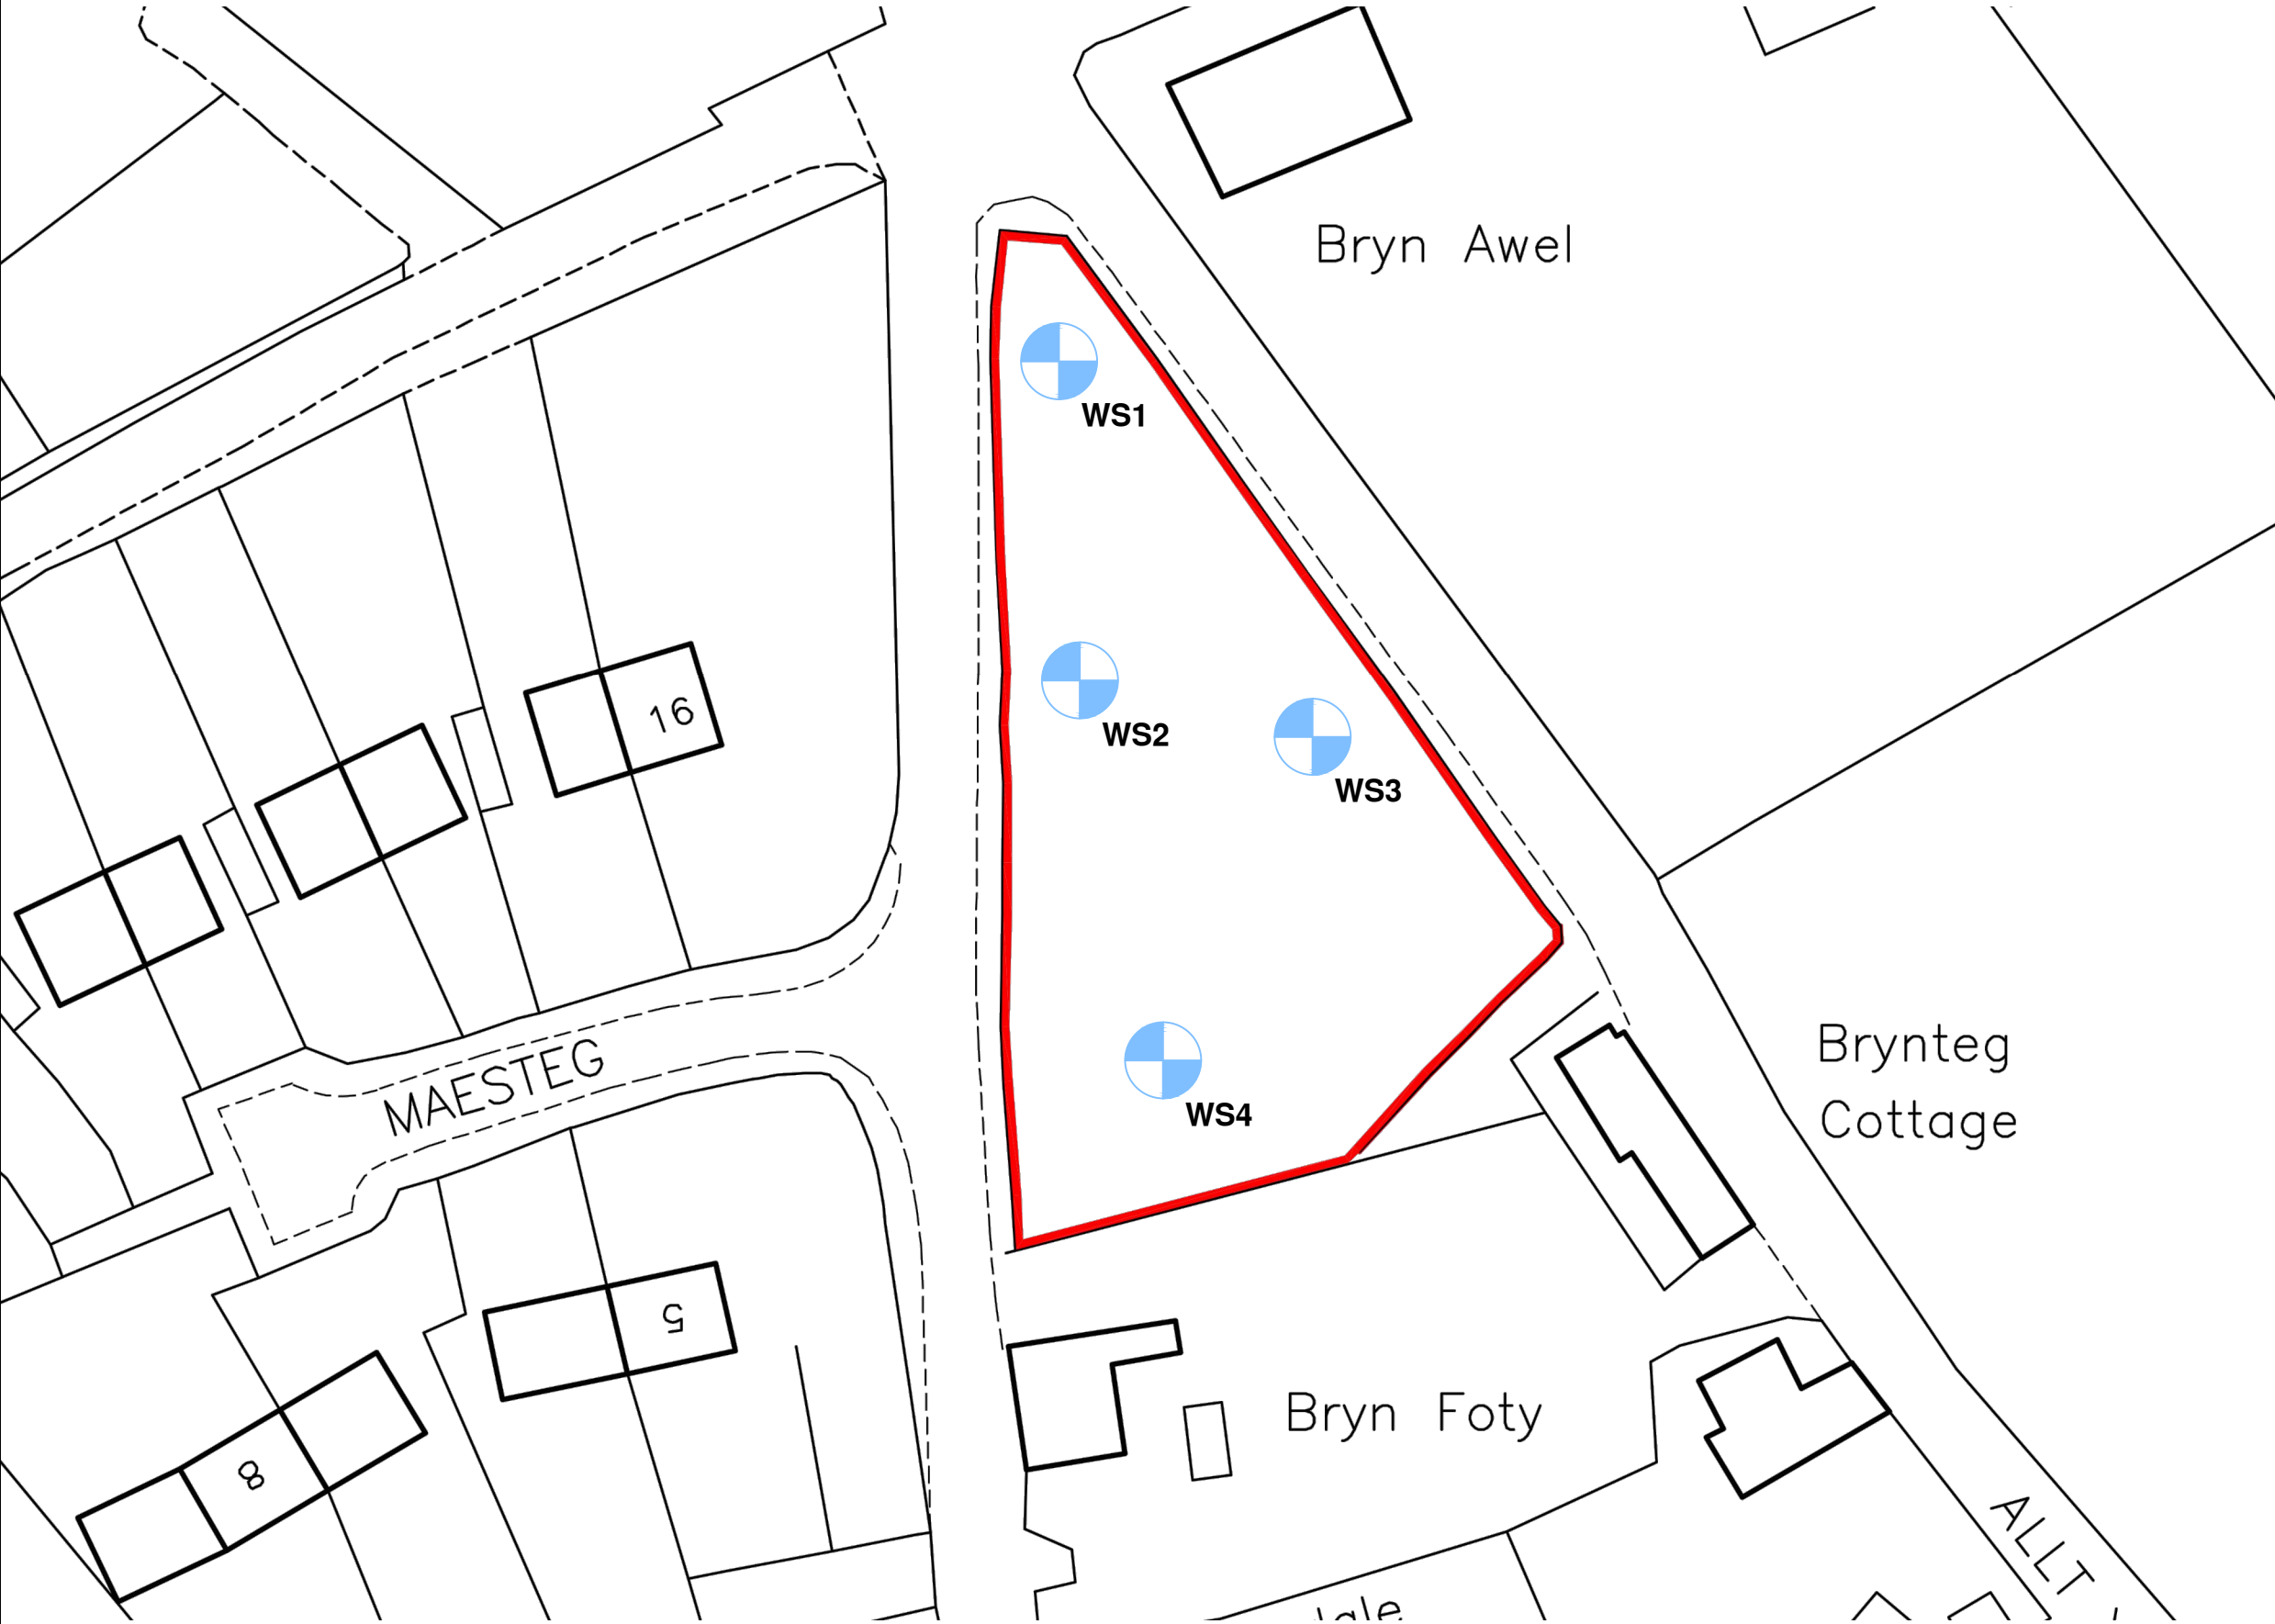
SITE PLAN VIEW

- 3.2.1 *The locations of the boreholes were chosen by ourselves in conjunction with the desk study information and services locations in an effort to identify the representative ground conditions present across the whole site area. The ground conditions actually identified within the boreholes are considered to be representative of the majority of the shallow soils within the site area.*
- 3.2.2 *The locations of each of the boreholes are indicated upon the appended borehole location plan. These locations are shown in relation to site features present at the time of the investigations.*
