**RE: TOTAL FITNESS, STANSTY ROAD, WREXHAM**

Thank you for your letter of the 11<sup>th</sup> March 2016, Reference P/2015/0812. In reply to your queries we have plotted up the proposed site boundary against other information currently available to enable the queries to be better assessed.

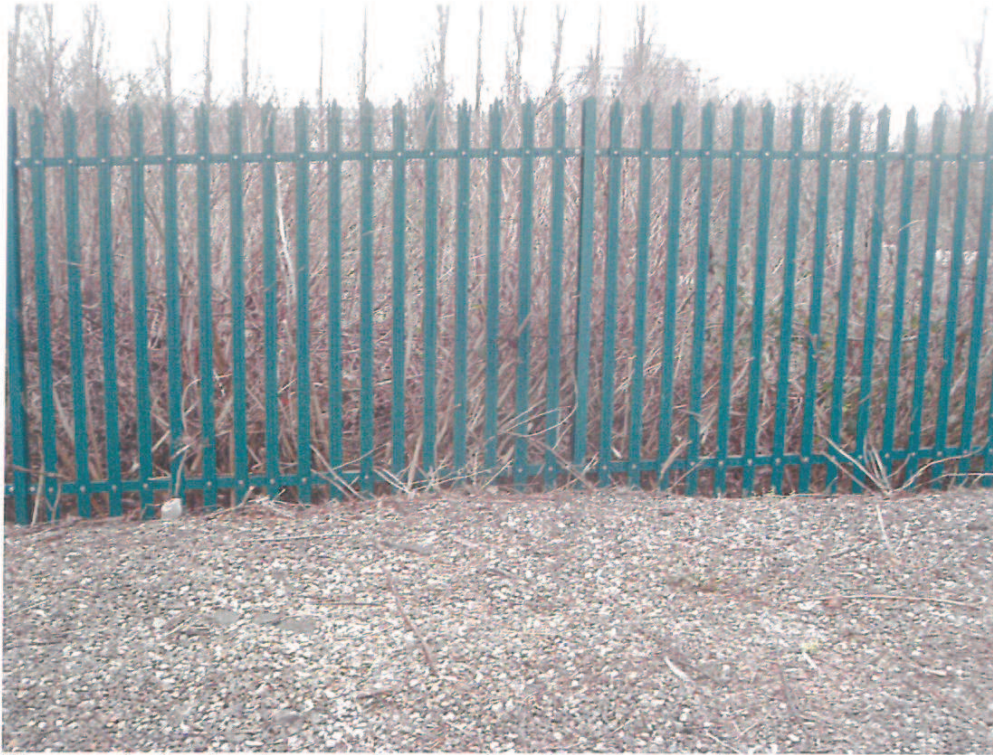
Regarding the Japanese Knotweed, the Ian Farmer reports identified one area which was outside of the site on the railway line, while the other area is to the south of the Gower Homes site, see

attached photographs. We have been back to site at a time when the Knotweed would be growing and can confirm that no knotweed is present on the Gower Homes site. However, the knotweed identified by Ian Farmer is still visible; although the section by the retaining wall appears to have been treated as it looks the same as the 2013, see photographs below.

Photograph showing Japanese Knotweed on the adjacent railway site, located to the south of the Gower Homes site.

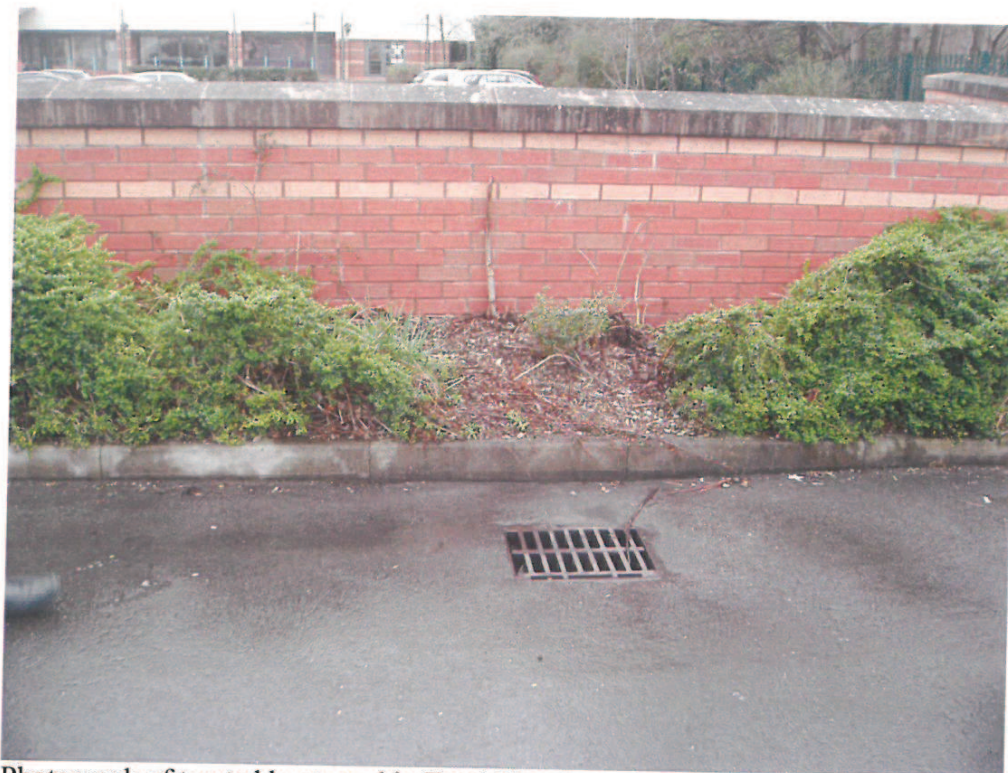
Photograph of treated knotweed in Total Fitness car park.

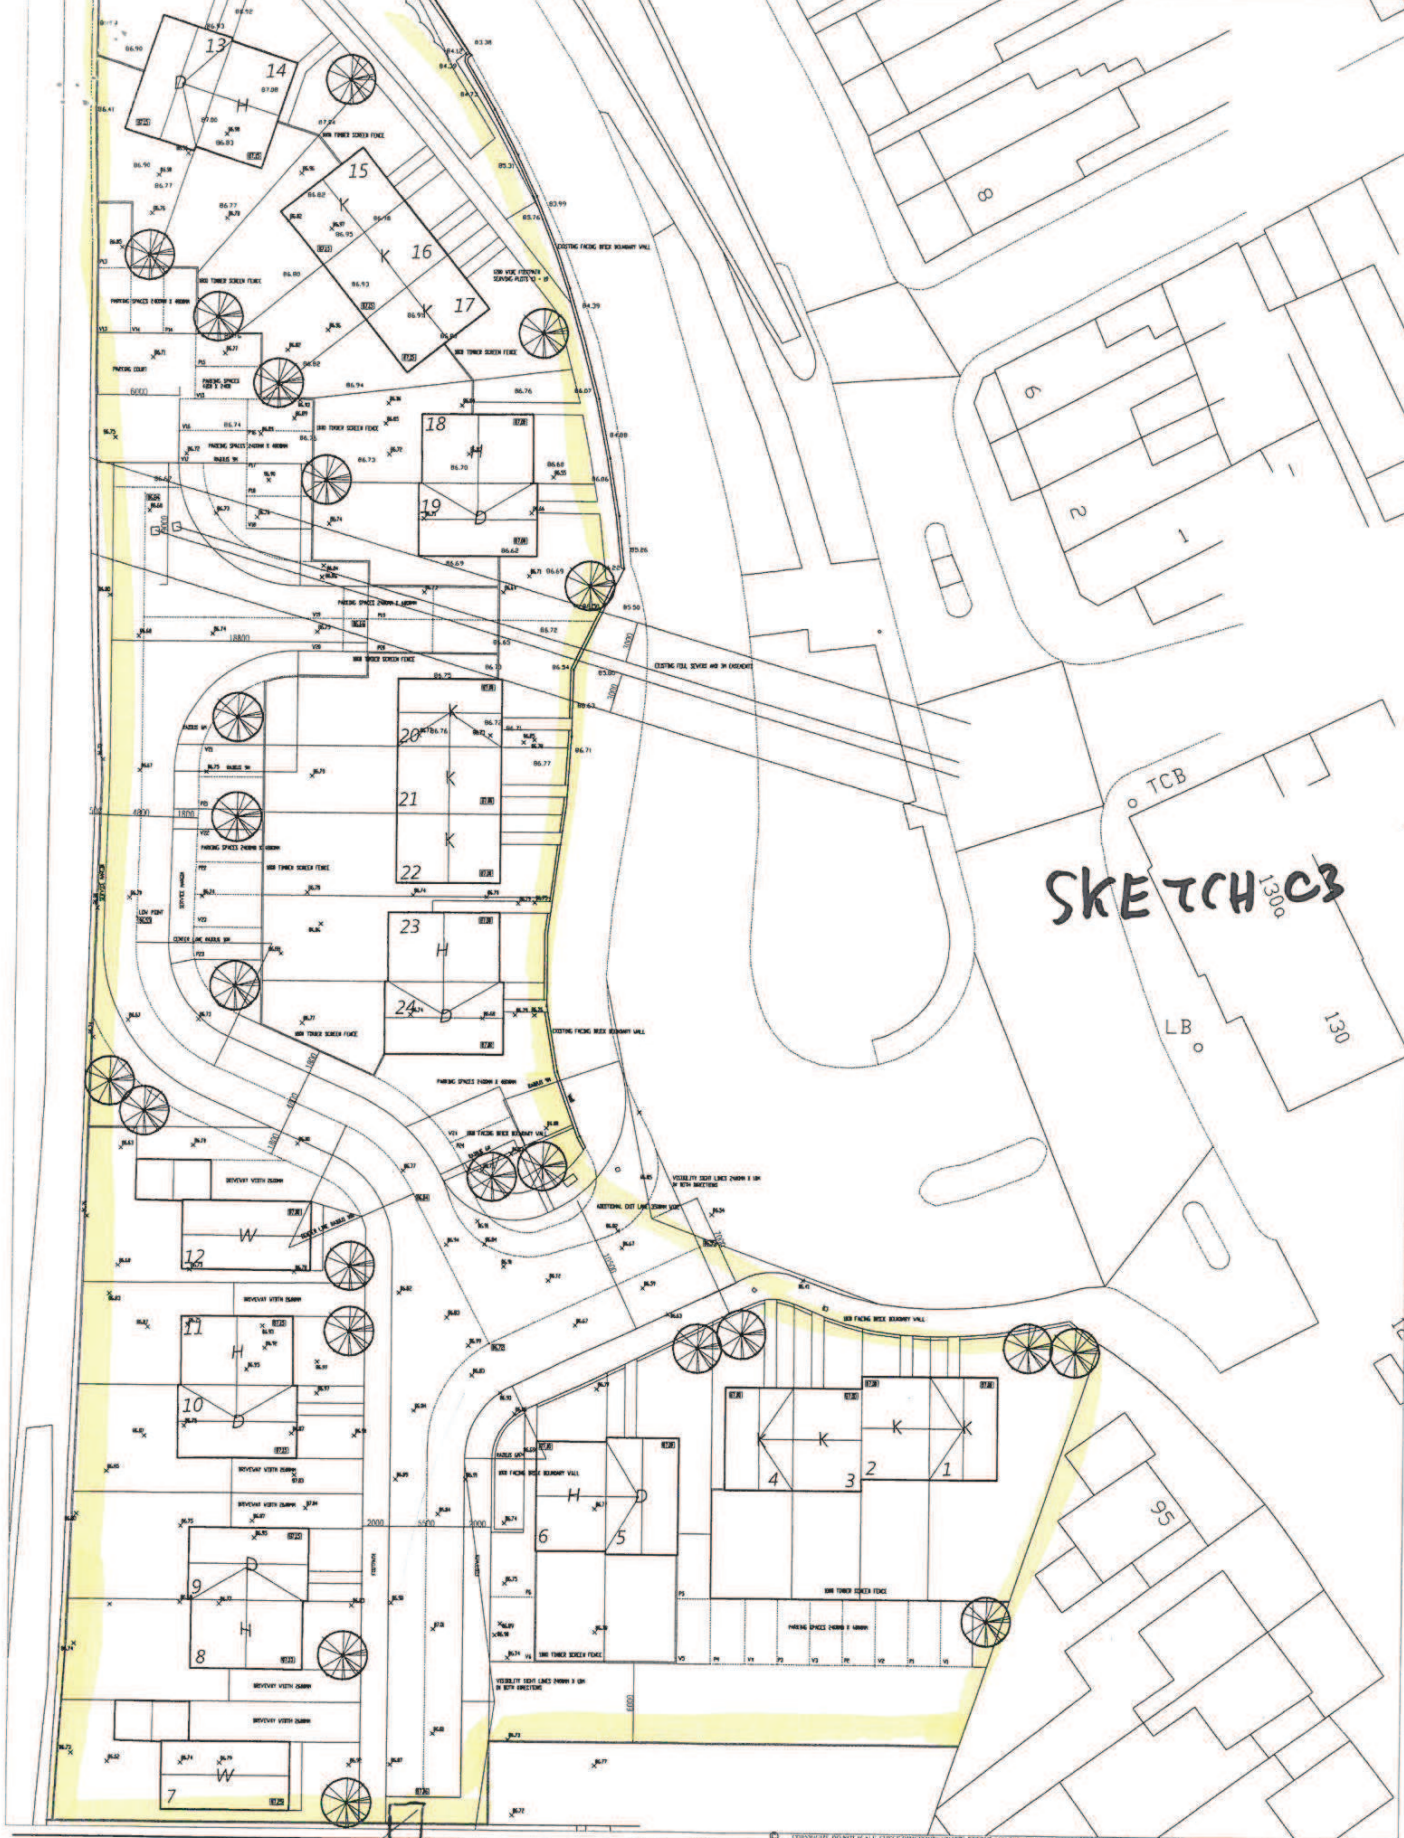
SKETCH C3

The location of the tank has then been transposed onto the proposed site layout, see Sketch 03. This shows the existing location to be in the middle of the Total Fitness car park and following development it will be beneath the access road for the development, which will also lead to the Total Fitness centre. As you will appreciate it is not possible at this time or during the development to dig up this location, as access will be required to Total Fitness at all times.

The tank would have been located on the Post Office hardstandings, and Total Fitness was constructed between 2005 and 2006, consequently, it can be assumed that any surface contamination associated with the tank would have been removed during the demolition of the Post Office and construction of the Total Fitness car park. In any case, should any residual contamination remain it is not in an area to be occupied by any proposed housing, consequently, the risk to future site users is considered to be very low. If any contamination was to be encountered it would appear in the excavations for service trenches into Plot 7 (Sketch 03) and can be removed at that time.
