REF: 1885/BG/RepLet/pbg

## **RE: KARINYA COTTAGE, BWLCHGWYN, WREXHAM – SOAKAWAY TESTING**

This report presents the findings of the investigation, and presents the results of the soakaway testing.

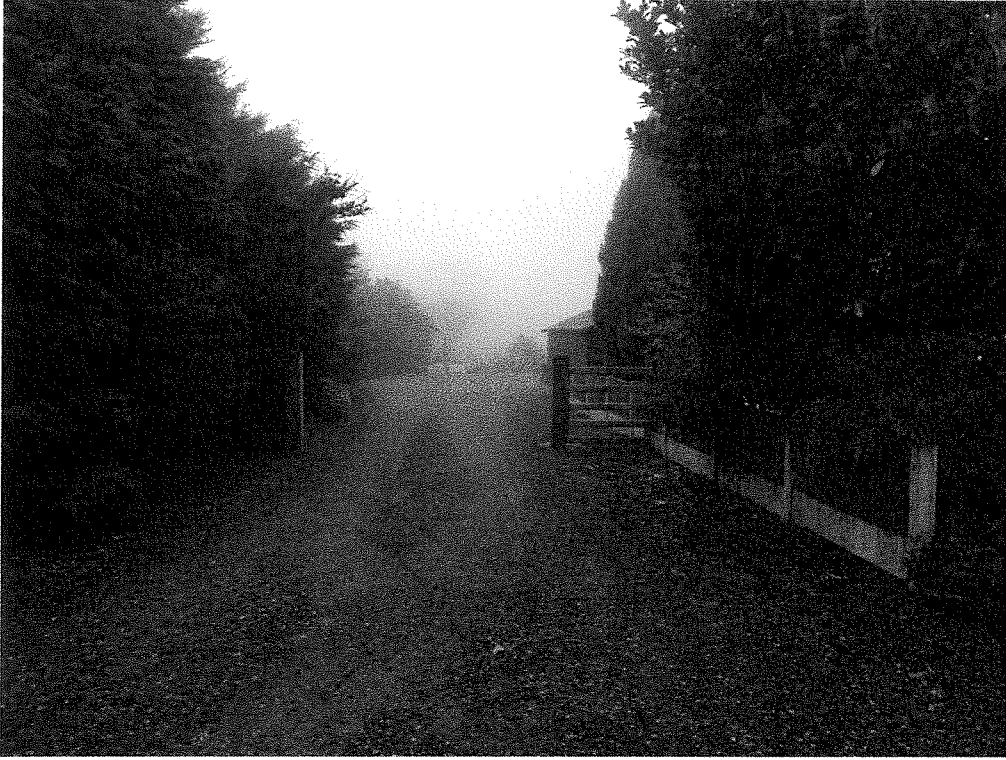
Photograph 1 looking south along the shared drive from Wesley Road

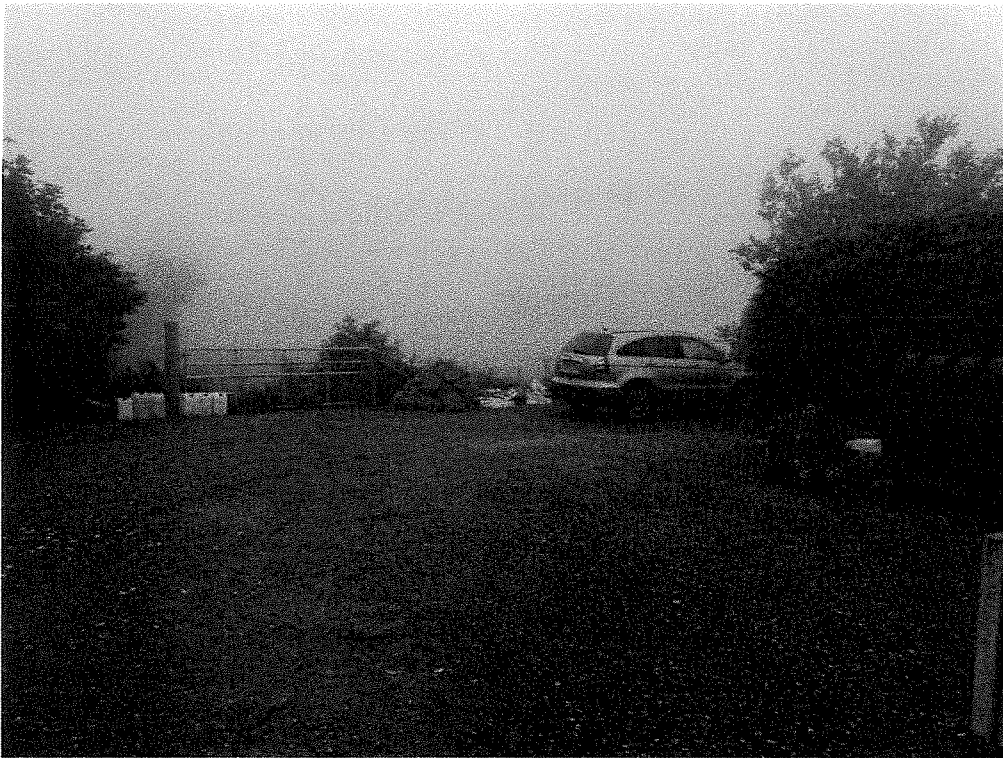
The site is currently covered with gravel to the south and grass with a number of coniferous trees to the north. A wooden shed and small residential oil tank is also located in the centre of the site.

Photograph 2 looking south west across the southern half of the site

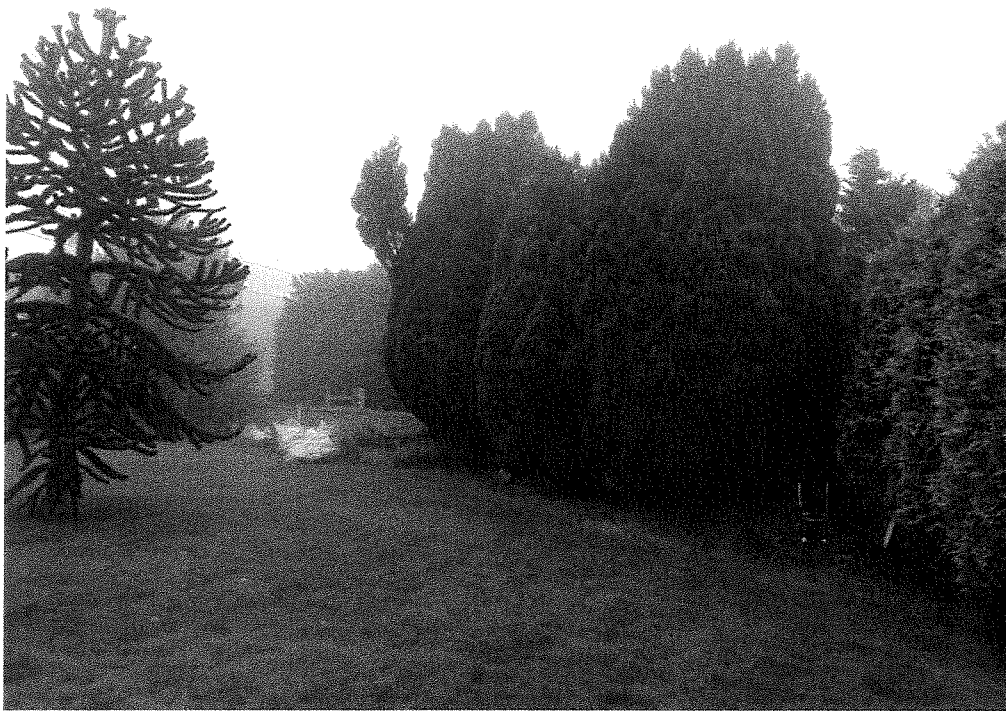
Photograph 3 looking north east across the northern half of the site

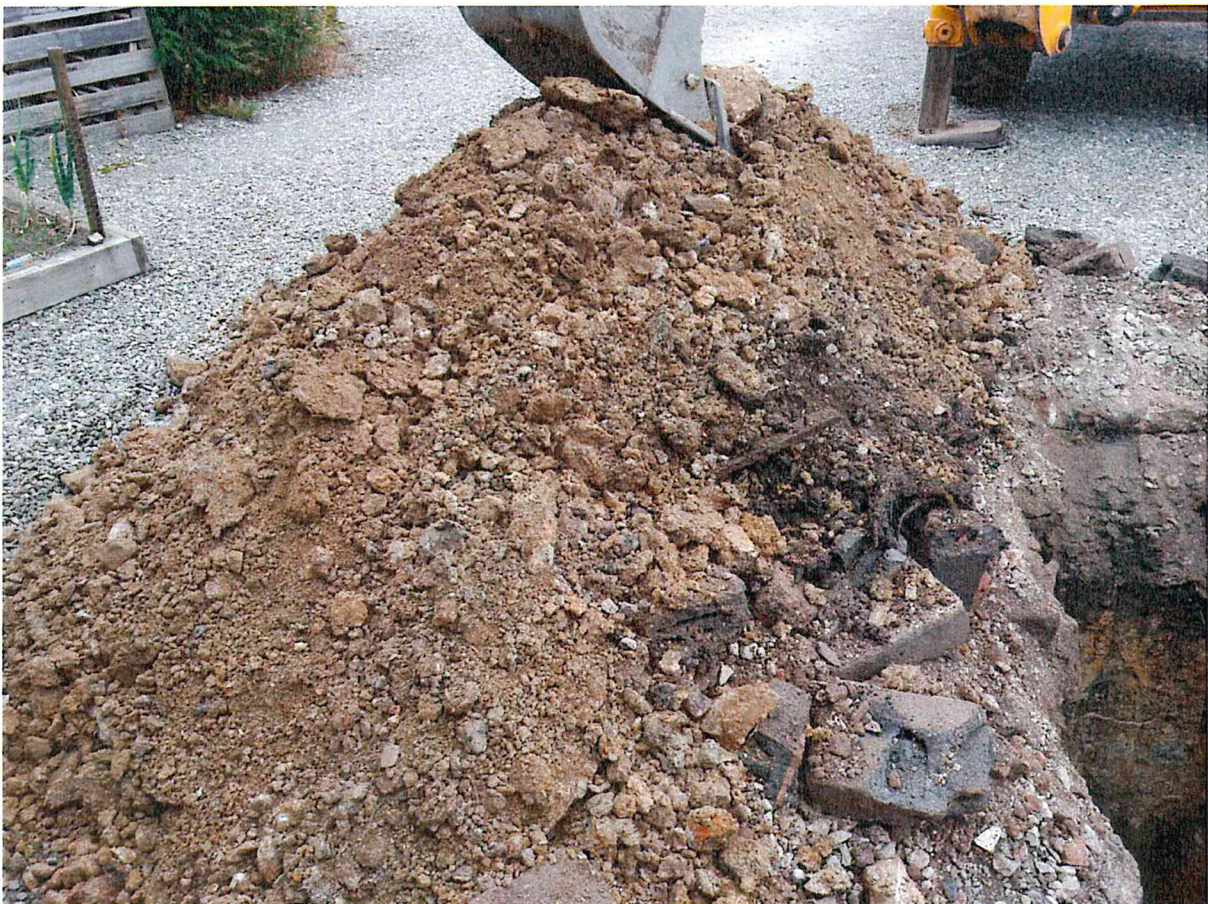
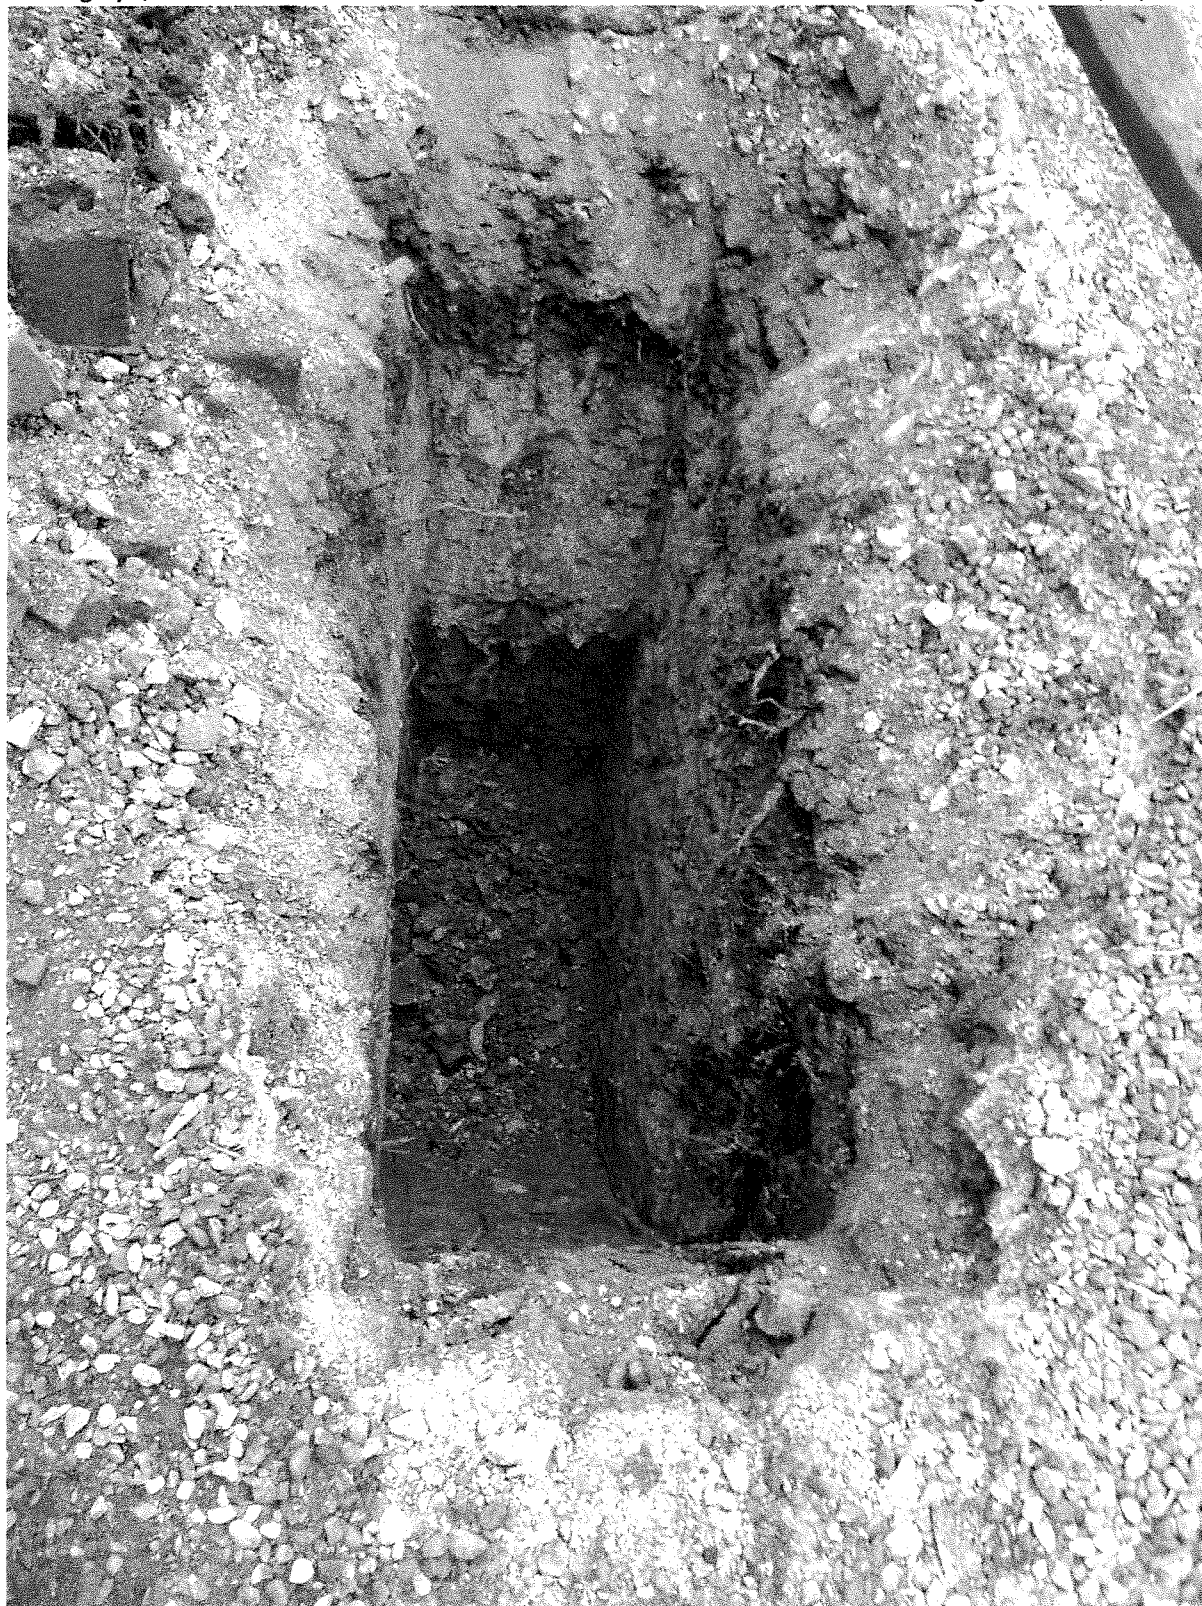
Trial Pit 01

Made ground was encountered to a depth of 0.35m and comprised loose, grey, gravel hardcore, constituting the driveway surfacing to 0.05m over loose, brown, clayey, silty, sandy, angular to sub angular, fine to coarse, gravel with a little wood fragments and some to much brick and concrete cobble to a depth of 0.35m.

The previous topsoil layer comprised firm, dark brown, locally mottled orangish brown, slightly sandy, slightly gravelly, silty, clay/ clayey, silt, with some roots, rootlets and wood fragments to a depth of 0.80m.

The bedrock was weathered near surface to firm, dark grey, mottled yellowish brown, slightly sandy, slightly gravelly, silty clay, with some limestone cobble and a little rootlets to a depth of 1.90m.

Below 1.90m the bedrock comprised mudstone recovered as cobbles and gravel, within a clay matrix, with the excavator refusing at a depth of 2.15m.

1. Pit dimensions 0.70m x 1.90m x 2.15m,
2. Pit sides were stable,
3. Groundwater was not encountered,
4. Excavator refused at 2.15m.
