## Ecological Assessments

Project: Building to the Rear of 20 Market Street, Rhosllanerchrugog,  
Wrexham. LL14 1AF.

On behalf of: Michael Clark

Date: July 2016

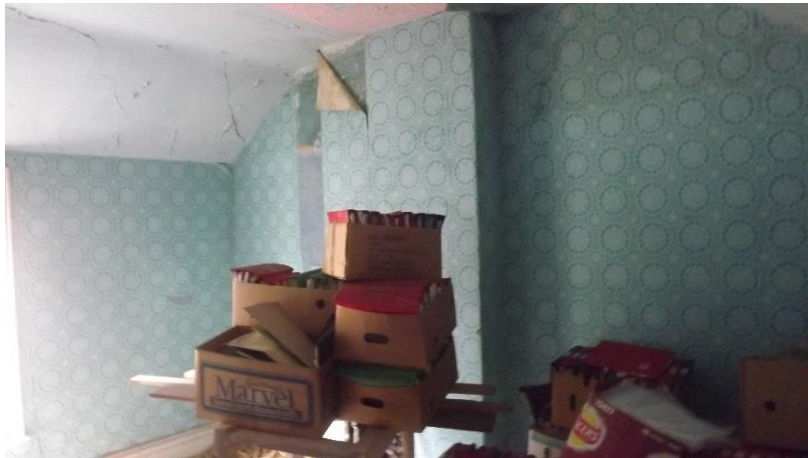
- 3.4 An internal inspection identified there to be no roof voids.

**Image 3.2** An internal view of the building

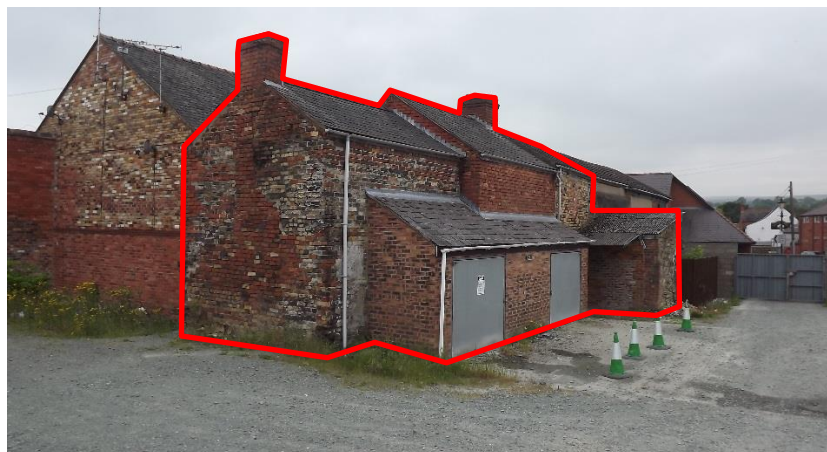
- 3.3 The former two storey dwelling is attached to the rear of the butcher's shop, constructed of brick with only one side gable present. There are two separated roofs with no voids, slate tiled containing small fascia's and lead flashing in some sections. Other External features include ridges, two chimneys, soffits and gutters.

**Image 3.3** North eastern aspect of the building. The full building depicted in red.

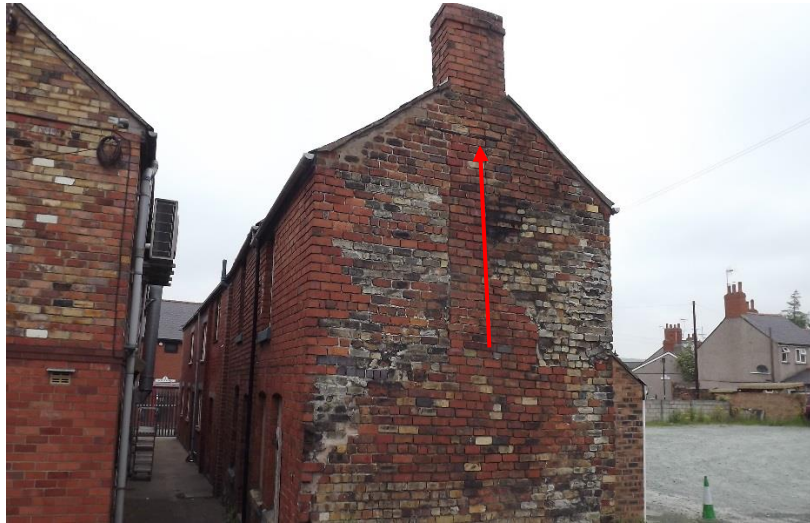
- 3.5 The roof is generally in good condition with a few crevices underneath tiles, raised lead flashing and some gaps along the ridge. The chimney on the eastern aspect is leaning westwards, causing bricks to raise on the main building creating gaps and mortar loss.

**Image 3.2** Eastern aspect of the building showing the raised bricks depicted by the red arrow.

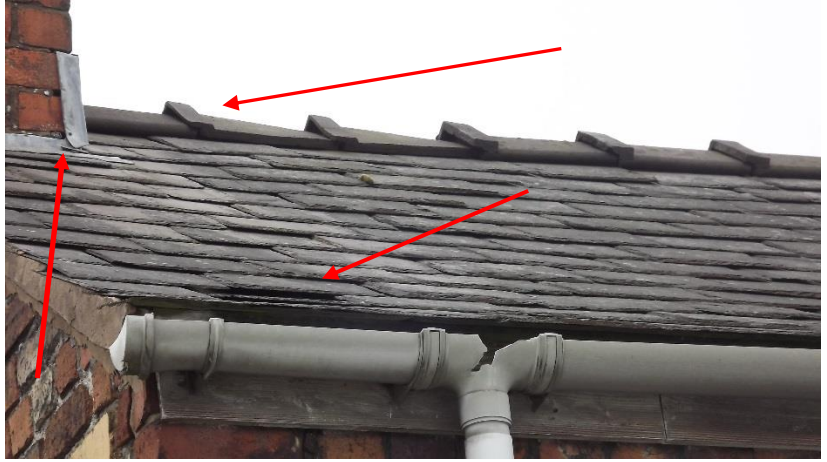
- 3.14 The building is currently vacant, whilst the exterior of the property is generally in good condition for its age, crevices were identified under ridge tiles, loose flashing, under slipped tiles and under raised bricks caused by the leaning of the chimney. The roof of the garage is generally in good condition and has been recently re roofed.

| | <p>Ridge tiles slightly warped causing a raising effect.</p> <p>Flashing against the chimney is loose causing a gap.</p> <p>A raised tile adjacent to the gutter</p> |

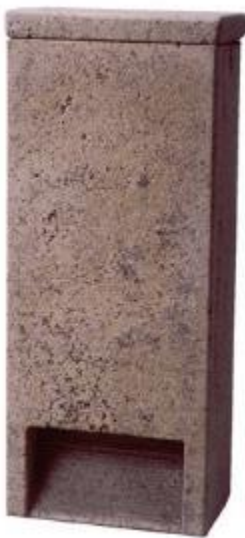
**Image 3.18** An example of a Schwegler 1FR bat box

- 3.27 The findings of the survey showed that no bats had emerged from the building. Therefore, no impacts are expected from the proposals and may proceed without any licensing measures.
- 3.28 A minimum of two Schwegler 1FR bat boxes are to be integrated into the fabric of the new buildings (**Image 3.18**). The exact location of these boxes is to be agreed with an appointed ecologist.
