**DEVELOPMENT AT TALPONCIAU FARM, ACREFAIR, WREXHAM, LL14 1TU**

**STAGE 1 - PHASE 1 – DESK STUDY AND PRELIMINARY GROUND  
CONTAMINATION RISK ASSESSMENT**

**REPORT No. E0761.S1.P1.R1**

**MARCH 2016**

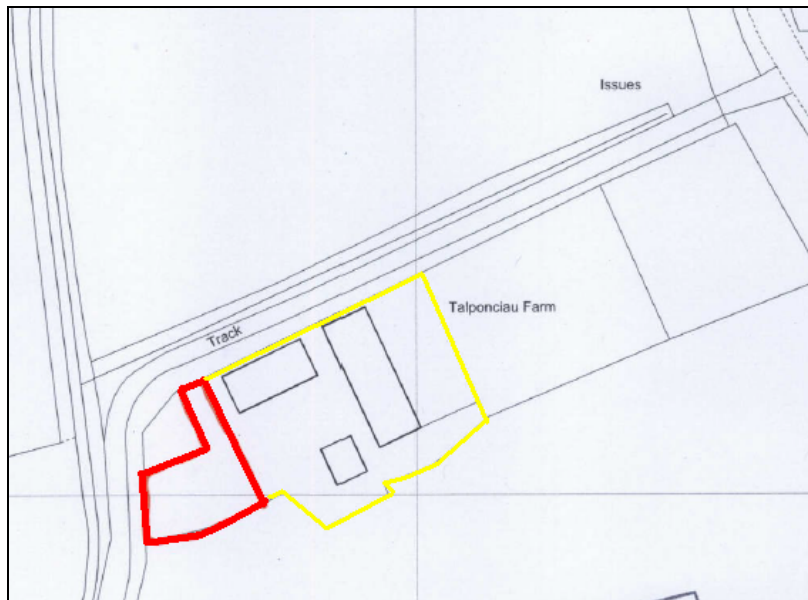
Figure 2 – Development Site Extent (red)

existing farm buildings and is presently occupied by a caravan/mobile home. The main farm buildings comprising barns are immediately to the east. The whole site is generally flat and level and at an elevation similar to the surrounding land.

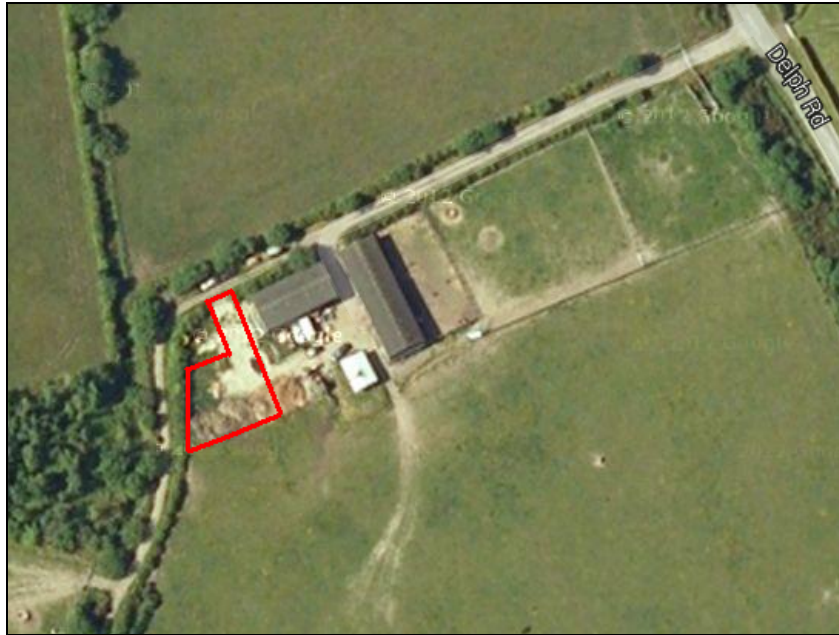
Figure 3 – Aerial Photograph and Site Context

- 2.2.2 To the east of the farm buildings and surrounding the site on all other sides is flat and gently sloping agricultural land used for grazing.
- 2.2.3 The site area is bordered on the west and north by a hedge and farm lane. To the east are farm buildings and southern boundary is marked by a fence and then agricultural land. An aerial photograph of the site is presented as Figure 3 and site photographs are presented in Appendix 1.

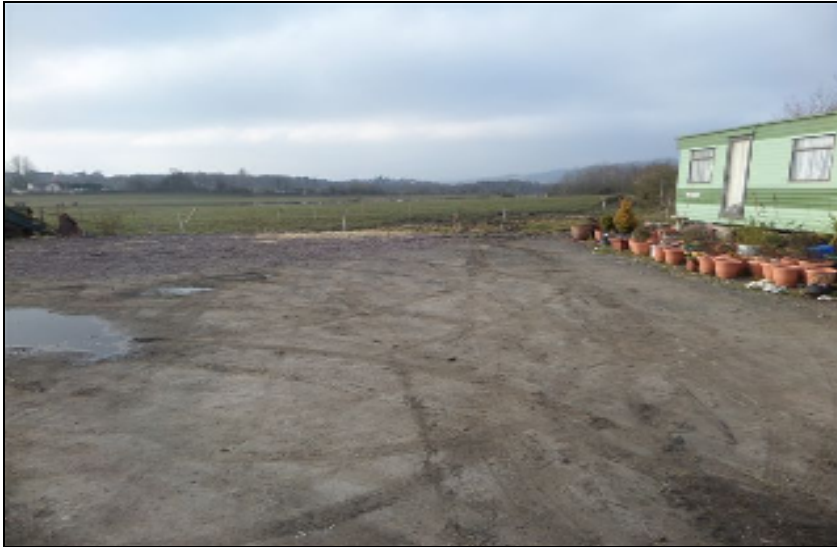
- The site is a flat area of compacted hardcore gravel.
- The only structure on the site is a mobile home/caravan used as accommodation surrounded by large flower pots.
- The ground surrounding the site comprises a farm yard of compacted hardcore gravel.
- There is no evidence of wastes, spillages or fuel-oil staining.

General view of the proposed development area from north to south

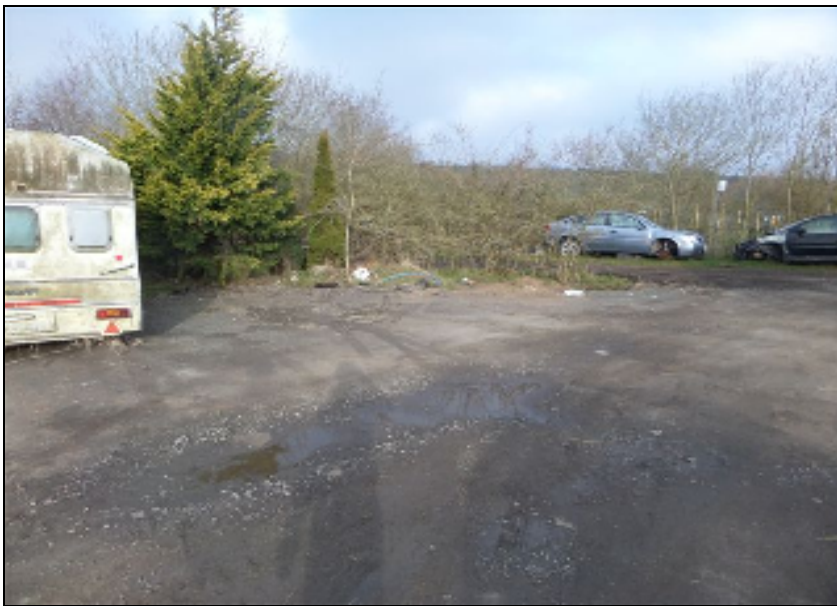
General view of the proposed development area from south to north

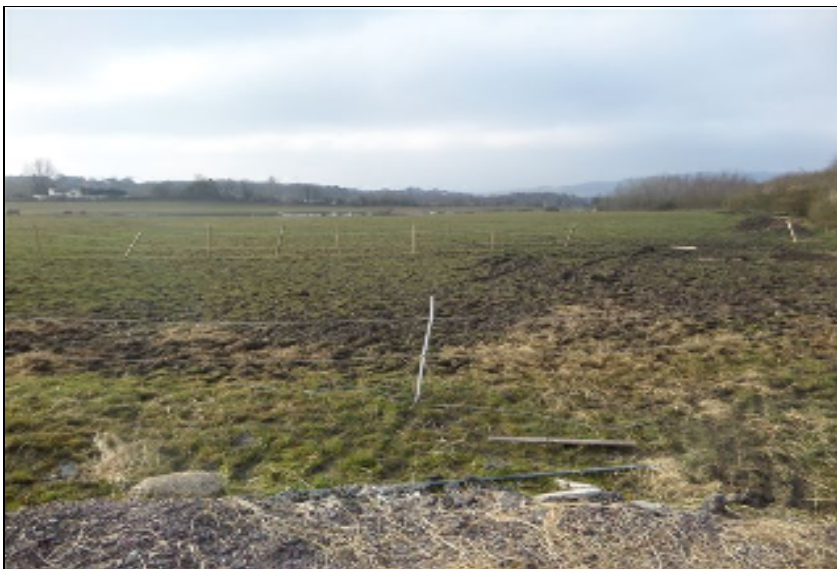
- The site is surrounded by agricultural land used for grazing to the south and a farm lane and then agricultural land to the north and west.
- To the east is a farm yard with a gravel surface and two barn type buildings.

Land to north and surrounding the site area
