## Gamford Farm, Rossett Ecology Mitigation Strategy

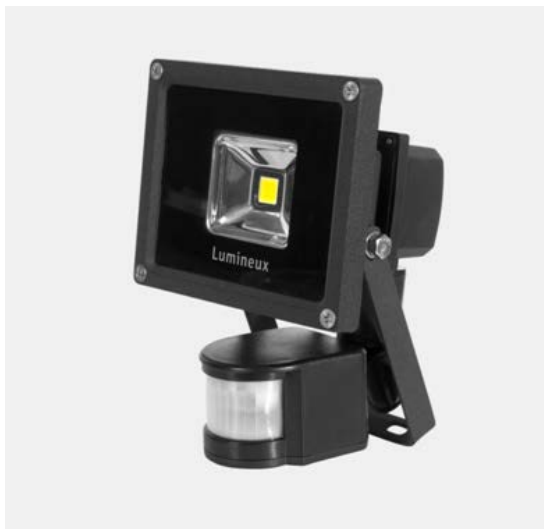
- 3.5 The product that would be specified is the Lumineux 400816-BL LED PIR Floodlight 20W 4000K Black (see image below). This has a brightness of 1600 lumens, in accordance with the document 'Bats and Lighting in the UK' published by the Bat Conservation Trust, which states that floodlights of more than 2000 lumens are rarely necessary, or suitable in locations where bats are concerned.

- 3.3 Exterior floodlighting will feature PIR sensors activated by movement. These will switch off automatically after a short period of time (user adjustable of between 2 and 12 minutes).

- 3.4 These will be mounted on barn 1 pointing west, barn 1 pointing south and barn 2 pointing north, focussed downwards at a 45 degree angle. These positions are the best possible to ensure effective floodlighting for the parking areas, whilst not shining directly on bat roosts, access points or flight paths.

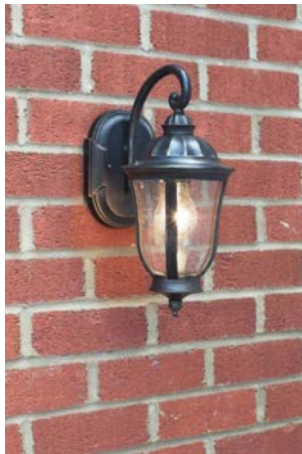
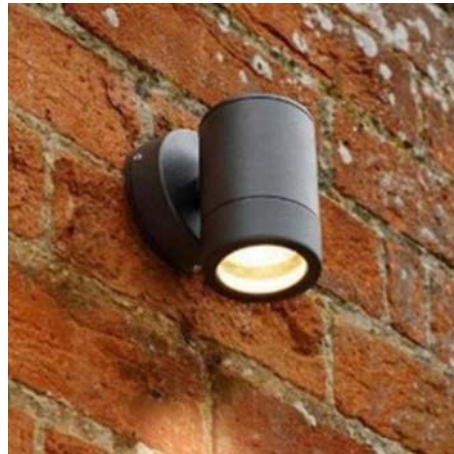
- 3.6 Lights on buildings will be at ground floor level entrances only. These will be in the form of minimal wall amenity down lighting (similar in style to either of the lights seen below) of the minimum brightness necessary.
