## Bat Presence/Likely-absence Survey

Report Prepared on behalf of Mr Guy Evans of Cassidy & Ashton

For the site of  
Gamford Farm, Gamford Lane, Rossett, Wrexham LL12 0EW

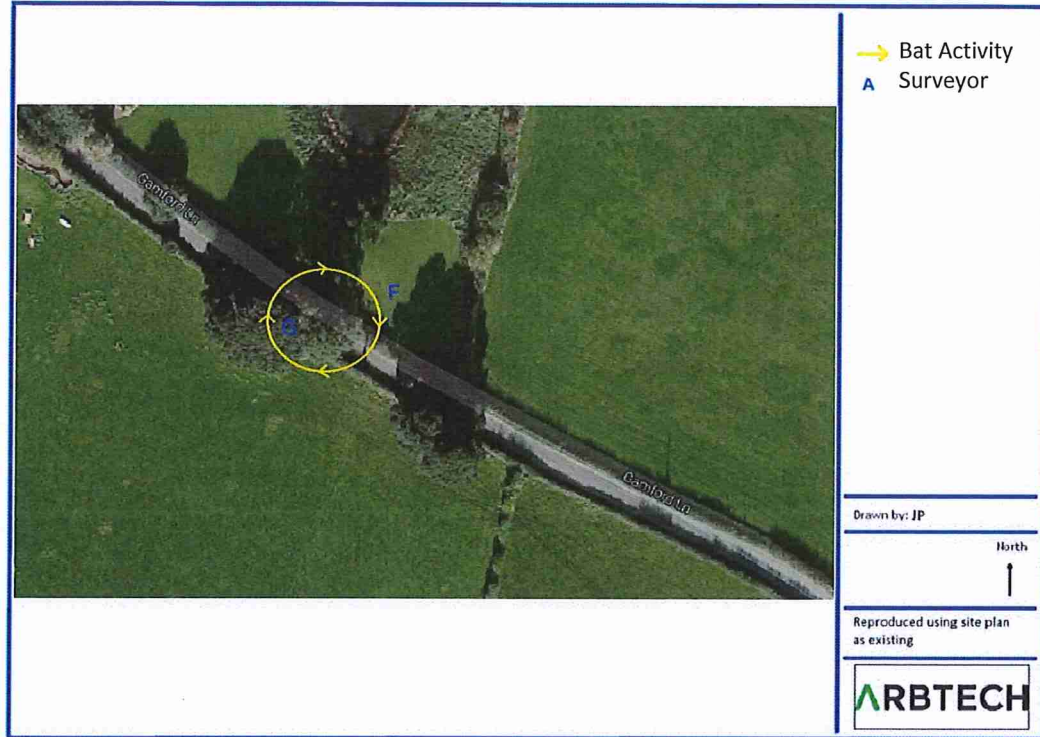
24/09/2015 - T1

| F | T1 | 19.19 - 19:56 | Soprano pipistrelle pass - not seen. | Activity |

| G | T1 | 19:22 - 20:00 | Soprano pipistrelle constant activity & foraging around trees at 19:22 - 19:34.<br>Soprano pipistrelle constant activity/passess heard but not seen from 19:38 - 20:00. | Activity |
