**Wrexham County Borough Council - Planning Service**  
**Land at Queens Road, Brymbo, LL11 5DY.**

Further to your request to provide a report regarding the structural stability and adequacy of the retaining walls at this new build development site. I write to you to report as follows;

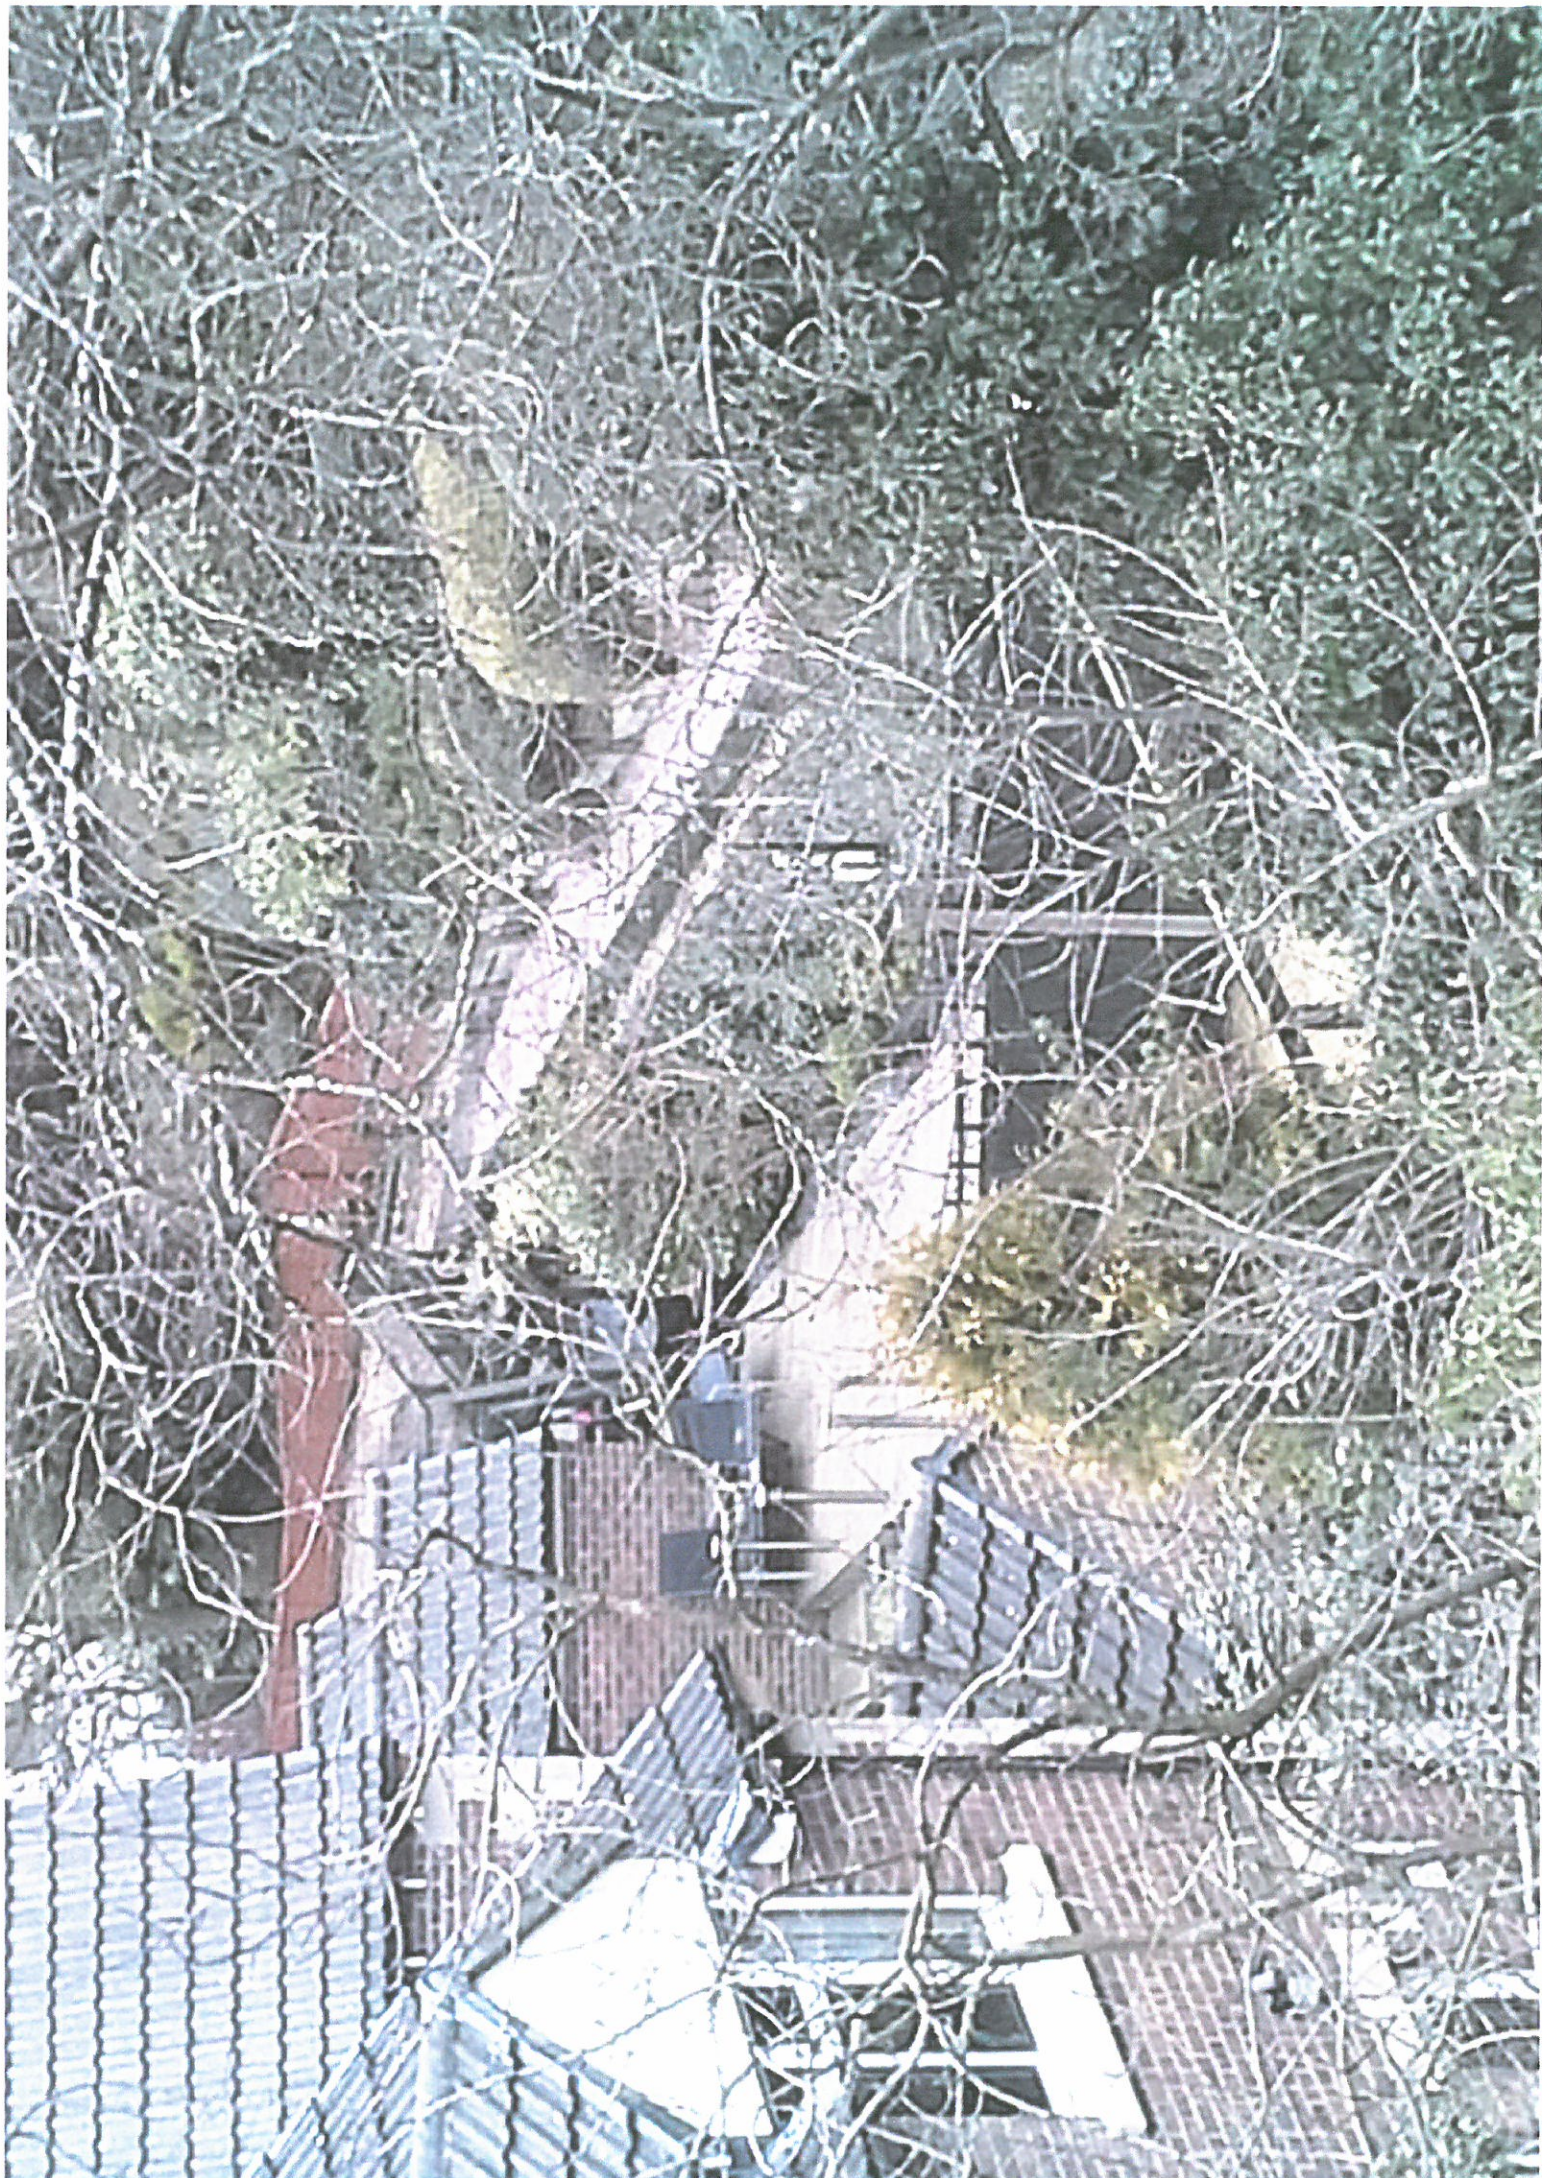
Throughout the treatment area, boreholes / grout injection points were drilled in accordance with the layout as shown on Drawing No SDS3285/CS/02 within Appendix A.

The ground conditions encountered in each borehole are detailed within SDS's daily drill log sheets, included within Appendix C of this report.

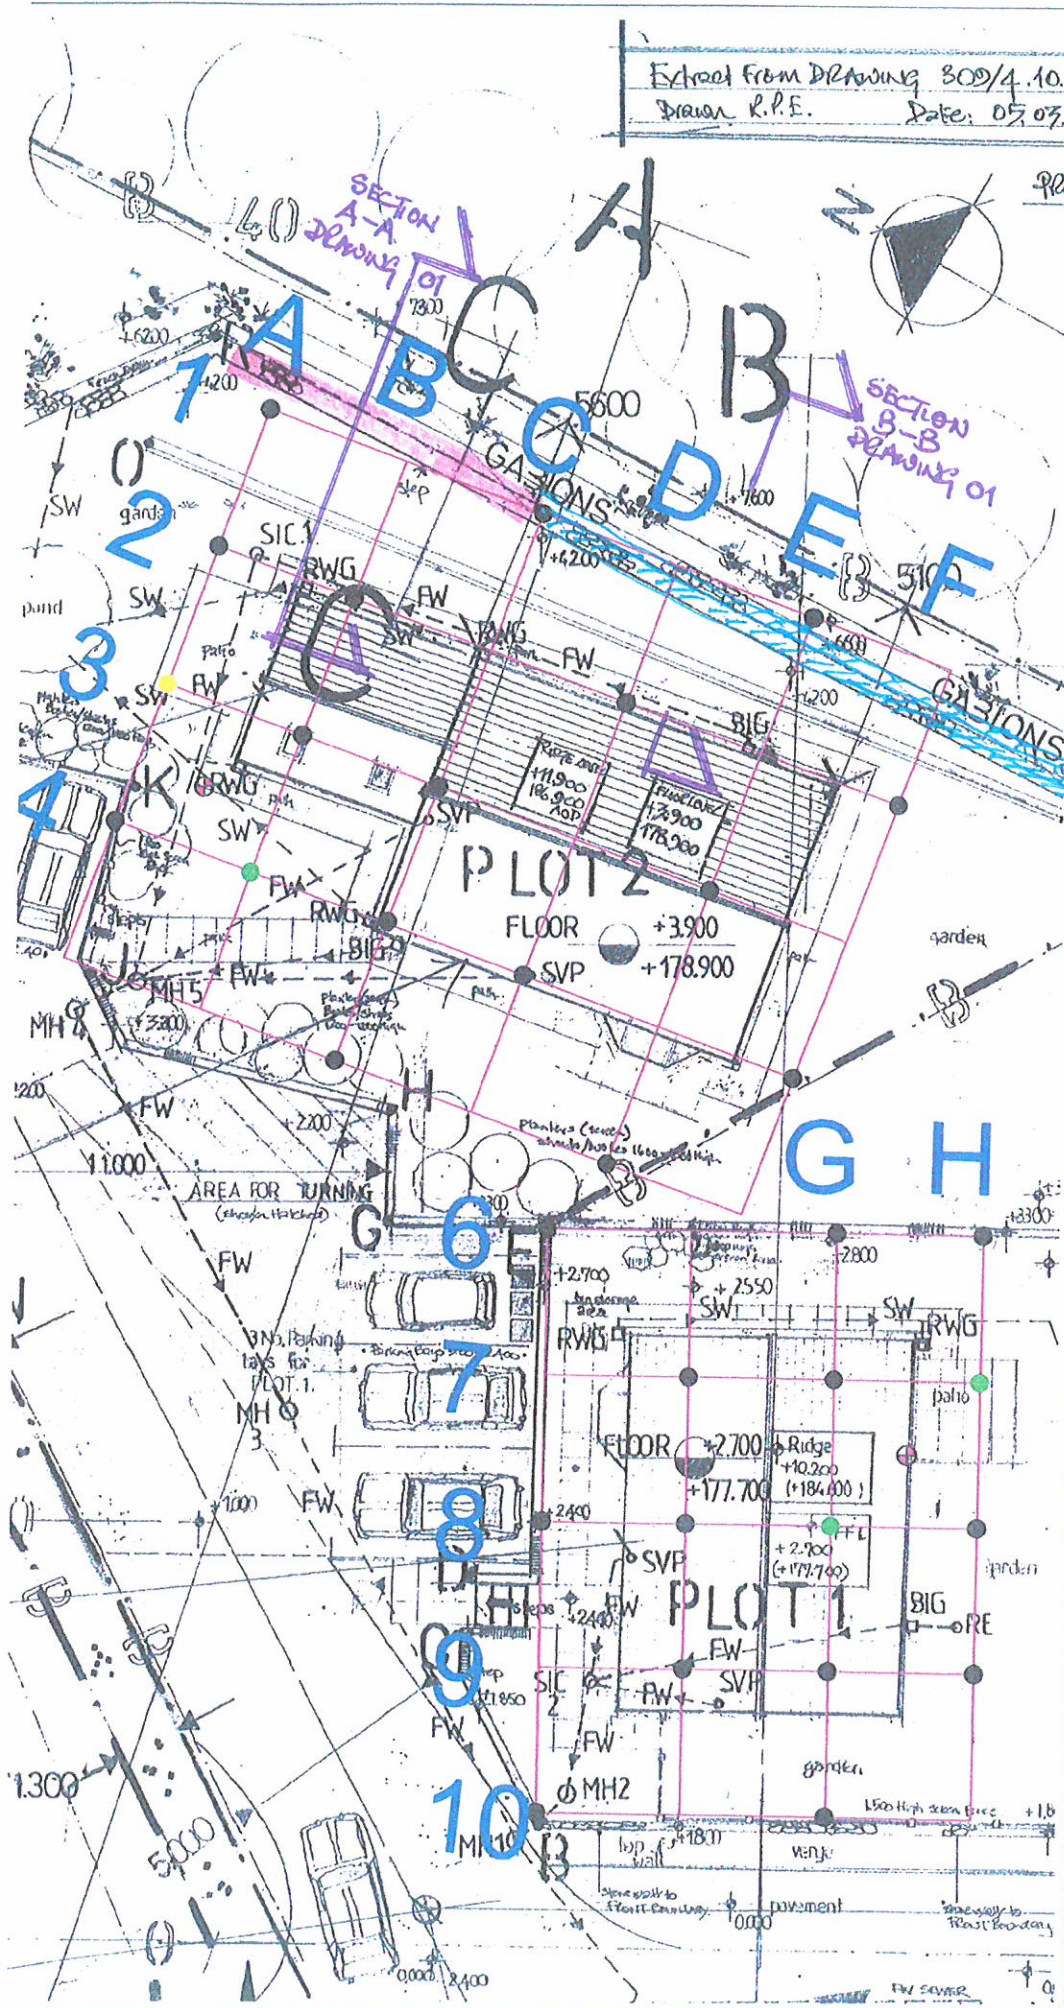
SITE  
QUEENS ROAD  
BRYMBODRAWING TITLE  
AS BUILT DRILL  
AND GROUT PLAN

The make up of the sub soil is confirmed by the Borehole Plan Drawing completed by Sirius and associated 'Drill Grout Summary' demonstrating that the 3No borehole positions, A01, C01 and E01 are all founded on coal. It is above these borehole positions that the gabion baskets have been built.

A total of 33 boreholes were drilled amounting to a total of 419.90 of drilling. The borehole locations and strata encountered are recorded on Drawing No SDS3285/CS/02.

The rotary probe holes typically encountered intact coal or evidence of workings at depths of between 5.50m and 11.20m bgl, the coal was found in two leaves in places. The thickness of the soft and broken strata encountered in places is indicative of migrated workings

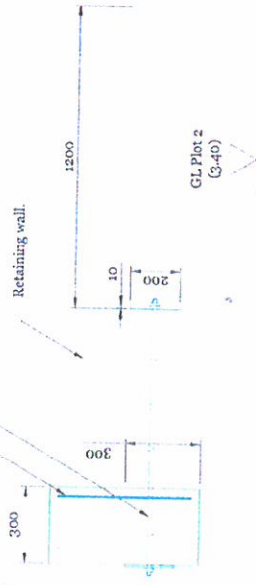
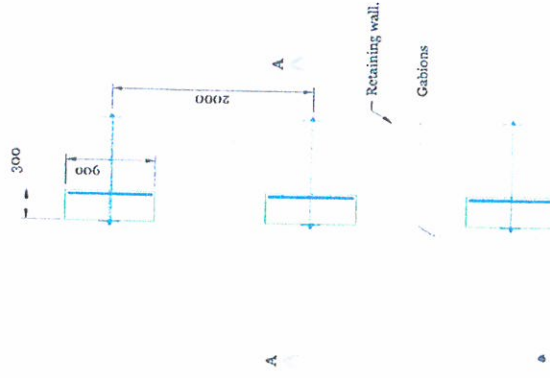
# PLANNING 04 - STRUCTURAL SOLUTIONS

Gabions sit on shale so there is no direct loading on the retaining wall.

Layer of A142 mesh in front face of concrete with 35mm cover.

H16 threaded bar with 200mm square x 10mm thick keeper plate on each end.

Detail showing ties to retaining wall.

A firm of Chartered Structural Engineers (Structural Solutions) designed the arrangement of the retaining walls confirming that they have been competently designed with due consideration of geotechnical factors. I refer you to the drawing by Structural Solutions which shows the retaining wall of hollow block (150mm) and concrete with steel reinforcement and concrete ties in front of the gabion baskets for further stability. The distance of this wall from the front face of this basket varies from 1500mm to 2100mm.

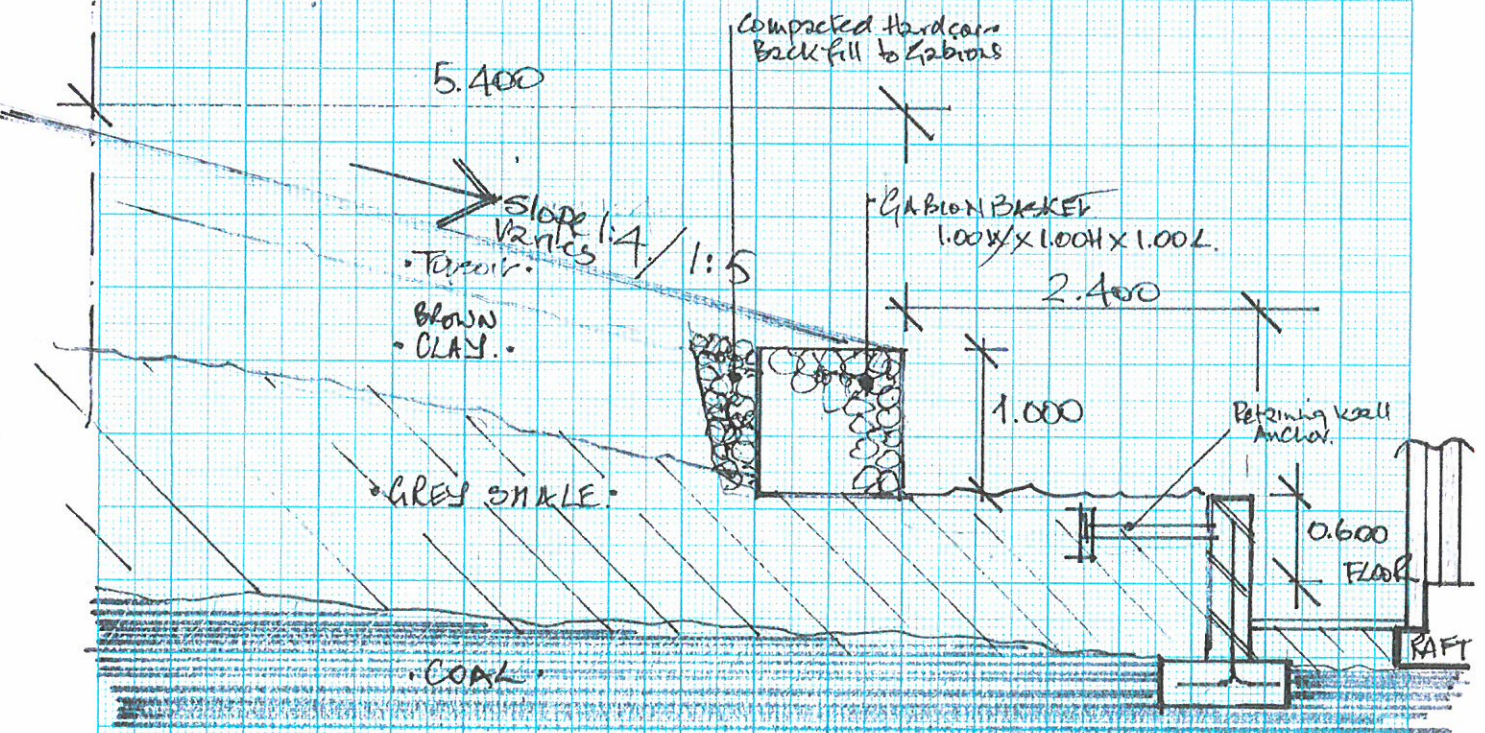
- DRAWING SHOWING EXISTING RETAINING WALL A→B ON LAND ADJACENT TO QUEEN'S RD SITE • DRAWING 03.

B (SITE BOUNDARY)

Land to south of site: Site of former dwellings with an existing retaining wall. The retaining wall was built approximately 100 years ago and of brick/stone construction. It is 2.400m in height and built on the existing slope on the same line and relative position as the retaining wall in the plot being developed. I refer you to C-D on enclosure 3) Location Plan (Showing ABCD) which gives the locations of the retaining wall in the neighbouring plot. The retaining wall on this site is shown A-B.

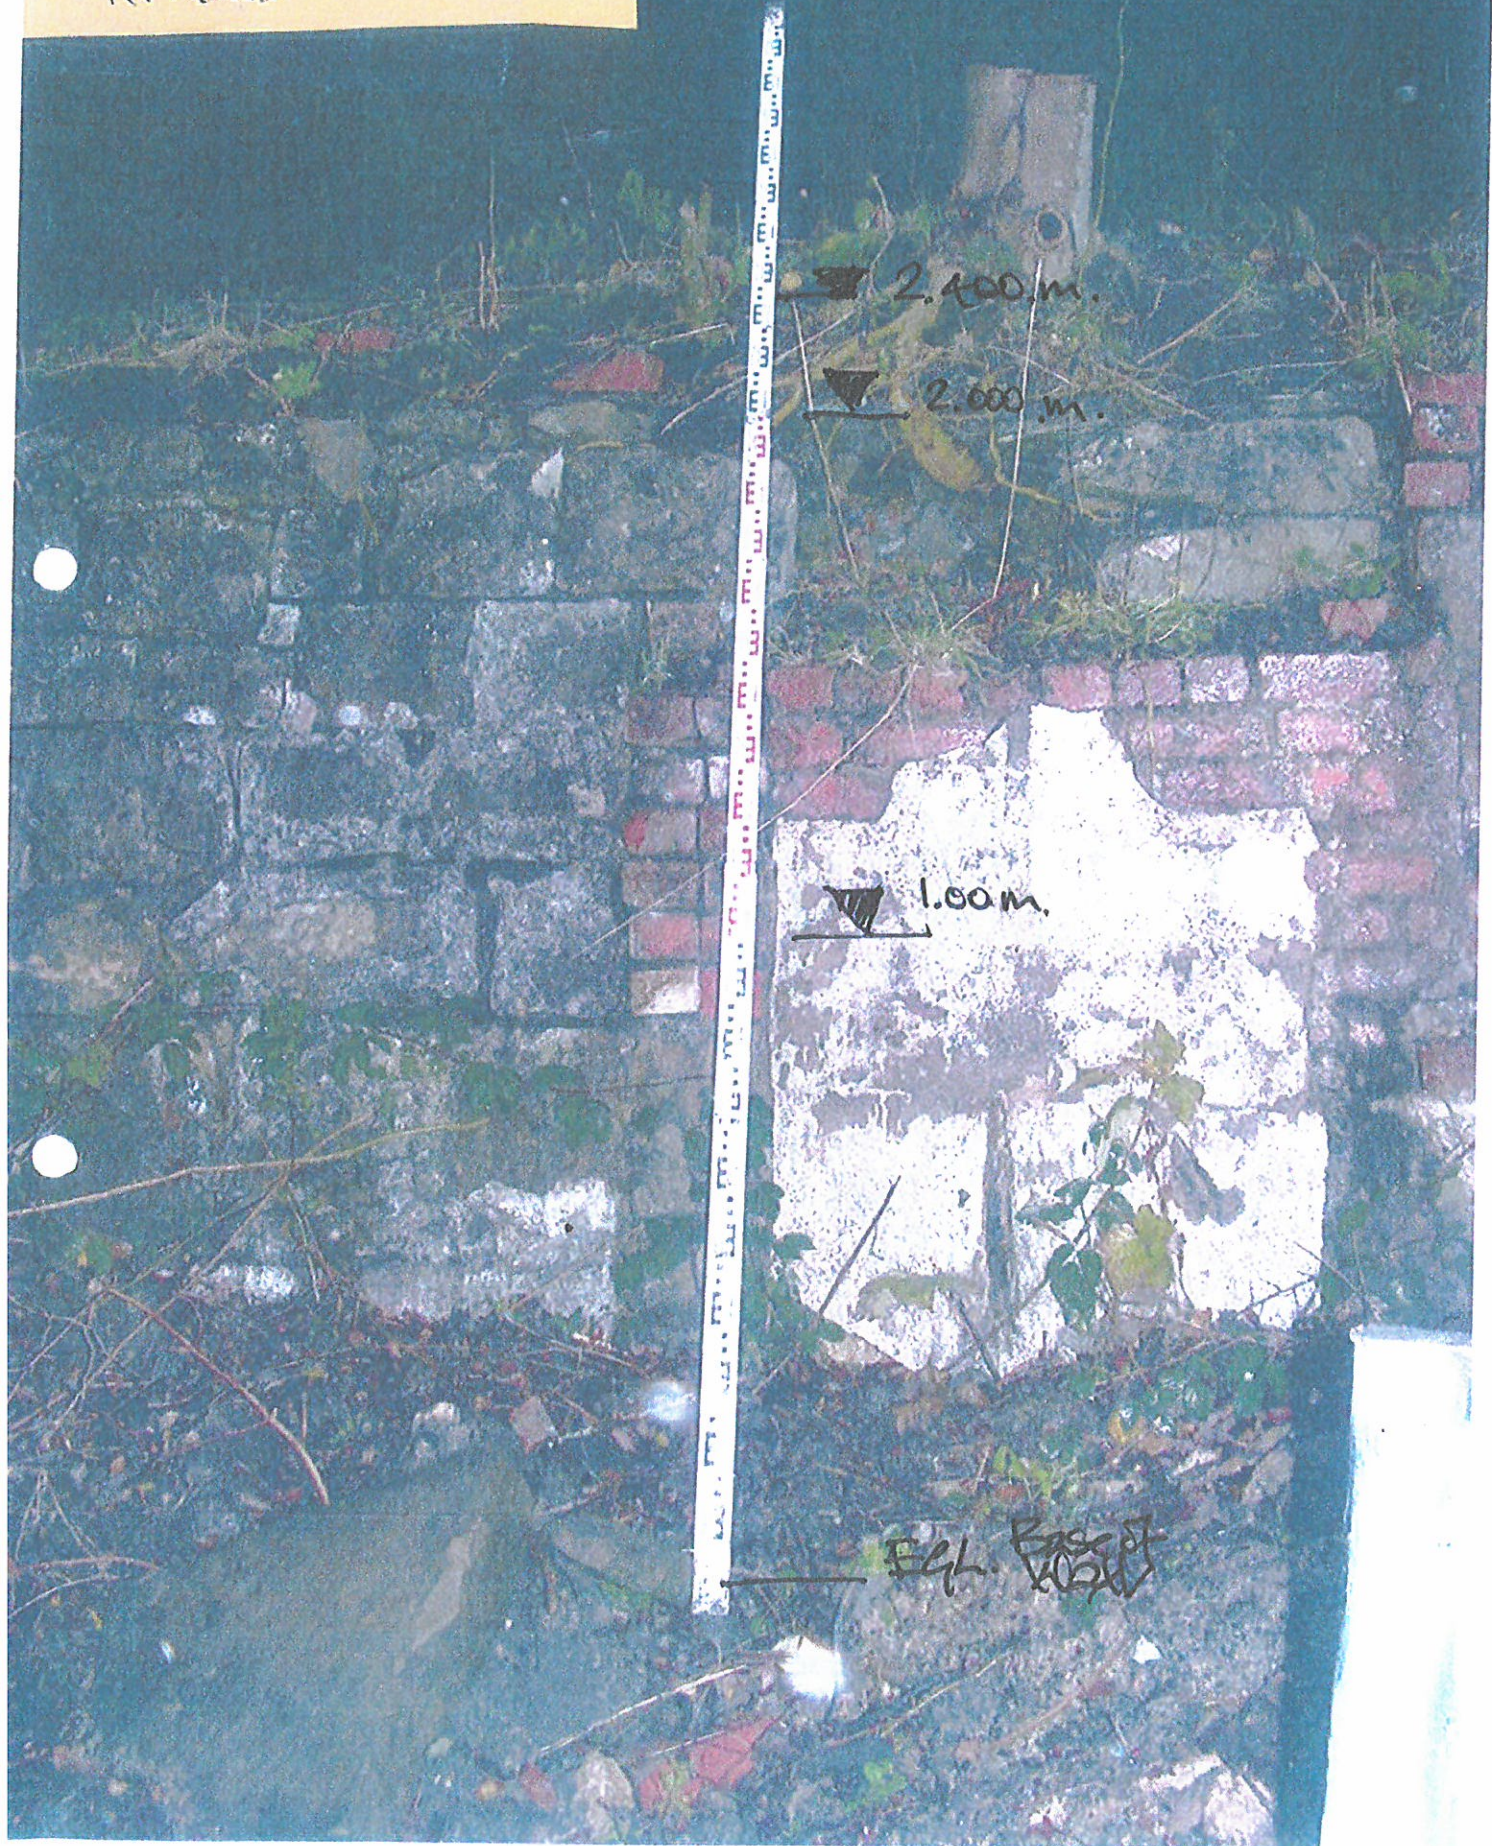
Sketch 2. HP Scans 0605  
Showing Existing Retaining Wall  
A to B / stone @ brick.  
on existing land. Boundary marked

Sketch. 1. HVS scans 0605  
showing Existing Retaining  
Wall A → B / Stone & Brick.  
on LAND ADJOINING

The retaining wall (C-D) is of simple construction using deadweight retention. The existing wall, although some 100 years old, does not show any sign of structural cracking, any significant horizontal movement or settlement as a result of movement forces in the sub soil, hydrostatic pressure or otherwise. This is a very good indication of the long term stability of this slope and the adequacy of the wall to retain the land mass behind it. I refer you to the first 2No enclosures accompanying this letter 'Retaining Wall at Plot to South of Site', photo 1&2.
