**Protected Species Surveys at  
Keeper's Cottage,  
Sandy Lane, Hanmer, Wrexham  
SY13 3DL  
SJ 44117 38932  
on 2<sup>nd</sup>, 5<sup>th</sup> and 30<sup>th</sup> July  
and 25<sup>th</sup> September 2015**

**Version 2  
14.3.16**

Evidence of protected species was searched for at the request of C and J Lane the owners, the surveyor being Tim Evans BSc Dip EP, The Shed, Pant Lane, Dudleston Shropshire SY12 9EP, in relation to a proposed extension following renovation of the cottage.

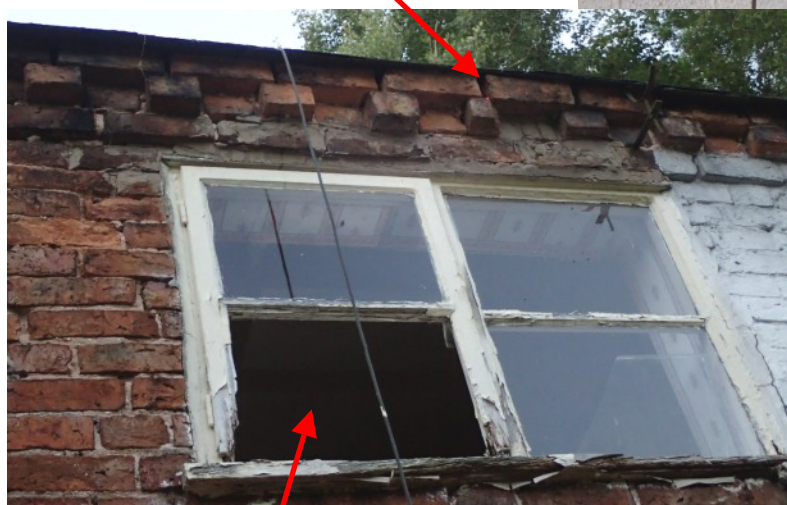
Access point 2

At 05.05 a bat entered access point 1, this was a soprano pipistrelle. Between 05.13 and 05.20 four bats entered access point 2 or adjacent crevices above the window. At 05.13 a bat entered access point 4. At 05.21 a bat entered access point 3.

At 18.40 a long eared bat was seen flying around in loft 1 (see annex 5.3). At 19.25 a bat emerged from access point 2. Between 19.30 and 19.40 four bats flew out of access point 5. Although the sonograms of calls during this time were of soprano pipistrelles these appeared to be long eared bats, which were not picked up on the detectors due to the quiet nature of the calls. At 20.30 two long eared bats were seen on the ceiling inside the house above the stairs (annex 5.5)

2. If any bats are discovered in gaps between bricks, these will be left until the bat has left, then the gaps may be filled.
3. Access points 3, 5 and 6 will be fitted with a flexible flap of plastic sheeting or other suitable material which will allow bats out of the building but not back in. Bat detectors will be placed internally next to 5 and 6 and when the sonograms indicate that no bats remain in the building the windows may be sealed. One emergence survey is also recommended to confirm the absence of bats inside.

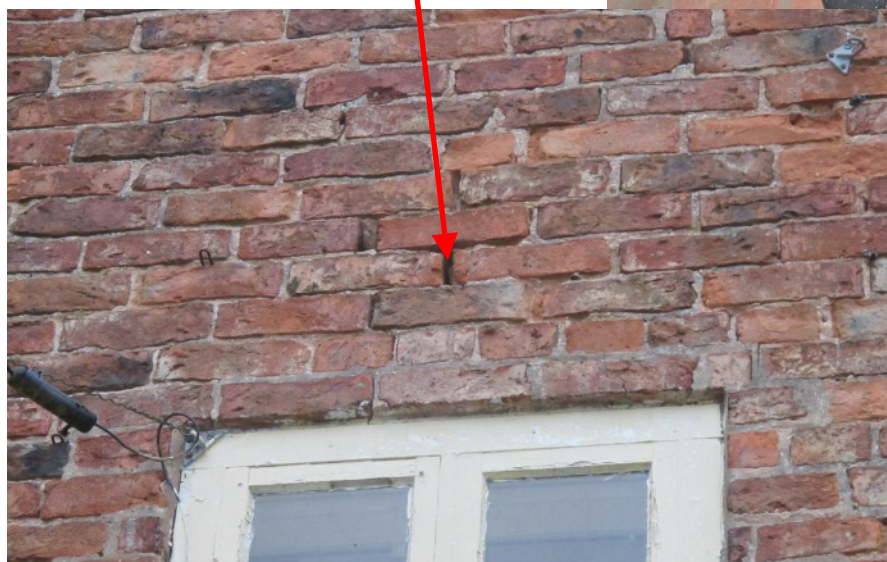
Access point 4

At 21.29 a bat was seen to emerge from the west gable end of the house, possibly from access point 4. This was a soprano pipistrelle. Another followed at 21.30. At 21.49 2 bats emerged from access point 2, then another at 21.52. At 21.53 another bat emerged from the west gable end of the house, possibly from access point 4. At 22.02 a bat emerged from another gap in the brickwork at the eaves between the two windows on the south side of the house. At 22.28 a bat emerged from access point 6. At 22.47 a bat was seen inside the house behind the window below access point 2. At 23.25 three long eared bats (*Plecotus* sp.) were seen perching on the ceiling above the stairs as shown in annex 5.5.

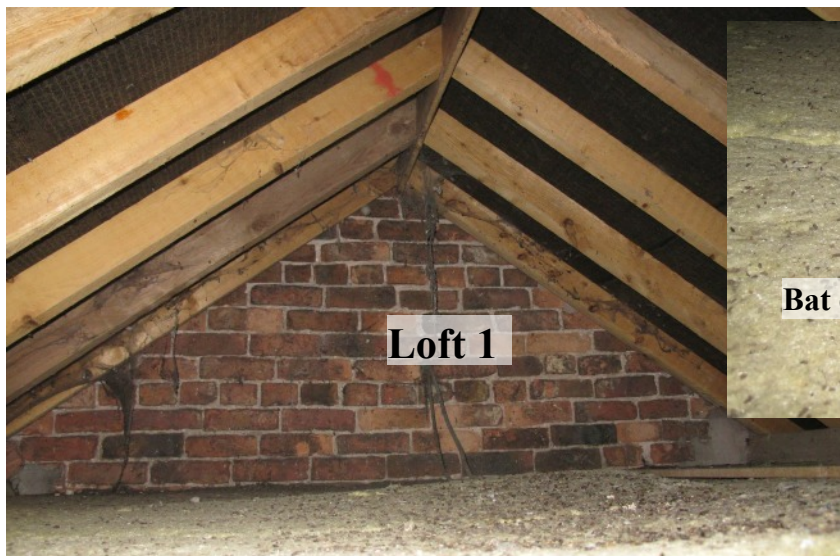
Loft 1

More than 300 bat droppings in both lofts and on the stairs. Approximately 30 butterfly wings in room H and 10 in room C.

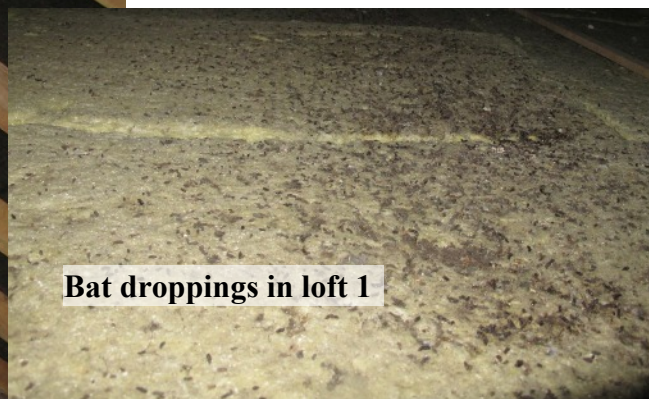
Bat droppings in loft 1

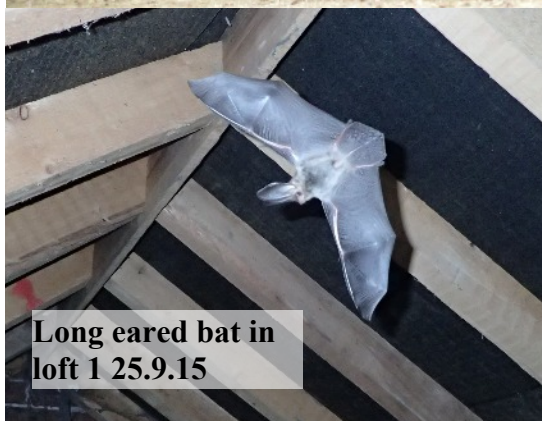
Long eared bat in  
loft 1 25.9.15

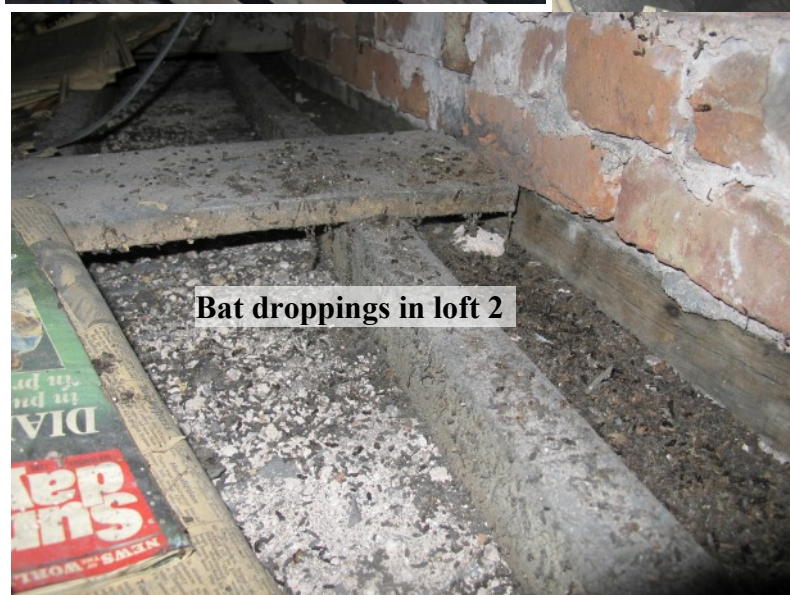
Bat droppings in loft 2

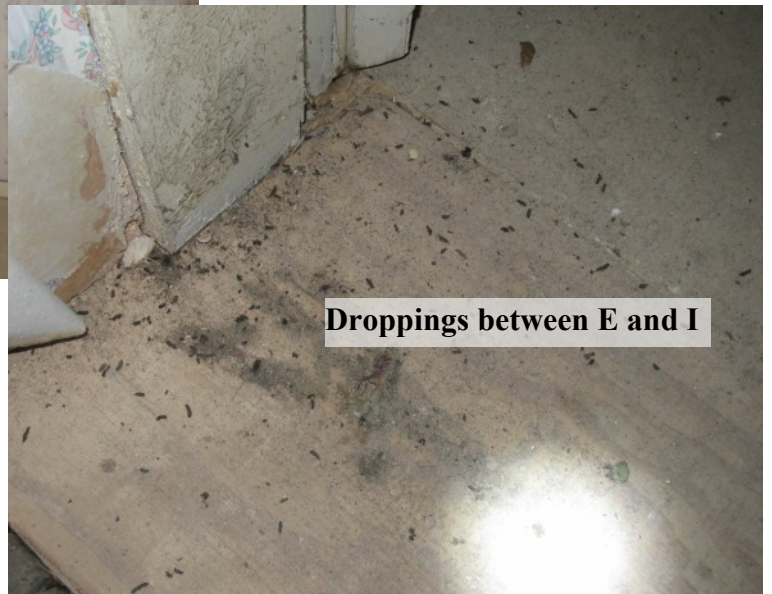
Droppings between E and I

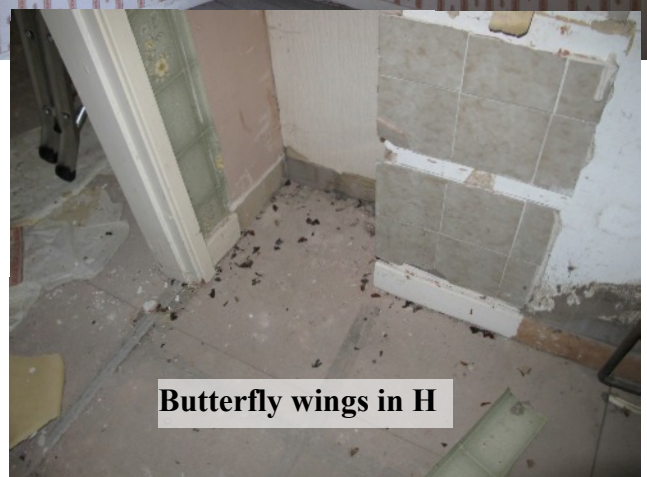
Butterfly wings in H

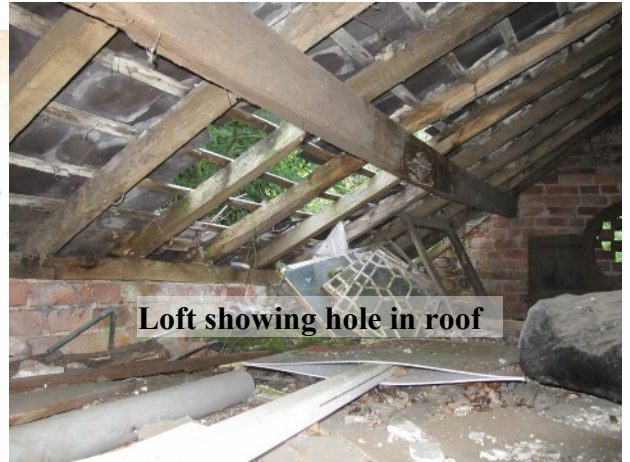
Two storeys. Walls - brick. Unlined. Roof - slate. Unlined. Timber frame. Large hole on the east side. Windows glazed and intact. Gaps around wooden stable doors. No signs of use by bats.

Loft showing hole in roof

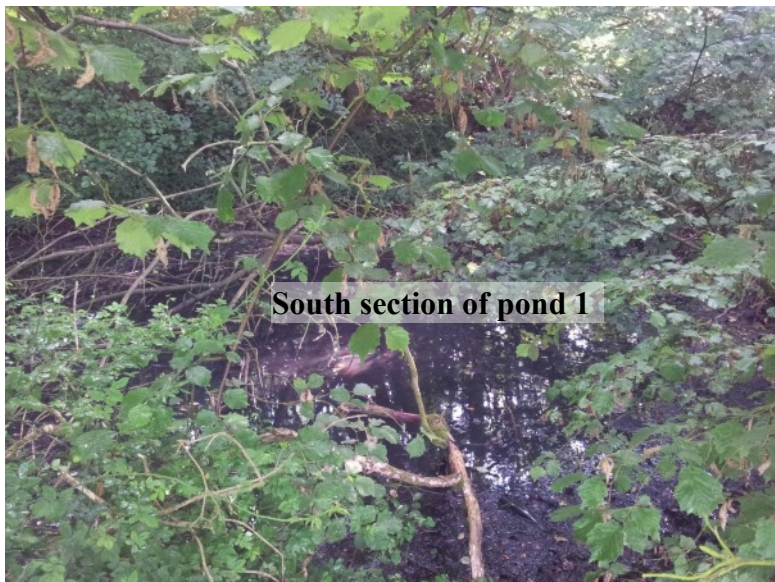
Pond 1 is approximately 160 m from the edge of the site. Although it appears as two separate ponds on maps it is continuous, although there is a narrower section in the middle which may dry out to form two ponds at times. It was not accessible so an estimate of water quality was made.

South section of pond 1

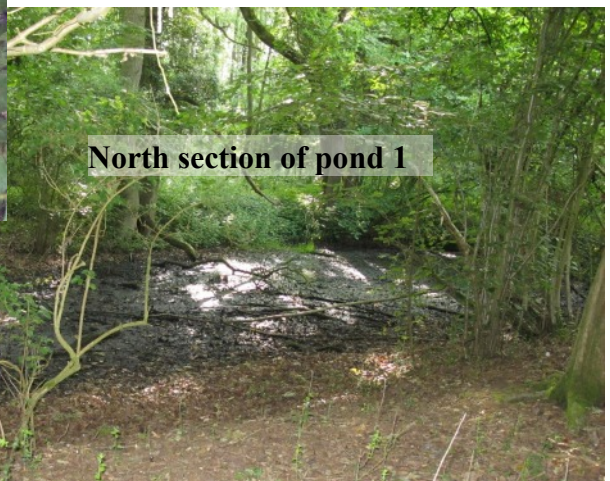
North section of pond 1
