## **PROTECTED SPECIES SURVEY**

### **FORMER THEATRE**

### **SALOP ROAD**

### **WREXHAM, NORTH WALES**

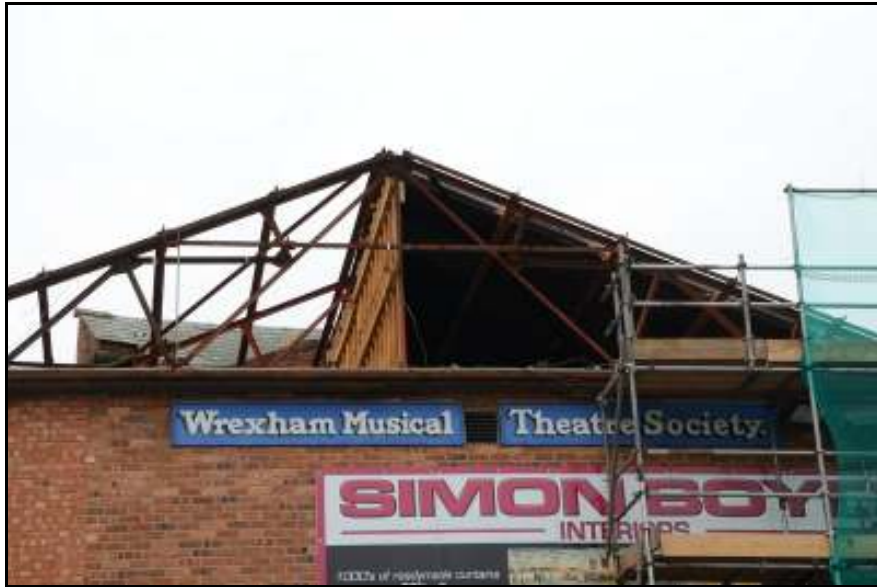
At the time of the survey a small section at the rear had just been demolished to permit scaffold to the rear of the building by the river. Sections of the roof at the front had recently been removed exposing the inner areas of the theatre as shown in the photos below.

**3. Large sections of the upper roof have just been removed**

- **All roof slates should be carefully removed by hand to ensure that no roosting, torpid or hibernating bats are injured during the proposed works.**
- **The upper sections of the brick/block walls should be removed by hand, particularly any sections which have a cavity area.**

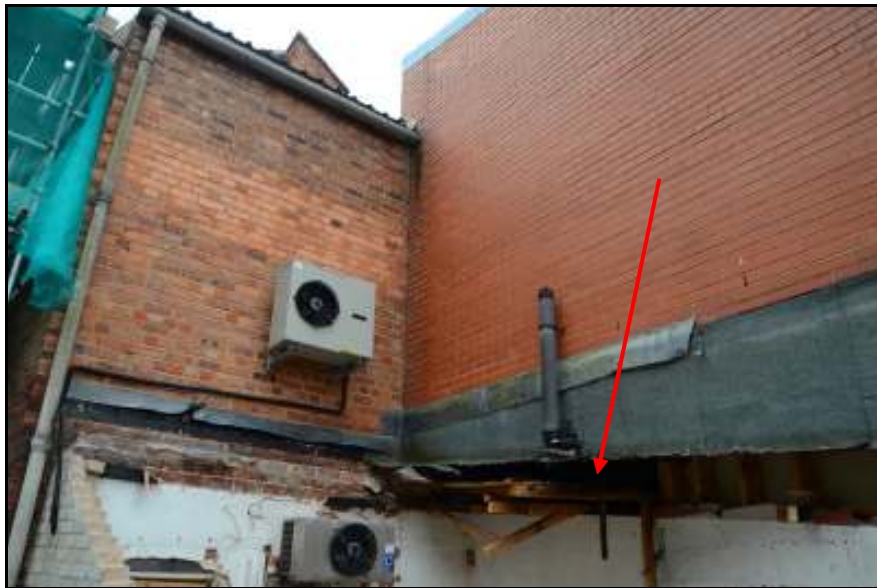
**4. Small section removed to enable scaffold access – this is all now open**

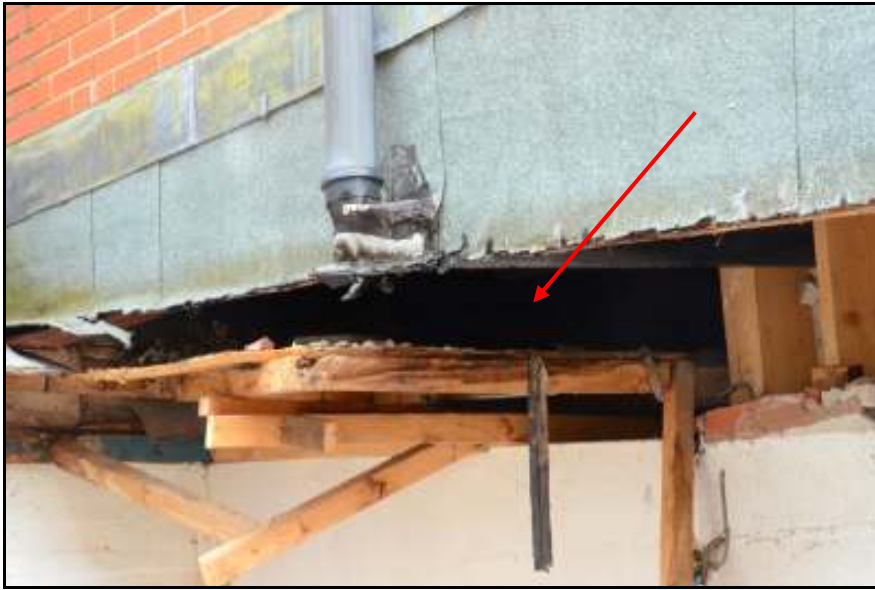
**5. Open area where the corner has been demolished**

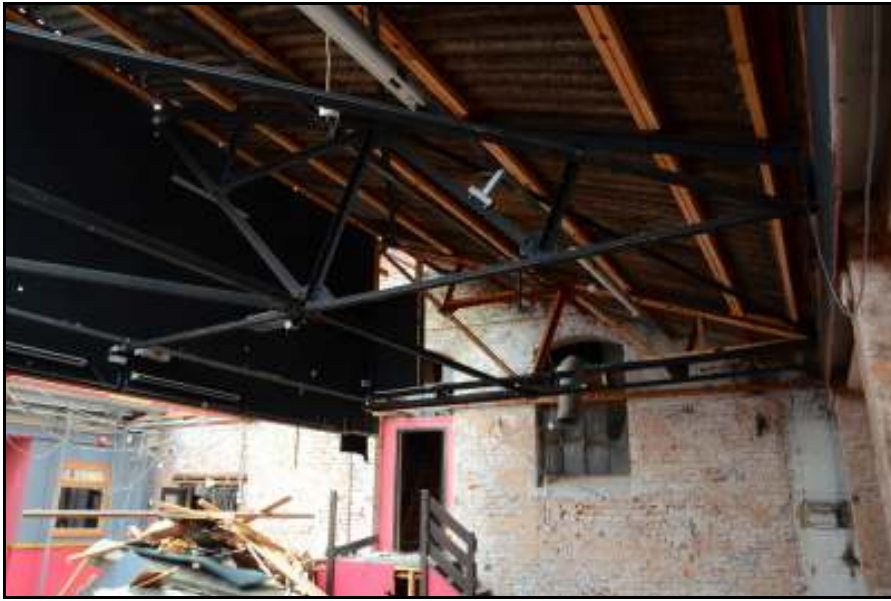
**7. Interior is open and light**

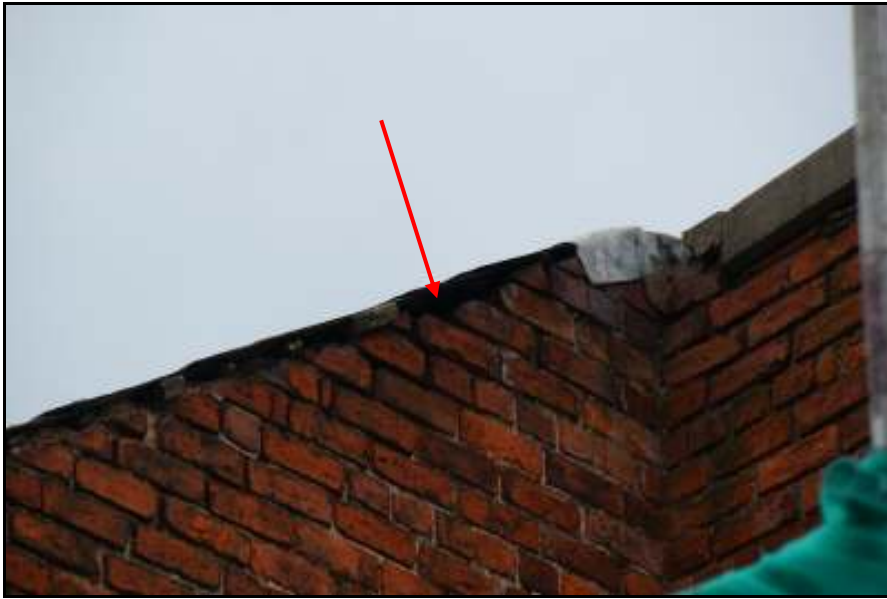
The building has apparently only just been partially opened up and exposed to enable the scaffolding and asbestos surveys. Looking at how the building would originally have been the main roof areas and walls all appear to be fairly well sealed with little opportunity for bats. There are some small gaps at the tile ends as shown in the photo below but these now lead into an exposed and revealed area of the roof.

**9. Gaps on the tile end are sometimes used by crevice dwelling bats**

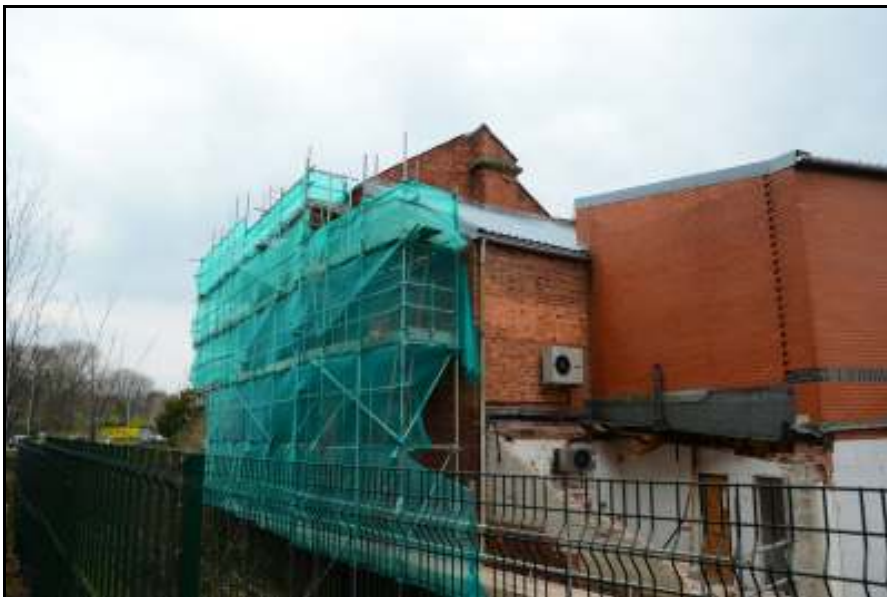
The brick walls all appear to be intact and no gaps, missing sections of mortar or wide cracks were evident. Some of the rear wall is obscured by the growth of ivy but this was inspected using the scaffold area. The potential for the building to support bats is thought to be low (based upon an intact building). The situation could change if the building is left exposed during the period when bats become active.

**Birds were observed using the dense ivy at the lower level (below the proposed demolition line) at the rear of the building by the river. Grey wagtails were present in and around the lower section of the wall (below demolition level) and they were feeding along the river.**

**10. Rear elevation overlooking the river**

**Ideally the building should be demolished between October and February to avoid the nesting season. However, due to the condition of the building within a town location it would be preferable to demolish it now. Advice provided at the time of the survey was to try and net all the exposed areas within the next few days following survey. In addition the building will require inspection immediately prior to any demolition works taking place. This may require more than one visit because the upper section will be removed by hand and the rate of demolition will be delayed. The ivy on the rear wall will need to be carefully removed in sections in case birds are found to be using it for nesting.**

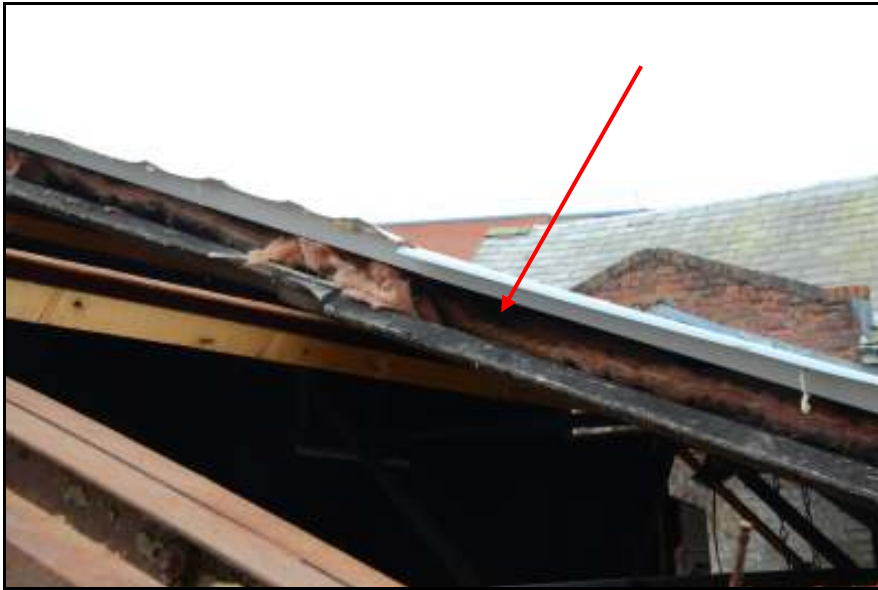
**The building is now very exposed with various points of access ideally suited for a variety of bird species. It is also possible that gulls may nest within the remaining upper roof valleys, they were inspecting the building at the time of the survey. Other bird species could enter the building and nest at any time now because it is exposed and relatively undisturbed.**

**13. Open roof section with insulated gap – birds could nest in here**

**If any birds were found to be nesting (or in the process of constructing a nest) then work in that area would have to stop. It would still be possible to proceed with care in other areas of the building until the young have fledged and left the nest.**

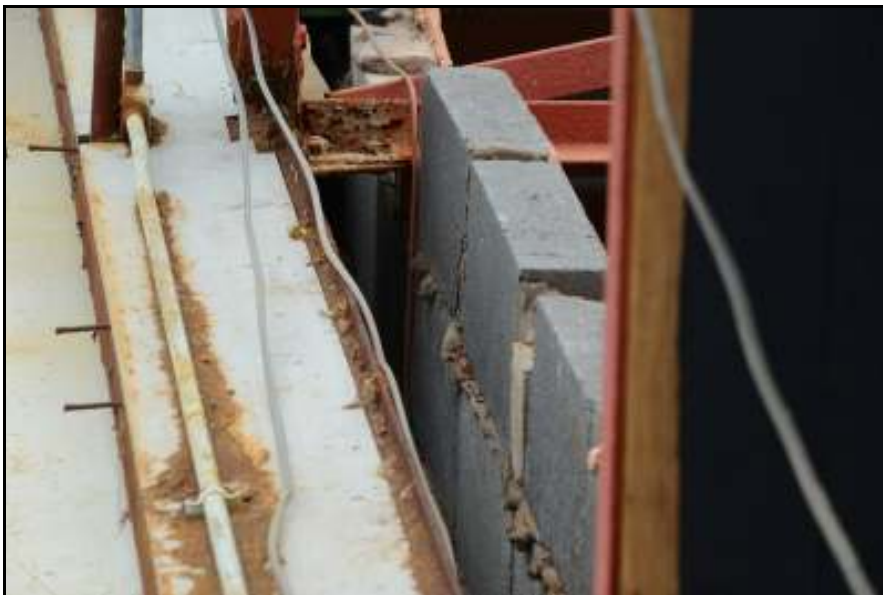
**14. Cavity wall is now exposed**
