Document type  
**Compliance Audit**

# **WREXHAM TECHNOLOGY PARK (PHASE 3) – WESTERN GATEWAY ACCESS ROAD**

## **COMPLIANCE AUDIT JANUARY 2016**

Ref             61034454/AUDIT/07

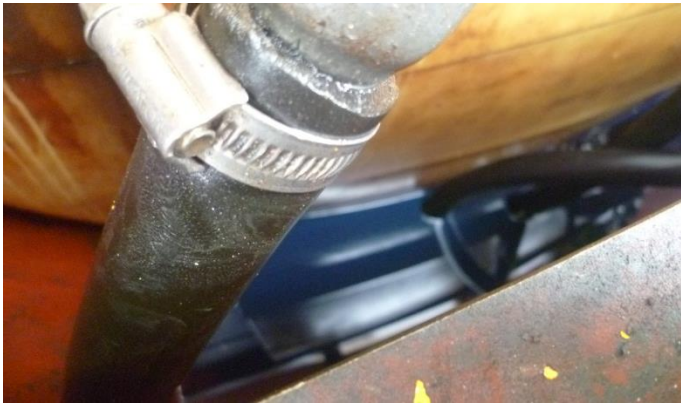
| | Observation November 2015 | Action Remaining from Previous Audit | Due* | Closed out by* |
|---|---|---|---|---|
| Drainage and Hydrology | <p>Mobile fuel bowser has a small amount of fuel within the double skin. No evidence of leaks surrounding the bowser.</p> | <p>Monitor fuel bowser for leaks, consider removal of fuel within double skin to ensure sufficient volume is available in the event of a catastrophic failure. If leaks are present then either repair or replace with bowser that is not leaking.</p> | <p>Next audit</p> | |
| | <p><u>Observation January 2016:</u> No evidence of leaks surrounding the bowser. Bowser stored away from River Gwenfro. Most construction plant has now been removed from site. No change since August compliance audit (see November 2015 observation below regarding use of drip trays).</p> | | | |

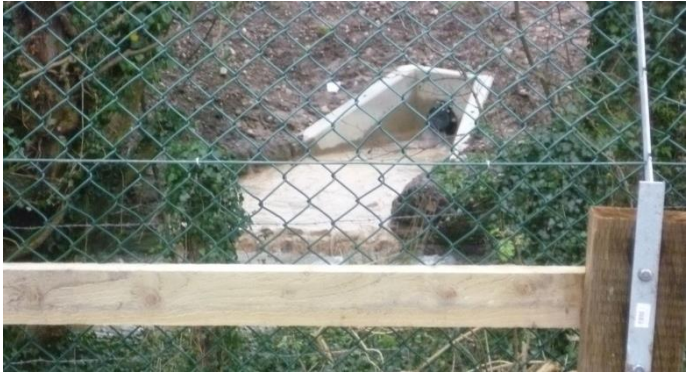
| | Observation | Action Required | Due* | Closed out by* |
|---|---|---|---|---|
| <b>Drainage and Hydrology</b> | <p>The filter bed outfall from the Moneypenny site is clogged with silt. It is not known what the source of silt is. Heavy rainfall could 'wash out' silt into the River Gwenfro causing a pollution incident.</p> <p><u>Observation January 2016:</u> Filter bed outfall from the Moneypenny site is still clogged with silt.</p> | <p>AGC should liaise with the Environmental Manager/Agent of the Moneypenny site to establish the source of the sediment. Sediment release is to be controlled and stopped at the source.</p> | Urgent action required, to be closed out by 22/01/2016 | |

| | Observation | Action Required | Due* | Closed out by* |
|---|---|---|---|---|
| | | <p>Although the sediment does not originate from the AGC Western Gateway site, the location of the outfall is located within the AGC Western Gateway site boundary. Therefore, AGC maybe accountable in the event of a pollution incident.</p> <p>Mitigation measures will be required to sensitively manage the release of sediment from the Moneypenny site to avoid a significant release of sediment/pollution incident. The proposed mitigation measures will need to be discussed with Gemma Fenn and Heather Nickson.</p> | | |

The Environmental Manager/Agent of the adjacent Money Penny site should be contacted regarding the outfall clogged with silt to prevent a significant release of sediment entering the watercourse. This is to be undertaken as a priority.

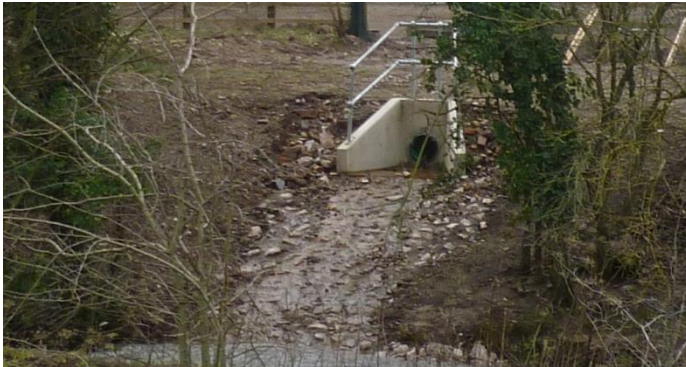
| | Observation | Action Required | Due* | Closed out by* |
|---|---|---|---|---|
| <b>Drainage and Hydrology</b> | <p>Heavy rainfall over the Christmas period has exposed fill materials. Soils in the area of the attenuation lagoon outfall have been washed away onto the outfall filter bed.</p> | AGC to repair attenuation lagoon outfall prior to completion on site. More resilient materials, measures and design to be considered to prevent a repeat of this in the future. | 02/02/2016 | |

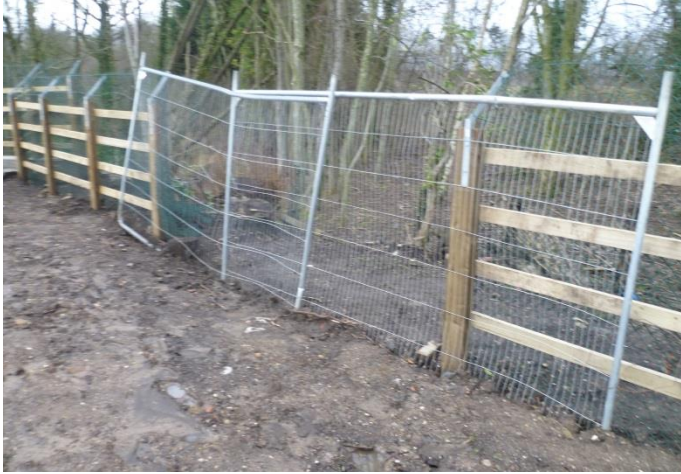
| | Observation | Action Required | Due* | Closed out by* |
|---|---|---|---|---|
| <b>Wildlife and Natural Features</b> | <p>The otter fence installation is complete with the exception of two gaps left for the installation of two gates to be used for maintenance purposes. The location of the two gates are:</p> <ul style="list-style-type: none"> <li>• The area close to the existing culvert north of the access road (shown in image below); and</li> <li>• The area by the attenuation lagoon.</li> </ul> | <p>Otter gate designs need to be approved by Emma Board.</p> <p>Note that gates should also be made 'otter proof' by attaching the correct size mesh to the inside of the gate, and by installing a concrete slab underneath. The gate should close to leave a gap of about 10 mm between the slab and the bottom rail and sprung so they close automatically<sup>2</sup>. The mesh attached to the gate should be extended as high as the mesh on the fence and be to the same specification.</p> | To be discussed at the progress meeting<br>02/02/2016 | |

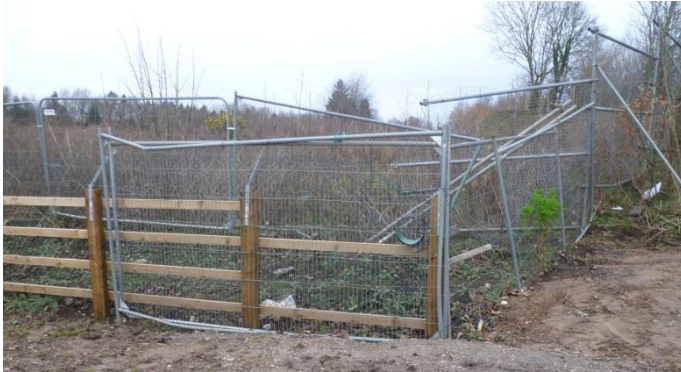
| | Observation | Action Required | Due* | Closed out by* |
|---|---|---|---|---|
| <b>Wildlife and Natural Features</b> | <p>Otter fence finish is untidy at tie in with existing fence.</p> | ACG to address prior to completion on site. | 02/02/2016 | |

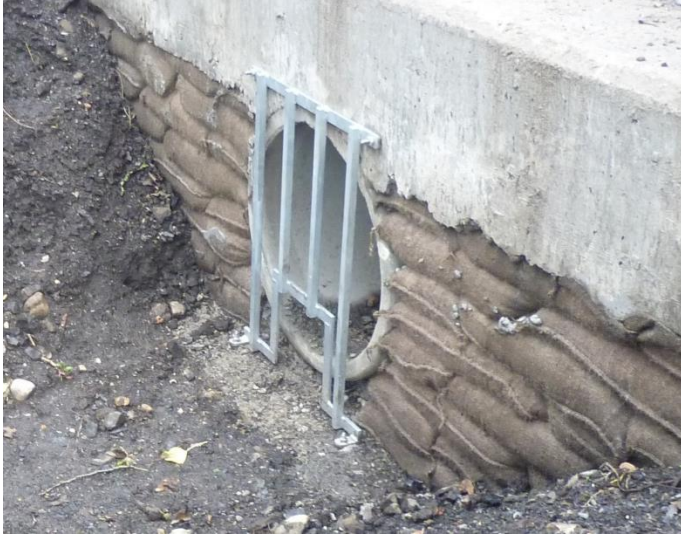
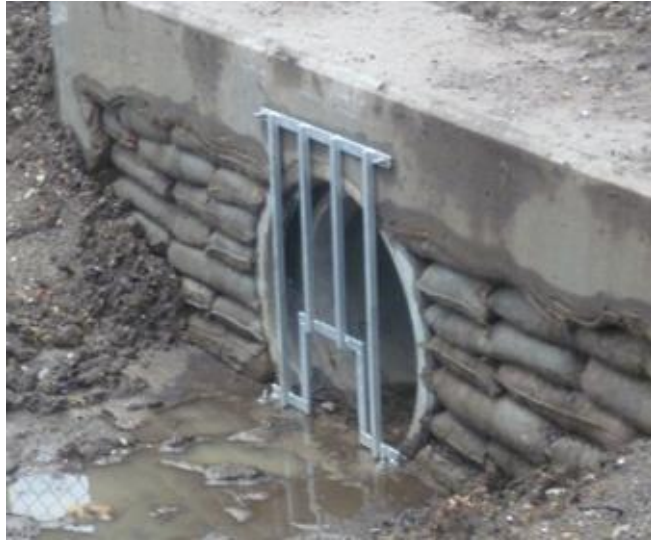
| | Observation | Action Required | Due* | Closed out by* |
|---|---|---|---|---|
| <b>Wildlife and Natural Features</b> | <p>Grillages have been installed on upstream and downstream entrances of the mammal underpass.</p> <p>In its current position on the downstream end, the grillage has been positioned incorrectly so that otters will be unable to pass (image below).</p> | <p>Grillage position on downstream entrance to the underpass needs to be raised in accordance with the NRW Otter licence (62559b:OTH:EPS:2015) and approved drawings.</p> <p>In its current position the agreed 20cm is not available on the downstream entrance, this should be raised and made flush with the base of the pipe as per the upstream entrance (image below).</p> <p>Urgent action required as otter will be unable to enter/egress the mammal pass.</p> | Urgent action required, to be closed out by 22/01/2016 | |

The grillage on the downstream entrance to the mammal underpass needs to be raised as a priority to enable otter to use this underpass.

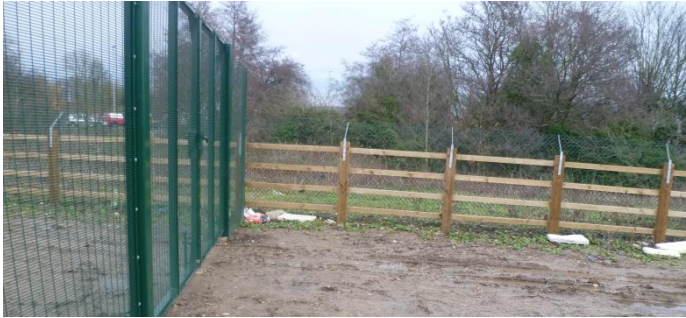
| | Observation | Action Required | Due* | Closed out by* |
|---|---|---|---|---|
| <b>Waste Management</b> | <p>Site generally tidy with the exception of windblown materials south of by the attenuation lagoon and otter proof fencing south of the River Gwenfro.</p> | AGC to clear all rubbish prior to final progress meeting. | 02/02/2016 | |
