## **PROTECTED SPECIES SURVEY**

**SEION CHAPEL**

**BANK STREET, PONCIAU**

**7<sup>th</sup> October 2013**

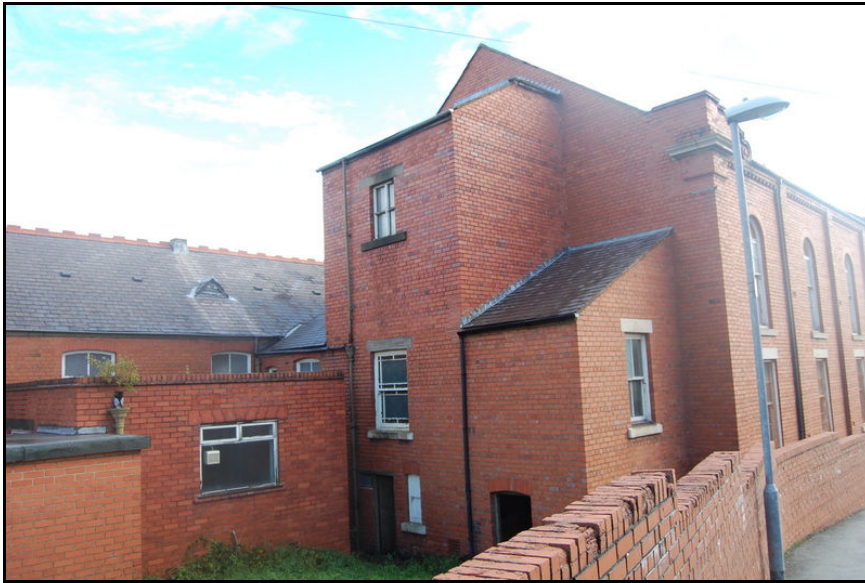
### **3. Chapel rear elevation with flat roof sections**

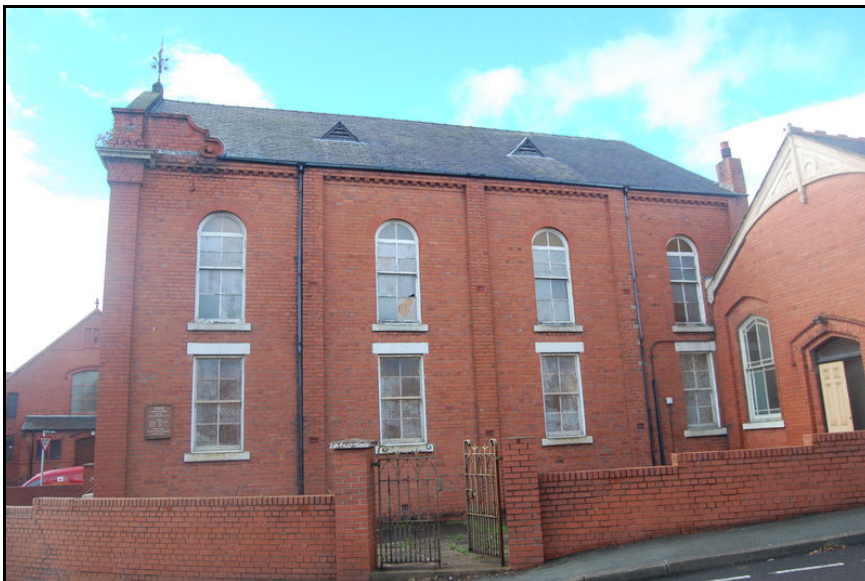
There are two louvre ventilation panels on each side of the roof pitch. Internally it appears that birds used to gain access from these points because there is ancient evidence of swallows. However they have been sealed by tacking cut pieces of Tyvek around the timberwork, this has effectively sealed them and prevents any further access by bats or birds.

### **4. Chapel side elevation with roof ventilation points which will be removed and a Slateline bat access tile placed in the same location each side**

- **No re-roofing of the main hall is proposed and the traditional bitumen roof felt will remain in place post conversion although the existing roof void will be converted.**
- **Four “Slateline” bat access tiles will be fitted to the roof of the main chapel, two on each side. Each slate will be positioned approximately in the existing location of the existing ventilation points which are due to be removed. These will provide access to the cavity between the roof tiles and the underfelt.**

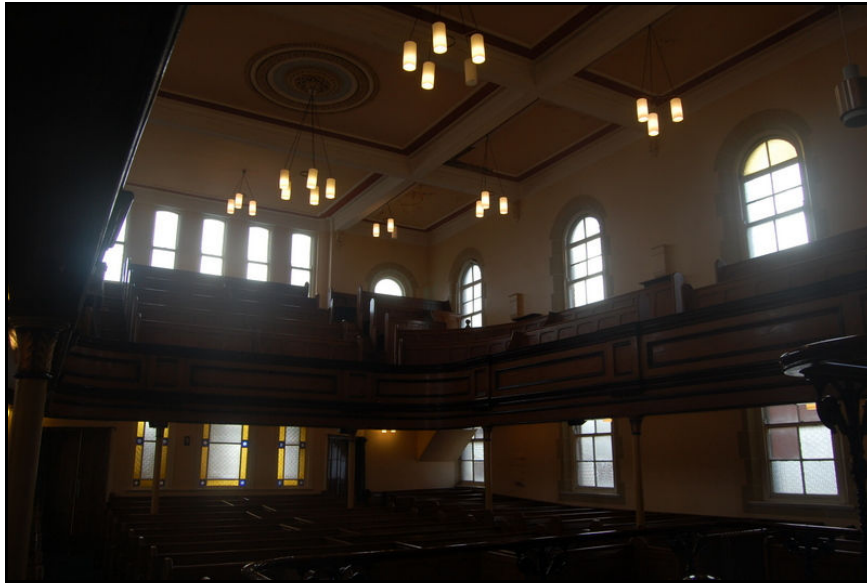
No evidence of bats was found anywhere inside or outside of the building. No droppings were apparent on the floor, roof and wall areas and there were no signs of feeding perches. The main roof void is covered with layers of dust and cobwebs. In this situation any droppings from past roosting or feeding bats would normally be clearly visible when there has been little or no disturbance.

**5. Inside the main hall of the chapel**

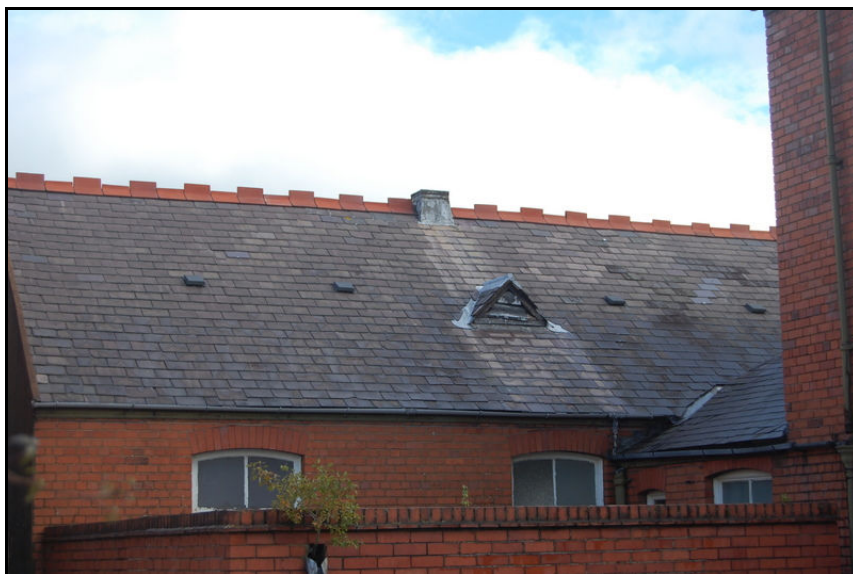
No evidence of bats was found anywhere within this building. The roof void is particularly dusty and covered in dense hanging cobwebs both on the sides but also along the ridge area. It would appear that there has been no movement or disturbance by bats or birds for a long time. The louvre roof ventilators (identical to the ones in the main hall) are actually open and accessible. However, nothing appears to have used them although free access is available. The more recent mechanical type ventilators still retain the mesh grill which prevents access.

**6. Ventilator in rear elevation of the schoolroom, standard grilled vents also shown**

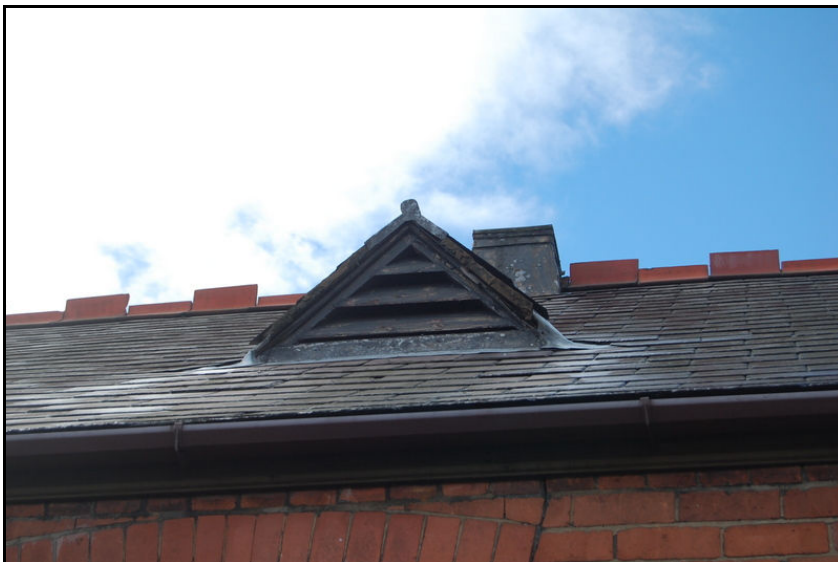
**10. Roof vent on schoolroom**

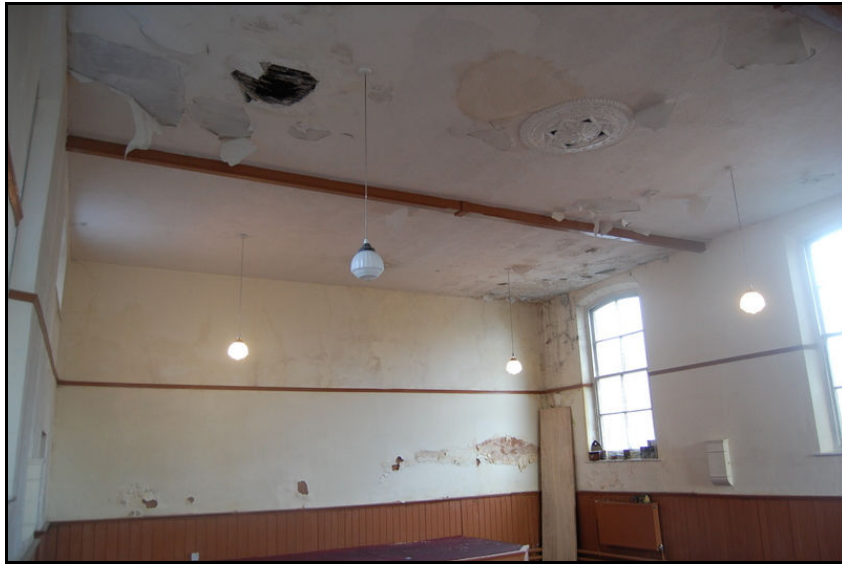
## 11. Inside the schoolroom
