**St Mary Magdalene's Church, Tallarn Green, Malpas, SY14 7JH**

### **Updated Surveys in Relation to Bats**

**Issued : 11<sup>th</sup> November 2013**

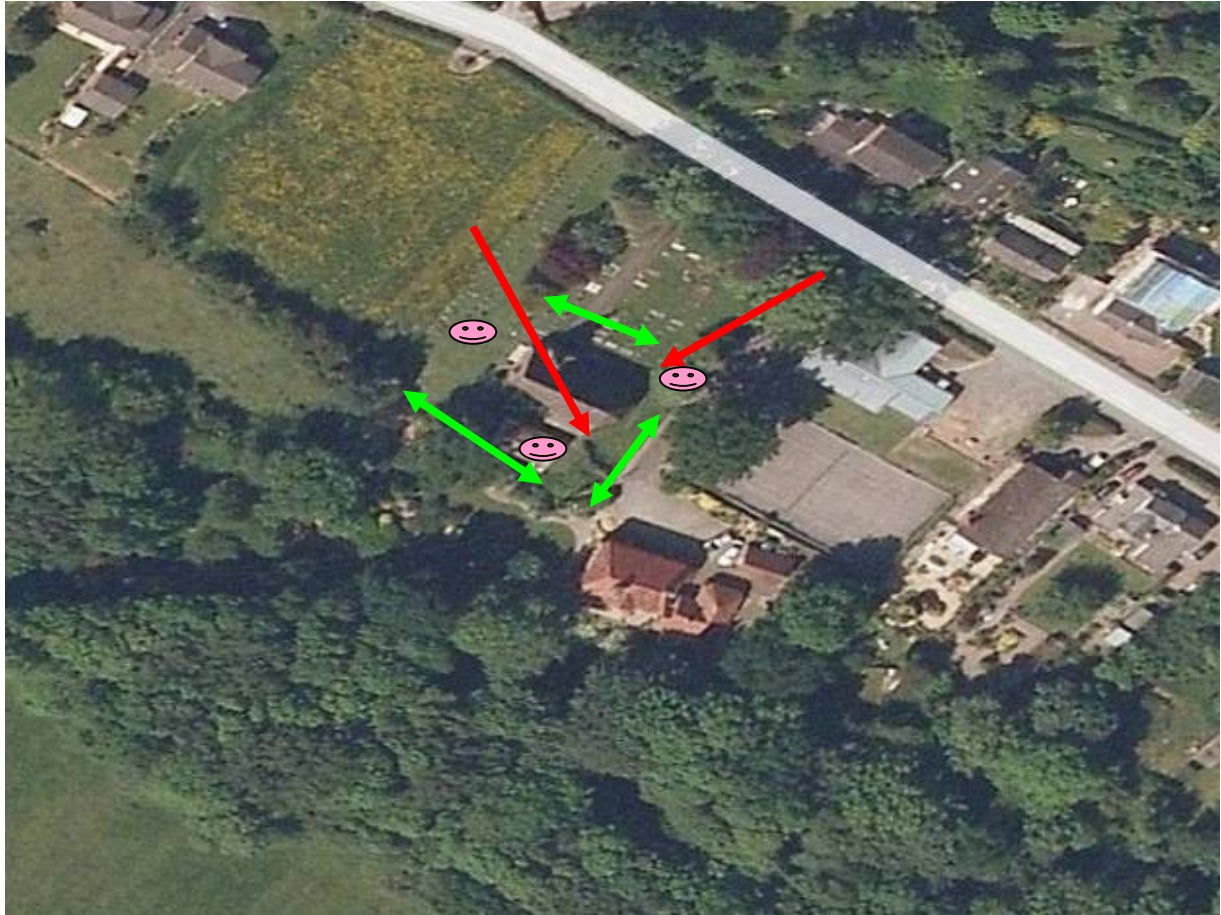
Location of surveyors
-

Commuting flight paths
-

Main foraging activity

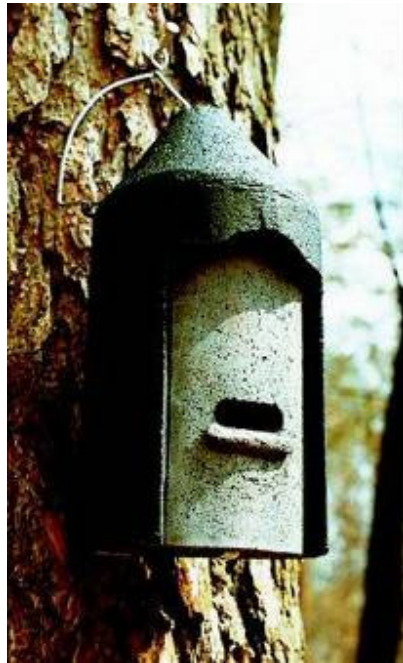
**2F Bat Box**

**Ridge tile access**

This area to be coarse or grooved to allow bats to crawl into gap of 20 mm deep x 100 mm long and access the space underneath the ridge tiles

- 7.3 During the re-roofing work two ridge tiles will be adapted to allow bats to gain access beneath the tiles. To facilitate full access under the ridge, the tiles will be fixed by edge pointing as opposed to setting the tiles on a 'bed' of mortar, this provision will not only compensate for the loss of roost potential in relation to the number of bats that were present but will provide additional roost opportunities over the full year. It is understood that a breathable membrane will be used in the newly converted structure; this type of membrane has been shown to cause problems in bat roosts whereby over time bats have become entangled in the fibres following the breakdown of the material associated with the fine claws of bats. Therefore the membrane will not overlap under the ridge tiles or alternately it should cover with traditional bitumen underfelt.

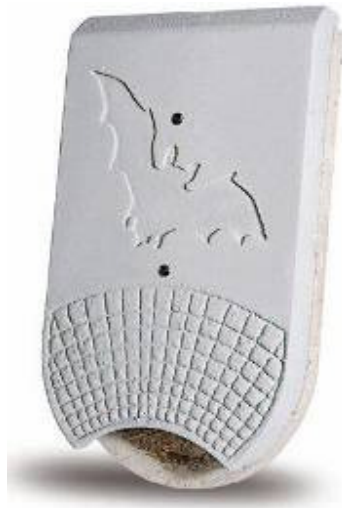
### **1FQ Bat Box**

This is a latest model, designed specifically to be fitted on the external wall of a house, barn or other building. The shape and design make it equally attractive to bats as a roost or a nursery. It is also pleasing to the human eye, an important consideration. It is easy to attach to most types of walls; it features a special porous coating to help maintain the ideal temperature inside. It requires no maintenance or cleaning and its tough construction will ensure that it helps bats for decades.

- 7.4 During the conversion work one 1FQ bat box will be installed on the external north west elevation of the former church, and one 1FE bat access panel will be fixed to the south east elevation. They will be a permanent and dedicated feature for bats, and the position of the roosts on opposite elevations will offer alternative climatic conditions for bats and thus maybe used at anytime of the year.

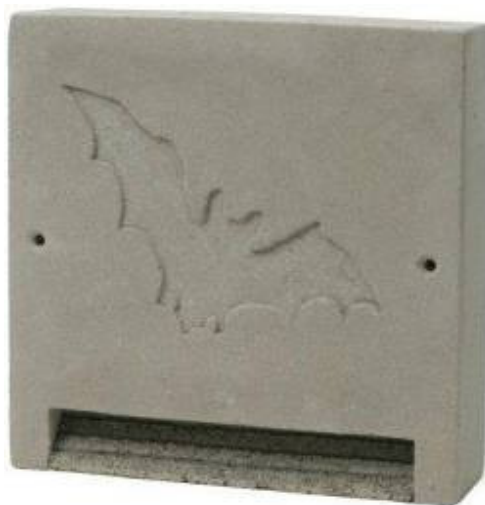
### **1FE Bat Access Panel**

This is a panel for installing on or in the surface of exterior walls. The open back enables bats to continue to use existing nesting sites in walls. The 1FE is especially suitable for use during conversions, renovations or insulation work on older types of buildings and historic buildings.
