**Bat & Bird Survey Report**

**Oakwood Barn, Bowling Bank**

**Ref: 830**

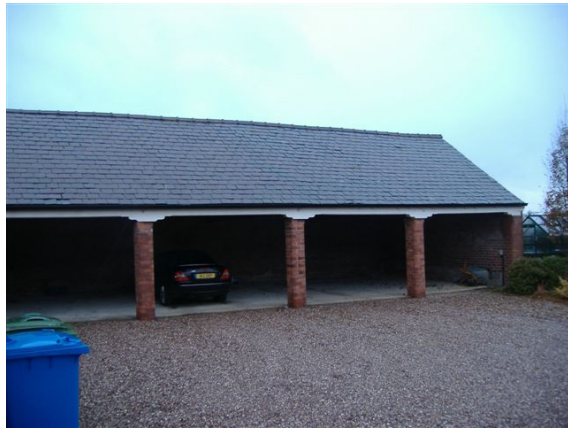
- 3.3 The northern part of the barn is open on its eastern side and is currently used as a garage (see photograph 2, Appendix 2). The roof is of king-post construction and has no felt on the interior (see photograph 3, Appendix 2).

**Photograph 2 – Northern part of barn**

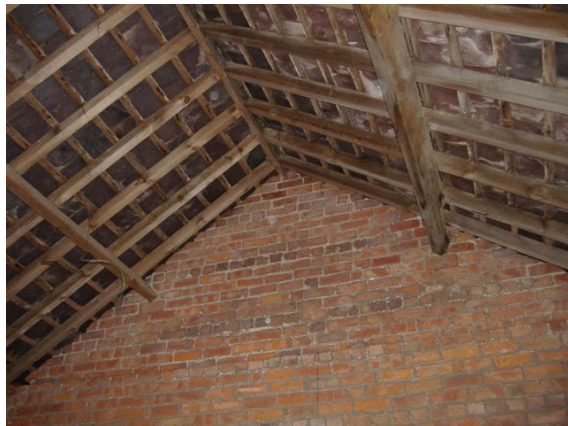
**Photograph 3 – Interior of northern part of barn**

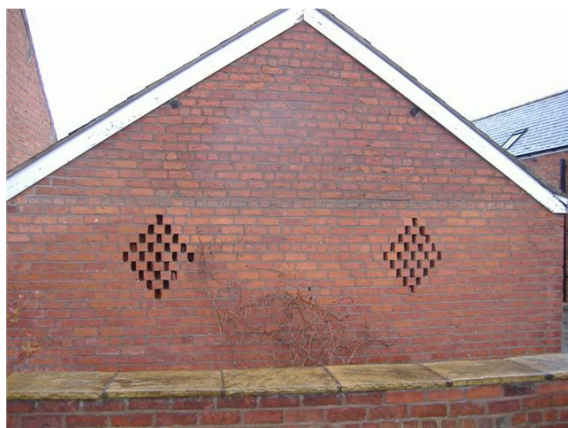
- 3.5 On the exterior of the barn there are timber fascia boards along all sides of the southern part of the building and along the eastern and western sides of the northern part of the barn. The brickwork is in a generally good state of repair on both the interior and exterior of the barn with few gaps or crevices. Two decorative brickwork vents are located on the western gable of the southern part of the barn (see photograph 8, Appendix 2).

**Photograph 8 – Vents on western gable of southern part of barn**

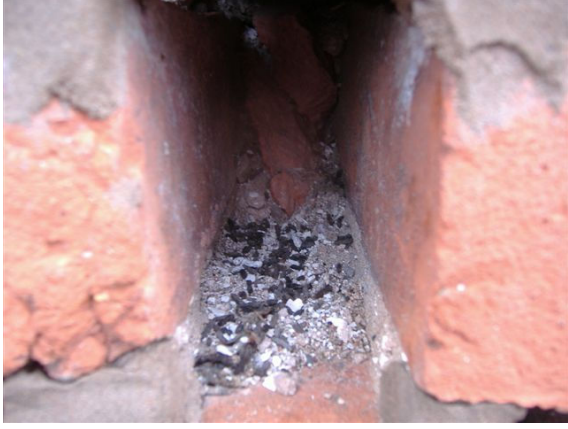
Approximately 50 droppings characteristic of the Pipistrelle bats were found in the southern-most of the two decorative brickwork vents on the western gable of the southern part of the barn (see photographs 11 and 12, Appendix 2). A further 11 droppings characteristic of the Pipistrelle bats were found on the interior of the barn adjacent to the western gable wall of the southern part of the barn directly behind the vent (see photograph 13, Appendix 3). The vents are sealed on the interior indicating that the droppings have been deposited by bats roosting on the top of the gable wall.

| <p><b>Photograph 11 – Bat droppings in section of brickwork vent</b></p> | |

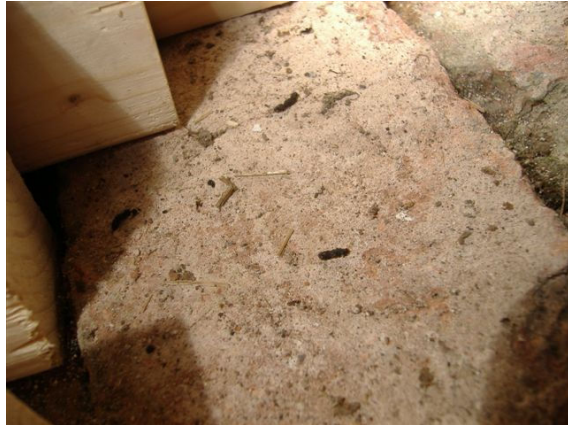
**Photograph 13 – Bat droppings  
adjacent to the interior of the  
western gable of the southern part  
of the barn**

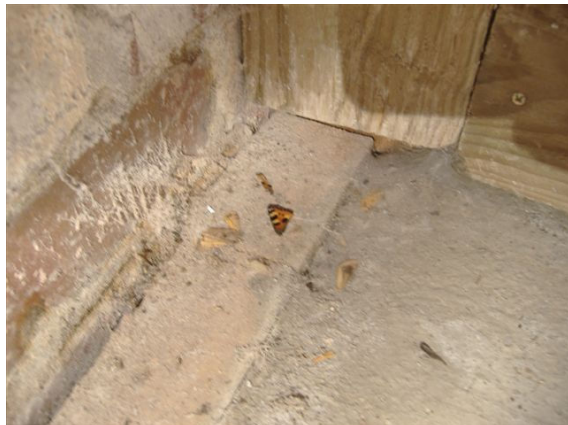
Approximately 20 dusty moth and butterfly wings were found in the north-eastern corner of the central section of the southern part of the barn (see photograph 14, Appendix 2). A scattering of no more than 10 additional butterfly wings were found throughout the southern part of the barn. No bat droppings were found associated with the moth and butterfly wings however the wings could indicate the presence of an old feeding perch of a species such as the Brown long-eared bat (*Plecotus auritus*).

**Photograph 14 – Moth and butterfly  
wings in the north-eastern corner of  
the central section of the southern  
part of the barn**
