**LLAND TO THE REAR OF CHURCH COTTAGE**

**16 HIGH STREET**

**OVERTON**

**ARCHAEOLOGICAL WATCHING BRIEF**

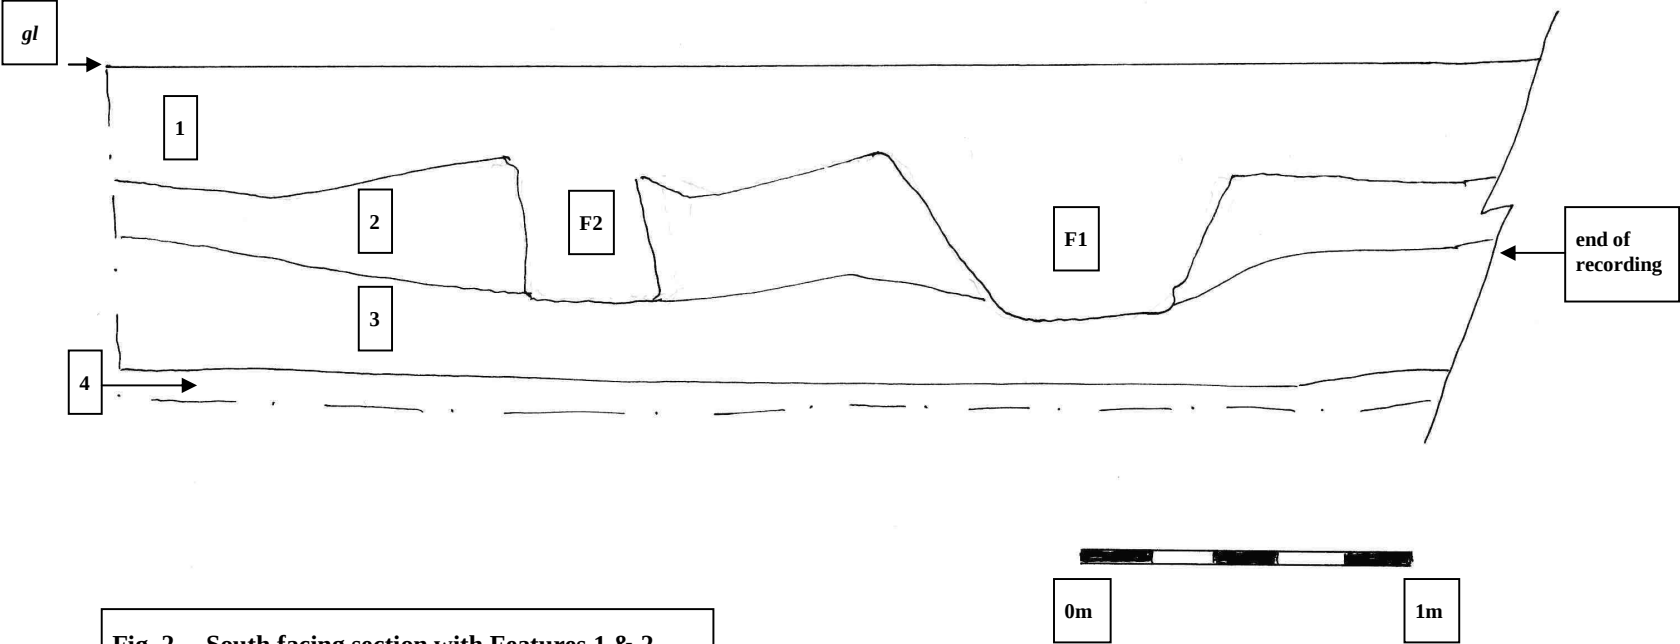
Fig. 2 South facing section with Features 1 & 2  
Scale 1:20

The northern trench was cut by a linear feature that crossed the footing trench in a north-south direction (Feature 'F1'; Plate 3). The feature was cut into the topsoil but below the overburden of topsoil that had been banked up against the modern concrete panelled fence, as seen in Plate 3 *following*. The feature measured 0.95m at the top and 0.5m at its base. The irregular semi-circular section of the feature extended to a maximum depth of 0.5m, where it cut into Context 2 and 3. The feature is interpreted as a possible ornamental hedgerow or similar garden feature of fairly modern date, rather than representing a boundary.

To the west of Feature 1, the topsoil was cut by a modern posthole (Feature 'F 2'; Plate 4), which may have been associated with a modern wooden structure. The posthole measured approximately 0.3m wide and was also clearly cut with a spade below the overburden of topsoil, as seen in Plate 4 *following*.

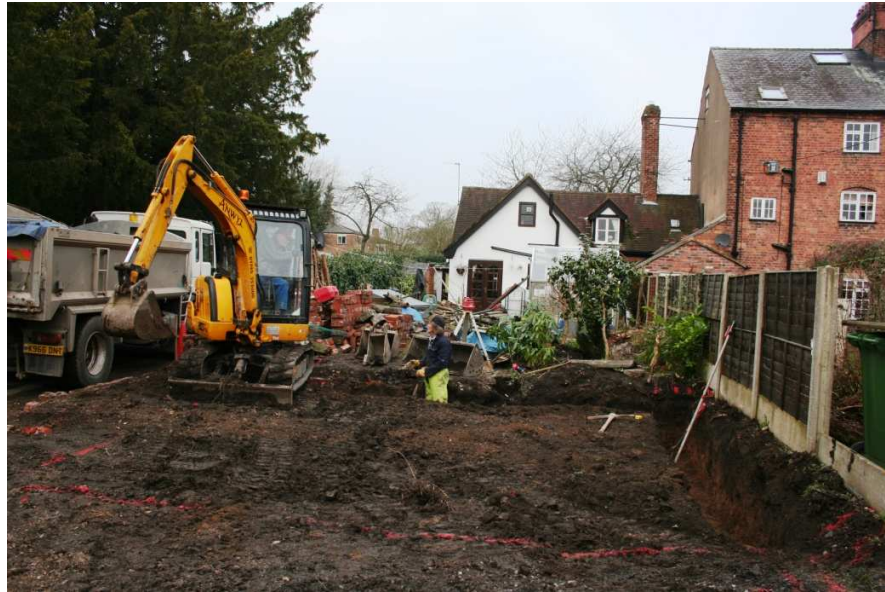
**Plate 1: Rear of No. 16 High Street, excavation of footings viewed from the east**

The plot lies on the north side of Dark Lane and the brick boundary wall to the lane was removed to provide access. Four footing trenches were excavated by a 3 tonne mechanical excavator to an approximate width of 0.5m and a depth of up to 1m, to accommodate the footings for the 5.8m square new build. The watching brief monitored the removal of >400mm of rich soft dark brown sandy humic topsoil (Context 1), which had clearly been well-cultivated in the past. In subsequent years, as the garden plot was altered, the topsoil has been re-distributed over the area of the proposed new build. In general Context 1 sealed an average of >300mm of mid-to light brown firm sandy clayey subsoil with charcoal flecks and small stone (Context 2), recorded primarily in the north, east and west trenches. Context 2 sealed a firmer and stickier mid-to light brown subsoil (Context 3), recorded particularly in the eastern and northern trenches, where Context 3 sealed brownish red sandy clay with fine stone (Context 4).

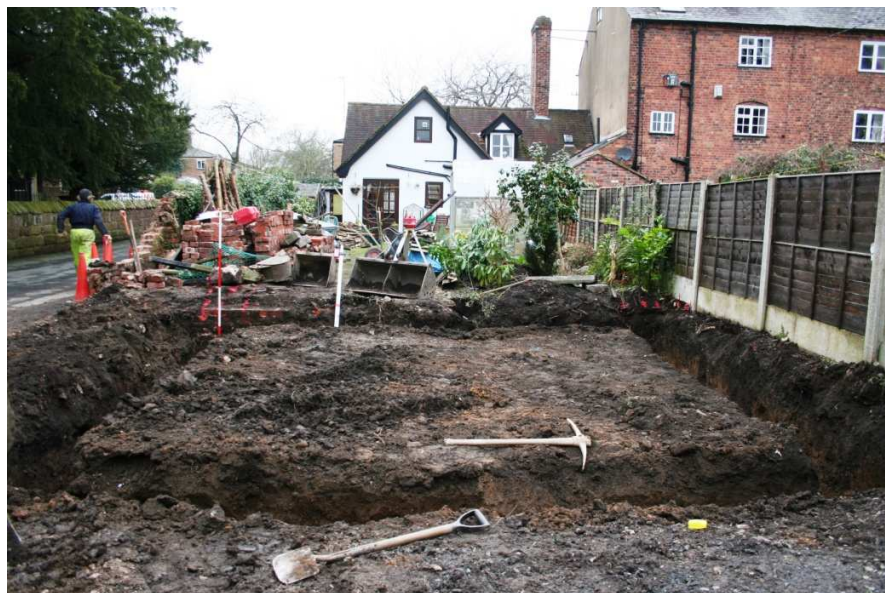
**Plate 2: Final extent of excavation, viewed from the east**

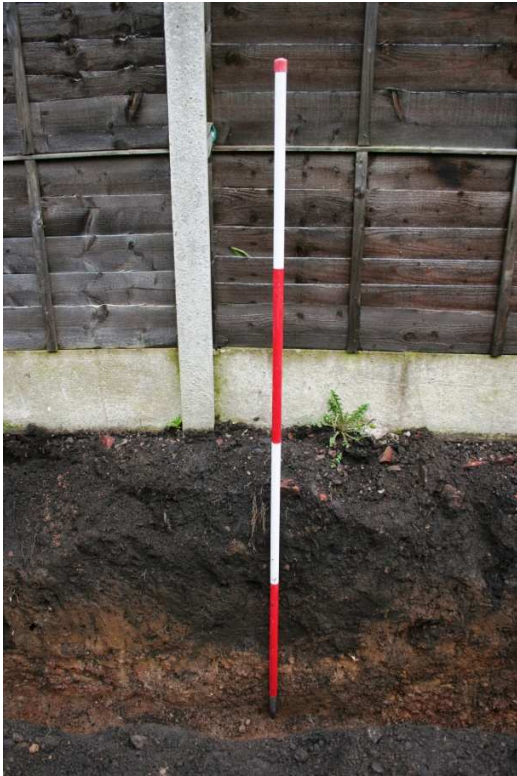
**Plate 3: North trench, Feature 1**

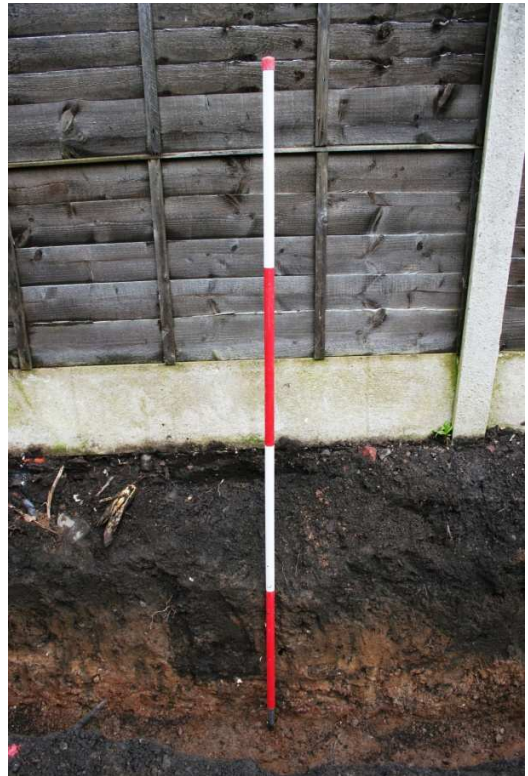
**Plate 4: North trench, Feature 2**

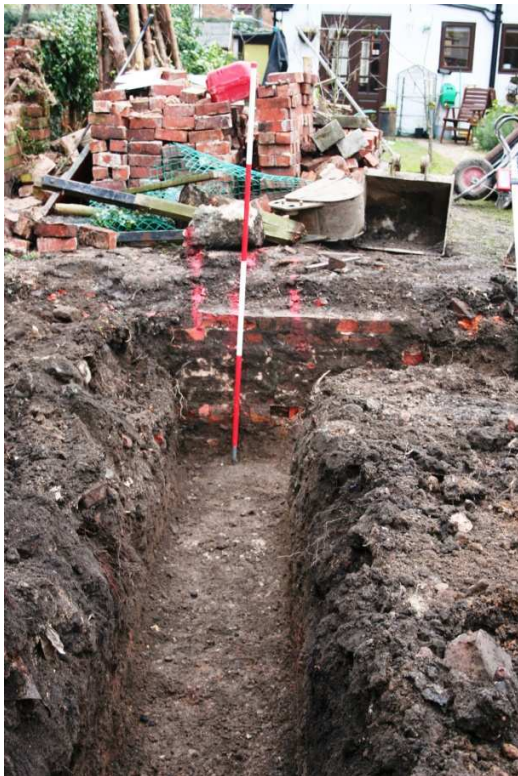
At the south end of the western trench, 1.6m of red brick wall was revealed in the east facing section (Plate 5 *following*). The wall was constructed in standard machine-cut red bricks laid with a hard lime-based mortar. The wall extended for approximately 0.62mbgl and appeared truncated at the surface. Continued excavation eastwards from the wall revealed disturbed ground that extended for approximately 4.3m throughout the width of the south trench. The disturbed ground comprised a moist homogenous mixed dark grey soil with mixed ash, brick, tile and slate fragments (Context 5). Two section of 10" diameter ceramic service drain were also recovered and none of the fragments of building material pre-date the late 19<sup>th</sup> century period.

The section of brick wall and the disturbed Context 5 appear to be roughly contemporaneous. Both the wall and Context 5 extended to a depth of 0.62 to 0.7mbgl, where they lay above a mid-to light brown clayey sandy matrix with gravelly stone that formed the base of the south trench (Context 6). The brickwork suggests the section of wall may have been associated with an outhouse of late 19<sup>th</sup> / 20<sup>th</sup> century date. The outhouse or its predecessor (Fig. 3 *following*) may have been the site of a 'bottom of the garden privy lavatory' and, although no outlet was seen in the section of exposed brick wall, such an outlet would explain the composition of Context 5. Waste was generally directed from the rear of the privy to a compost pit where additional rubbish was often placed. The presence of a compost heap at this location would also explain the fine grade of the topsoil on site. In more recent times, the lavatory presumably fell out of use and the unfirm ground to the rear was made-up with fragments of building waste.

**Plate 5: Section of brick wall, viewed from the south**

The watching brief recorded the ground disturbance possibly associated with a red brick outhouse / privy. While the section of wall appears to be in the position of the south wall of the small structure recorded by the Tithe in 1838, the brickwork on site confirms a later date. The brickwork may be the surviving evidence of the south wall of the small structure recorded by the OS in 1871, as seen on Fig. 4 following, and the 1838 record suggests a likely predecessor.
