**Bat & Bird Survey Report**

**Marchwiel Village Hall**

**Ref: 1354B**

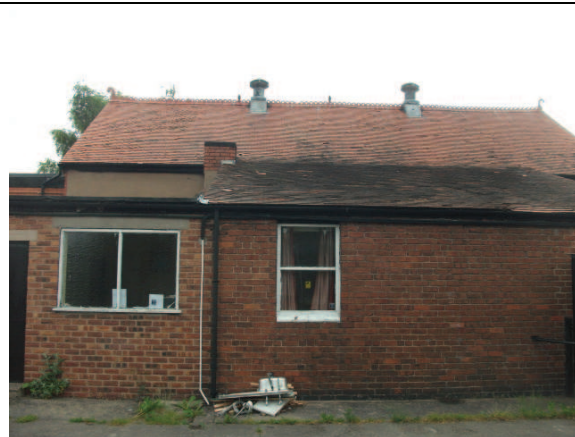
**Photograph 1 – Marchwiel Village Hall**

- 2.1 The site is located to the south of Piercy Avenue, Marchwiell
- 2.2 The site comprises a detached village hall building. The original building is of brick construction and has a pitched clay tile roof (see photograph 1, Appendix 2). Flat-roofed single-storey brick extensions with felt roofs are located on the northern, eastern and western sides of the building (see photograph 2, Appendix 2). A small additional section with a pitched clay tile roof is located on the southern side of the building (see photograph 3, Appendix 2).

- 5.6 The hall building, particularly the pitched roof over the original section of the building, is in a poor state of repair. There are a number of slipped and missing roof tiles which could give access for bats into the roof area or allow small numbers of bats to roost beneath the roof tiles themselves. Potential access points and roosting sites for bats were also identified in the form of gaps along the eaves of the original part of the building.
- 5.7 The flat-roofed sections of the building offer limited roosting opportunities for bats. The flat felt roofs do not offer suitable entrance points or roosting sites for bats and the timber fascias of these parts of the building are generally tight to the walls.
- 5.8 Overall, the hall building was assessed as having MODERATE potential as a roosting site for bats (BCT, 2012).

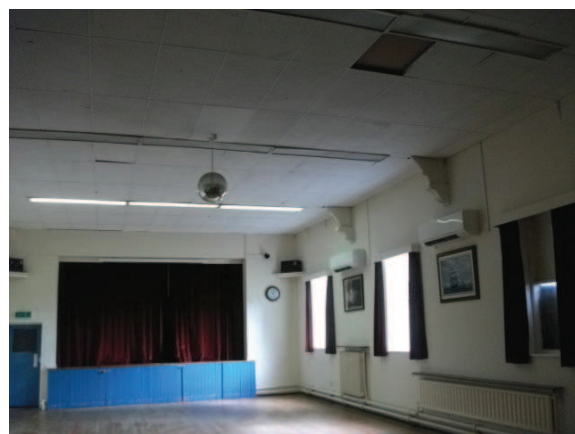
**Photograph 4 – Interior of main hall**

- 2.3 The main hall building has a hanging tile ceiling and a large loft space which could not be accessed or survey (see photograph 4, Appendix 2). A second small loft space is located in the pitched roof section on the southern side of the building. This loft was accessible. The interior of the roof of this part of the building is torched.

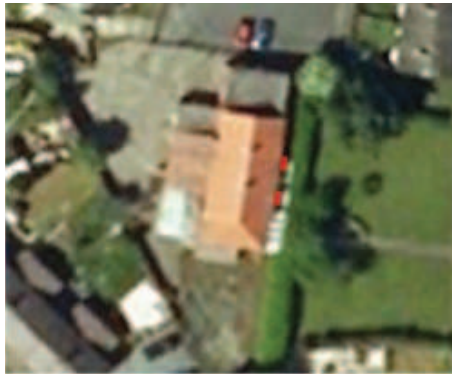
**Figure 1** – Location of proposed bat boxes

• = Proposed 1FF bat box

Two Schwegeler 1FF bat boxes will be installed on site (see Figure 1 below). These boxes are to be erected prior to the start of works to the hall building. The boxes will be installed directly below the eaves on the eastern side of the hall building and will act as a receptor site for any bats found during the removal of the roof of the building and as long term new roosting provision for bats.
