Former Bethlehem Congregational Chapel, Coedpoeth, Smithy Road, Wrexham

Inspection & Assessment in Relation to Bats

**Issued:** 20 June 2013

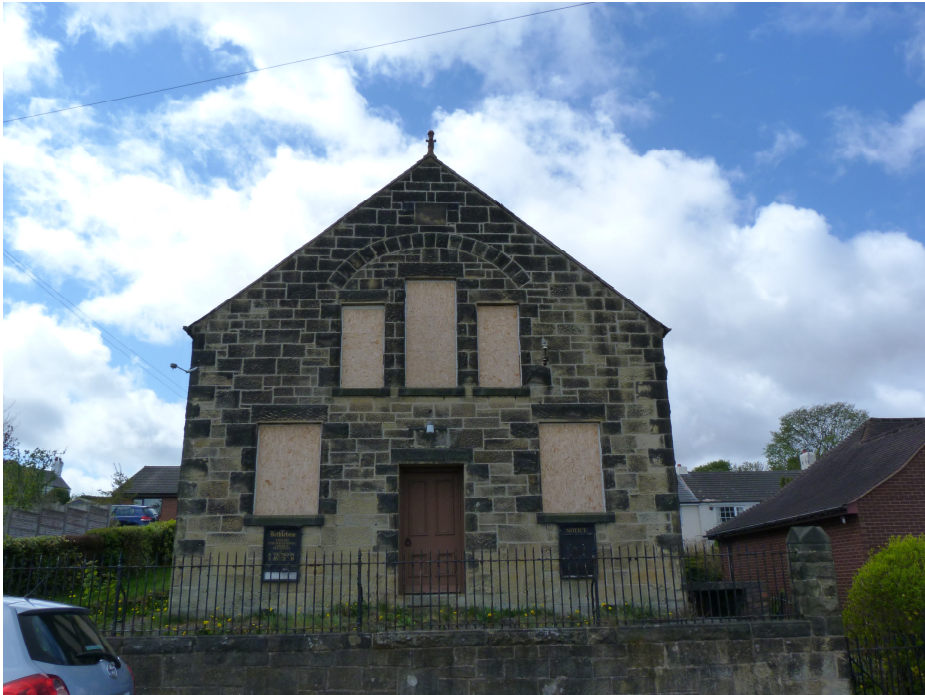
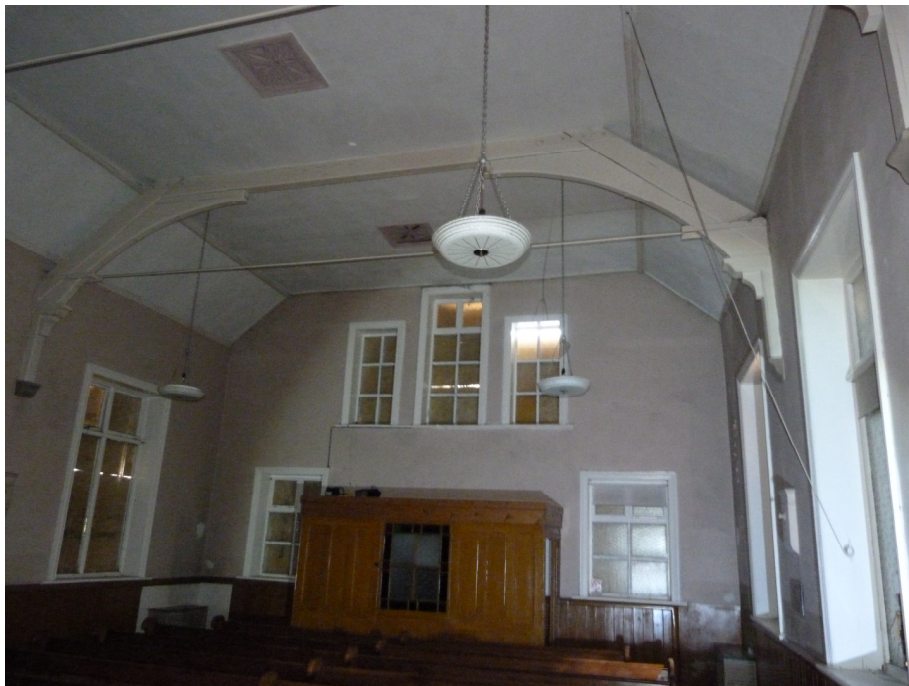
- 6.2 The chapel is a large dressed stone built structure with a slate roof and the ceiling is vaulted; a hatch is present in the ceiling but due to its height the loft or void could not be accessed. Although a loft or void is present the habitat is not entirely suited to loft dwelling bats; typically Brown Long Eared (*Plecotus auritus*) and as a result the potential for their presence, is significantly reduced, as this is a species that favours a more woodland environment close to their chosen roost site. Within the interior of the building no evidence of bats was located but evidence of crevice dwelling bats is not always evident, particularly where ceilings are well formed and are absent of gaps that allow bats to gain access into the interior of a building.

Exterior & Interior of Chapel

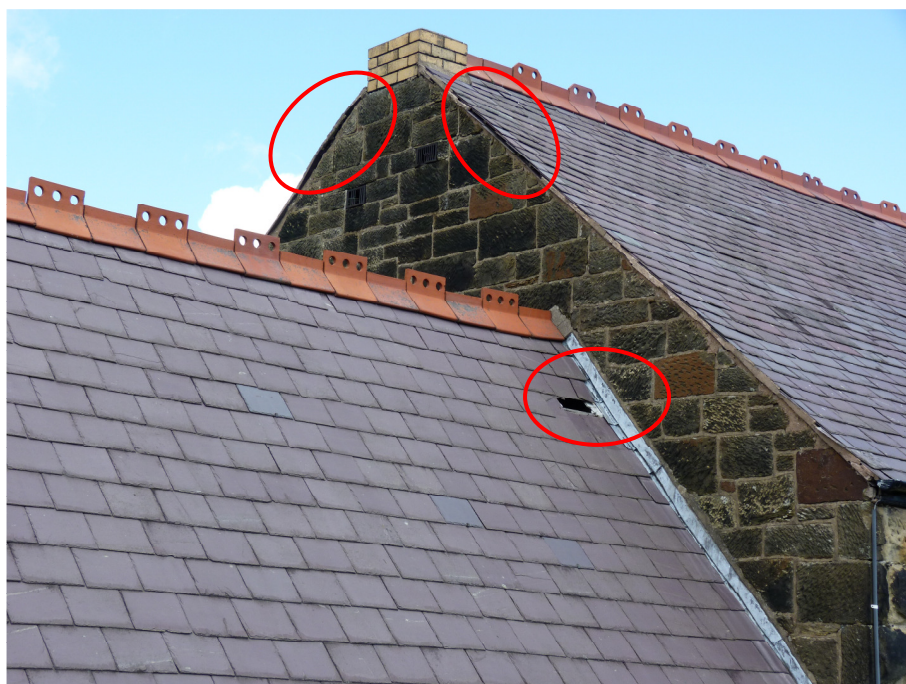
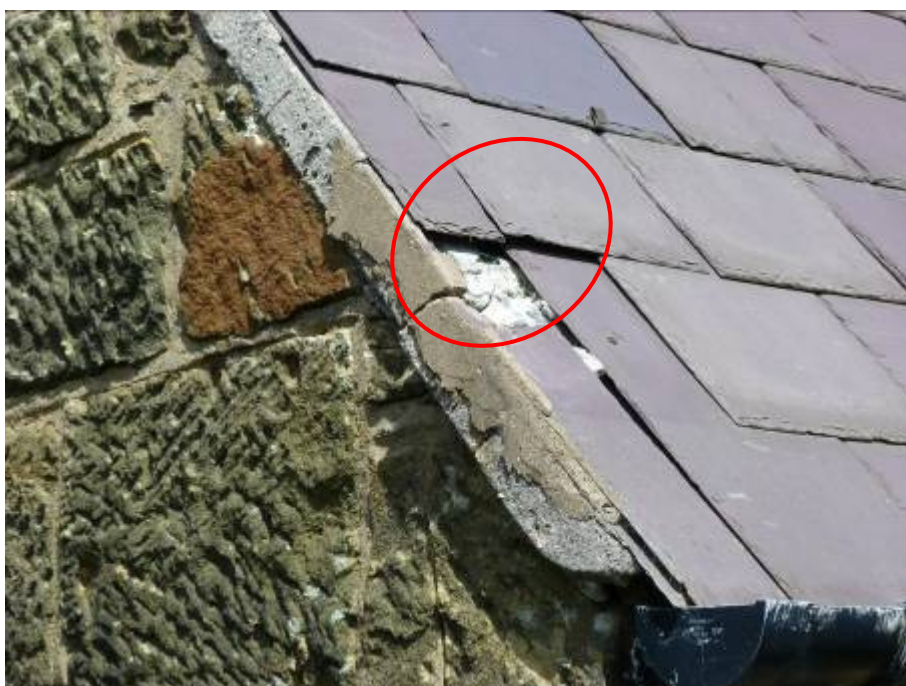
- 6.4 During the external inspection several areas were identified that hold potential for crevice dwelling bats, i.e. gaps at the roof verges where mortar pointing has perished, gaps at ridge tiles and slipped or missing slates. Although no obvious evidence of bat use was located the building is considered to be of moderate – high value in relation to bat roosting opportunities.
- 6.5 Whilst undertaking the bat related inspection the building and the land was also assessed in relation any other ecological factors, including nesting birds that show a high dependency upon built structures. On the day of the survey no nesting birds were noted and potential is generally low although there are opportunities for hole dwelling species; furthermore the land holds no habitats that are of ecological importance.

- 7.1 Although evidence of bat use was not located during the daytime investigation, roost potential and ingress opportunities for crevice dwelling bats has been identified within the structures, notably within the roof verges and ridge tiles. The presence of true loft dwelling bats is considered to be low – absent.
- 7.2 The bat roost potential for bats that has been identified at the buildings could be used for more than one roost purpose i.e. breeding, occasional/transitional use and over the hibernation season. The value of roost potential is considered as being moderate – high and the combination of suitable foraging habitat and the level of bat roost potential that is present will instigate recommendations for dusk and/or dawn surveys to be undertaken at the building prior to any work schedule being undertaken.

Gaps in extension roof void, slipped slates & roof verge on main building

- 8.1 For the reasons outlined in the survey results, it is recommended that nocturnal emergence and/or dawn re-entry surveys are required prior to any work being undertaken. The surveys will need to be conducted during the main active season of bats i.e. between May – August and where bat roost potential is moderate – high then three dusk and/or dawn surveys are generally required as bats, particularly Pipistrelle, often alternate between roosts and do not necessarily occupy a single roost over the entire breeding season. (See Figure 1: Extract from Bat Conservation Bat Surveys: Good Practice Guidelines)
