## **Llwyn Onn WTW: Phase I Contamination Report**

August 2010

## **LLWYN ONN WATER TREATMENT WORKS: PHASE I CONTAMINATION REPORT**

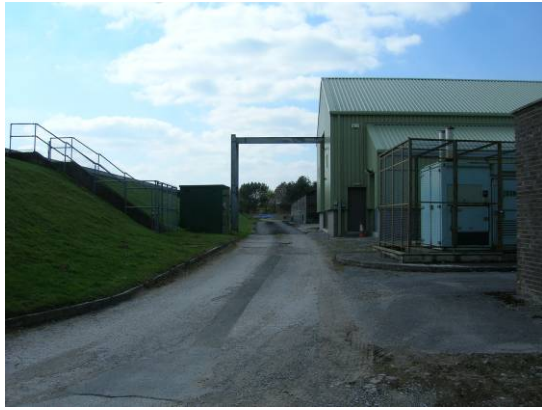
Photograph 1: View of centre of site looking west from near the entrance gate. Showing access road in centre, raised water reservoir (to left of photograph) and generator compound (right, front) and chemical house (right, back).

A site walkover was undertaken on the 16<sup>th</sup> of April 2010. The centre of the site contains a large above ground water reservoir (Photograph 1, Appendix B). This would remain in use as part of the proposed scheme. To the northern side of the reservoir are a site office building, pump-house building (Photograph 2), an electricity substation/ transformer building, an enclosure housing backup generator (with integral diesel tank), chemical house and two long wooden storage sheds (Photograph 3). The generator enclosure is bunded with a low concrete block bund (Photograph 4). There is no evidence of any staining within the bund, and it appears intact (Photograph 5). The wooden sheds contain a variety of tools and equipment. There is a storage area to the west of the wooden sheds that contains mainly empty fibreglass and plastic water tanks, wooden pallets, wooden sleepers and plastic pipes (Photograph 6). There is no evidence of any staining or hazardous materials in this area, and the main storage area and building footprints are located on areas of hard standing. There is also further storage of empty large plastic and fibreglass water tanks to the west of the reservoir in an area overgrown with brambles (Photographs 7 and 8). The chemical house stores Chlorine and Sulphur Dioxide. Other chemicals used within the treatment process include Monosodium Phosphate, Alum and Lime, which are stored in containers located in or near to the treatment building.

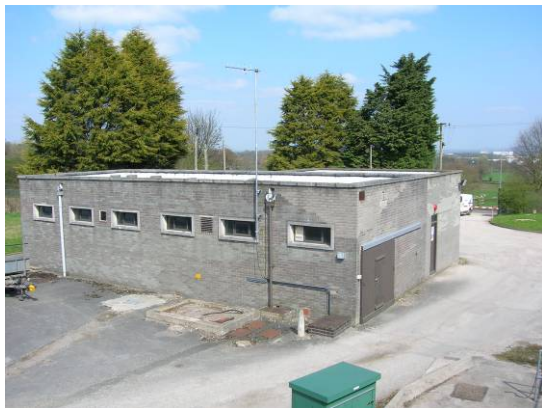
Photograph 2: View of pump house looking from water reservoir towards site entrance.

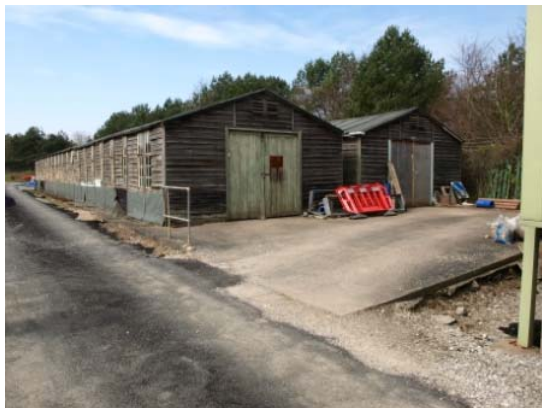
Photograph 3: View of wooden storage sheds located on northern side of water reservoir and access road. Wooden storage sheds are to be removed as part of the development to allow temporary construction access and storage area to be built.

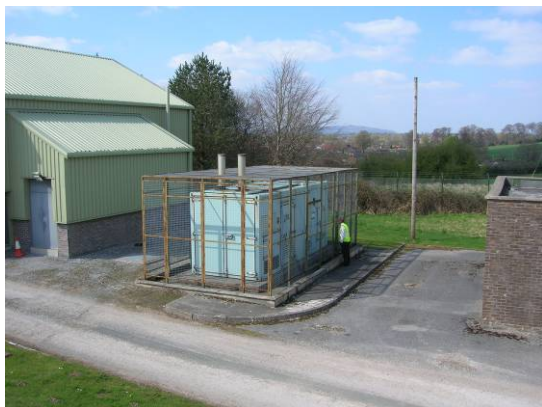
Photograph 4: View of compound housing backup generator within wire enclosure and shallow concrete bund. Electricity sub station / transformer house is located to right of photograph. Chemical house is located to the left of the photograph.

An electricity sub station / transformer house is located on site (access was not gained into this building during the site walkover). Historic maps show that the substation was constructed between 1979 and 1992, so is unlikely to contain PCBs as the use of PCBs in new equipment was banned in the UK in 1981.

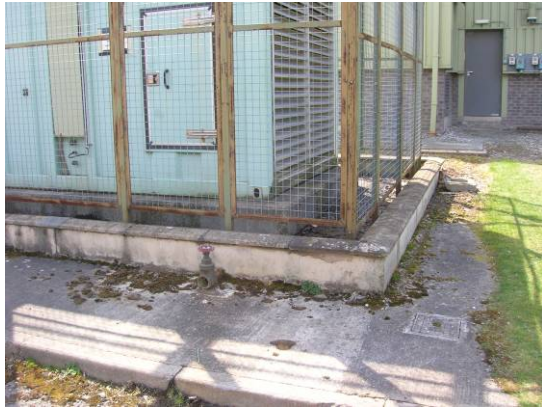
Photograph 5: Close up view of the wire enclosure and low concrete bund housing backup generator. No visible signs of staining near outlet tap.

A small volume of diesel is stored on site for use within the backup generator (stored within an above ground tank that is integral to the generator). This is contained within the low bund surrounding the generator enclosure, and no spillages have been recorded on site. Diesel is only used within the self contained generator building and is not used to refuel plant or equipment that would be likely to cause spillages across site.

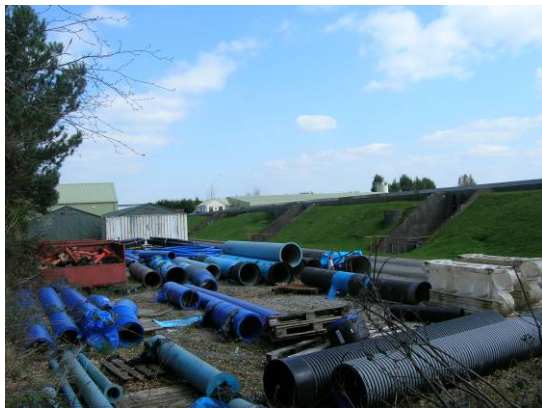
Photograph 6: View of current storage area to west of wooden storage sheds. The raised grass banks of the water reservoir can be seen in the background of the photo.

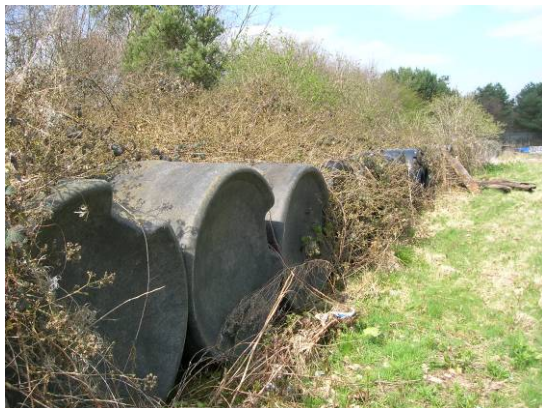
Photograph 7: Close up view of empty drinking water tanks stored within the western side of the site. There is a mixture of plastic and fibreglass tanks stored here. Partially overgrown with brambles.

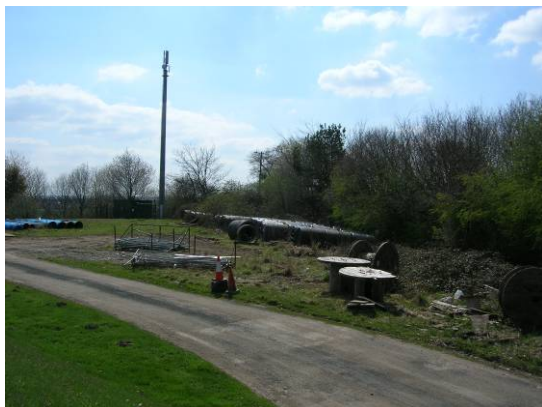
Photograph 8: View of western perimeter of site from water reservoir, showing storage area (wooden pallets, plastic pipes and empty water drinking tanks) and telephone mast.

There is also a telephone mast located within the south west of the site (Photograph 13 and 8).

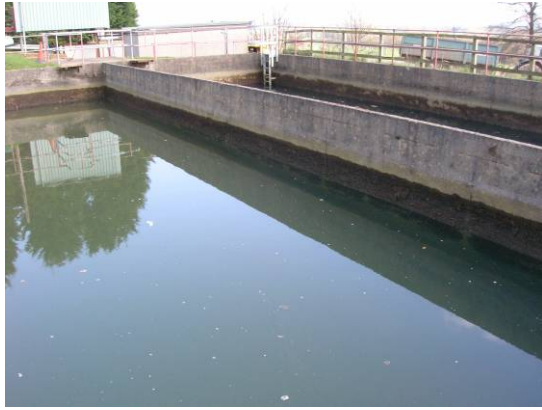
Photograph 9: Showing wash water tanks within south eastern portion of site.

To the east of the reservoir is the existing treatment building and south of this are located two concrete wash-water tanks (Photograph 9) and a series of settlement and sludge storage lagoons (Photograph 10). The lagoons are drained and emptied of sludge regularly. Sludge 'cake' is a by product of the water treatment process and is centrifuged and then removed from site on trailers to be used as fertiliser for nearby farmland. There is also a lime silo (attached to treatment building, Photograph 11) and LPG tank located within the east of the site.

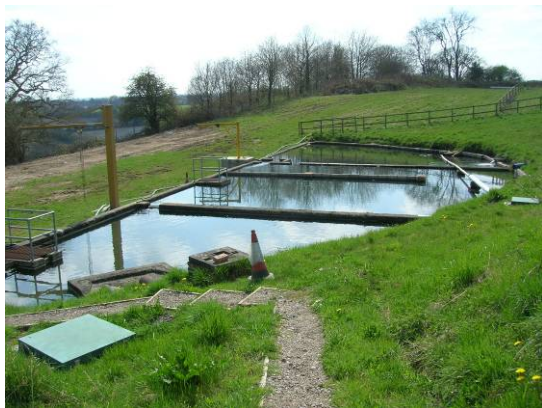
Photograph 10: Showing 'half moon' shaped settling lagoon within south eastern portion of site.

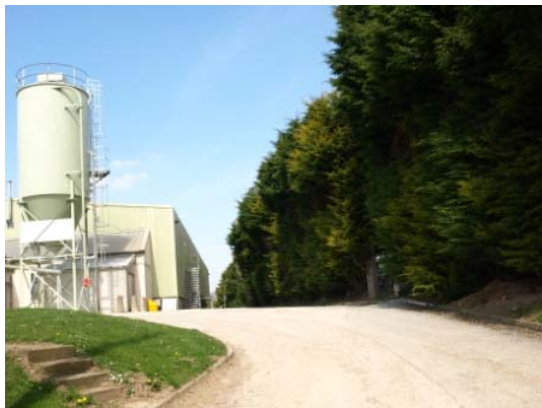
Photograph 11: Showing lime silo attached to current water treatment building located along the eastern side of the site.

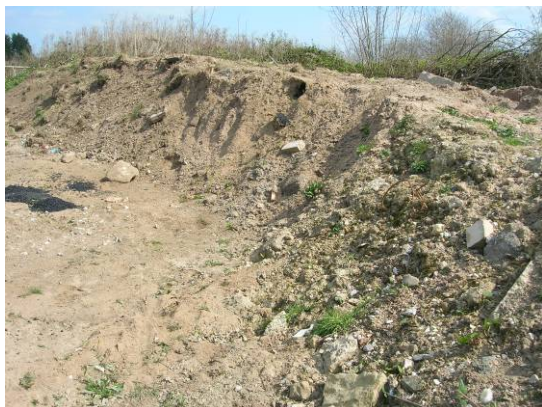
Photograph 12: Showing raised ground level within south western corner of site where there is storage of soil material.

Within the southwest of the site there is some evidence of material storage adjacent to the haul road, some areas of which have become overgrown with vegetation. The material is

of unknown origin but is thought to be clean fill for pipelines from offsite. It comprises sandy soil material and contains concrete curb stone (Photograph 12).

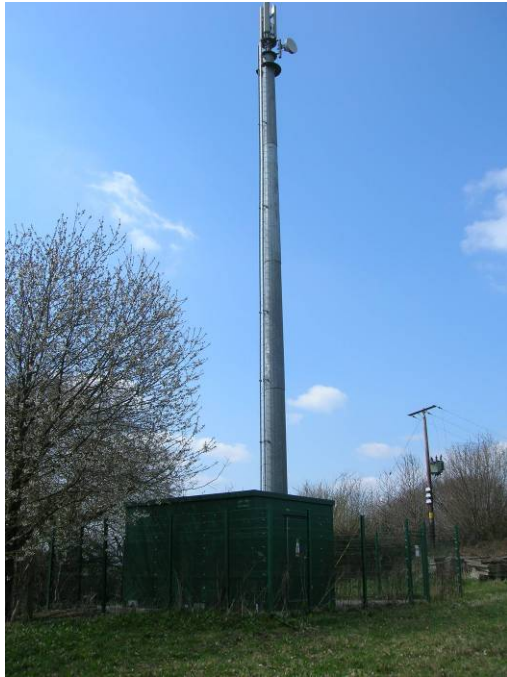
Photograph 13: View of telephone mast located at the western boundary of site.
