## **GROUND INVESTIGATION REPORT**

**Report No. 15076**

**Land Off Meredith Close**

**Acrefair**

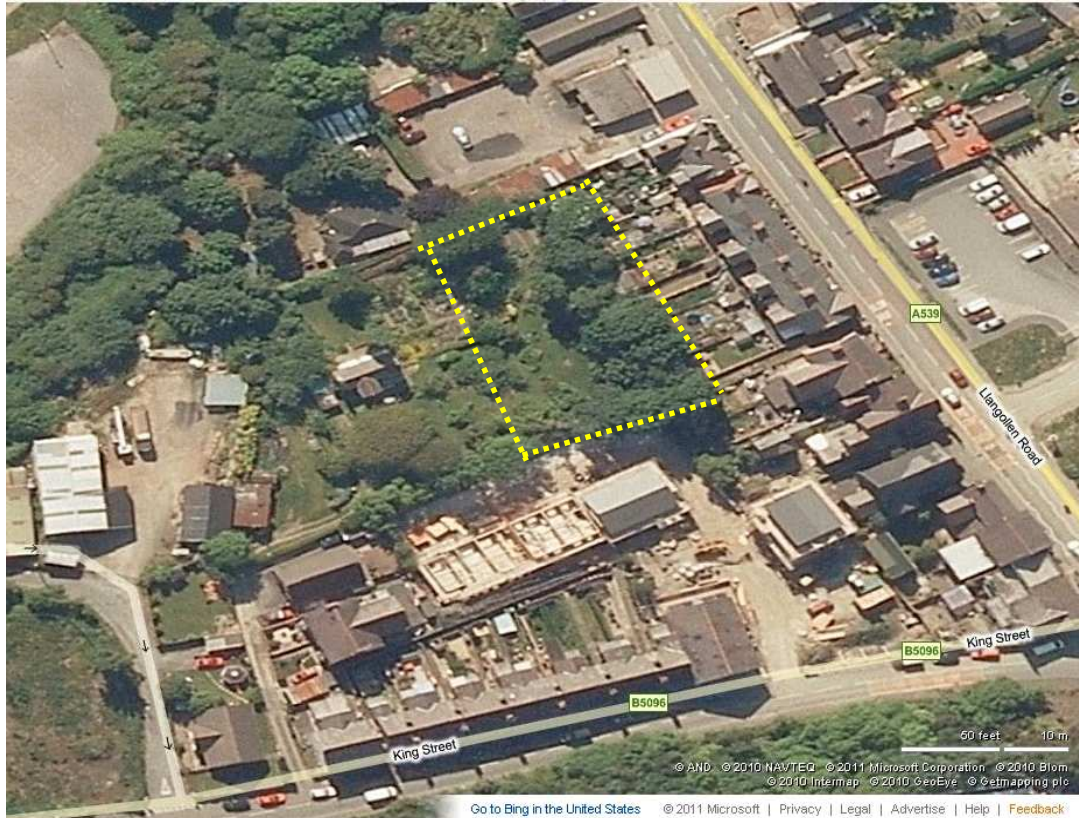
The aerial photograph below shows the general site arrangement.

The site is now roughly vegetated and some general site preparation works have been undertaken locally clearing vegetation.

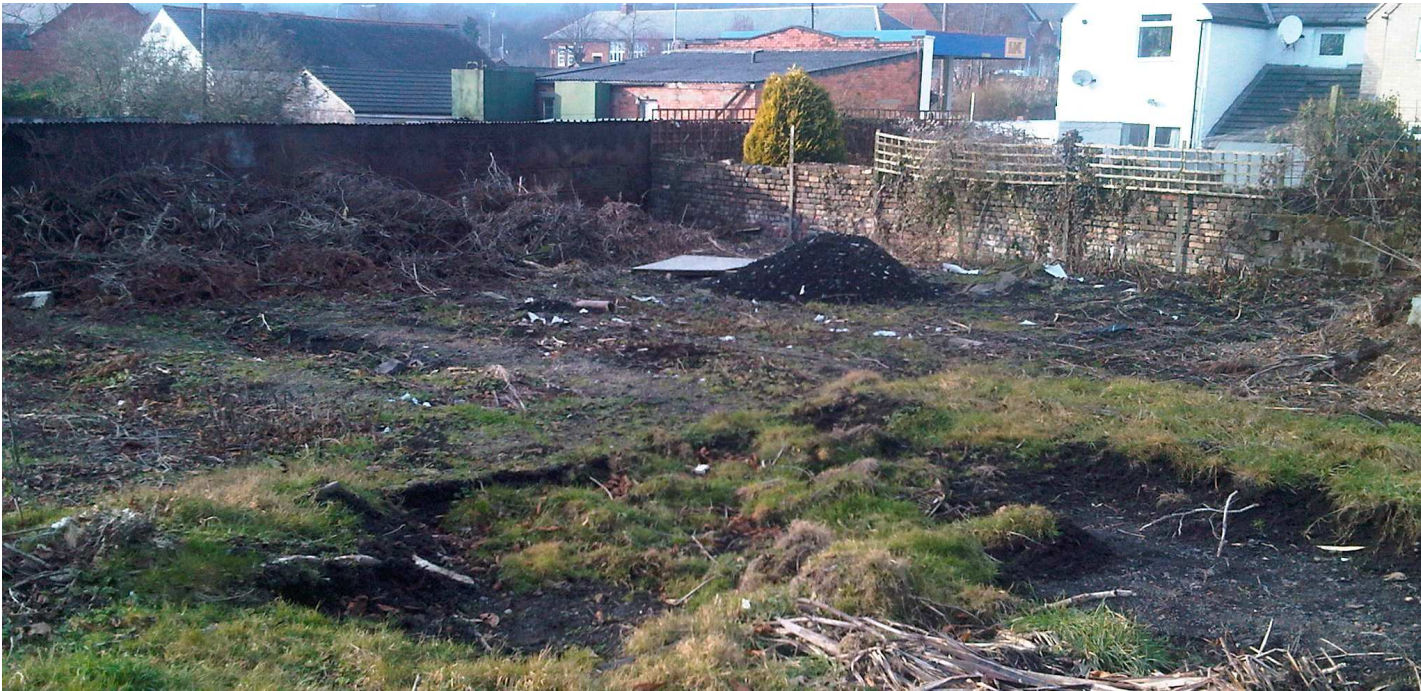
View of the north west corner, note trial pit excavated for infiltration assessment.

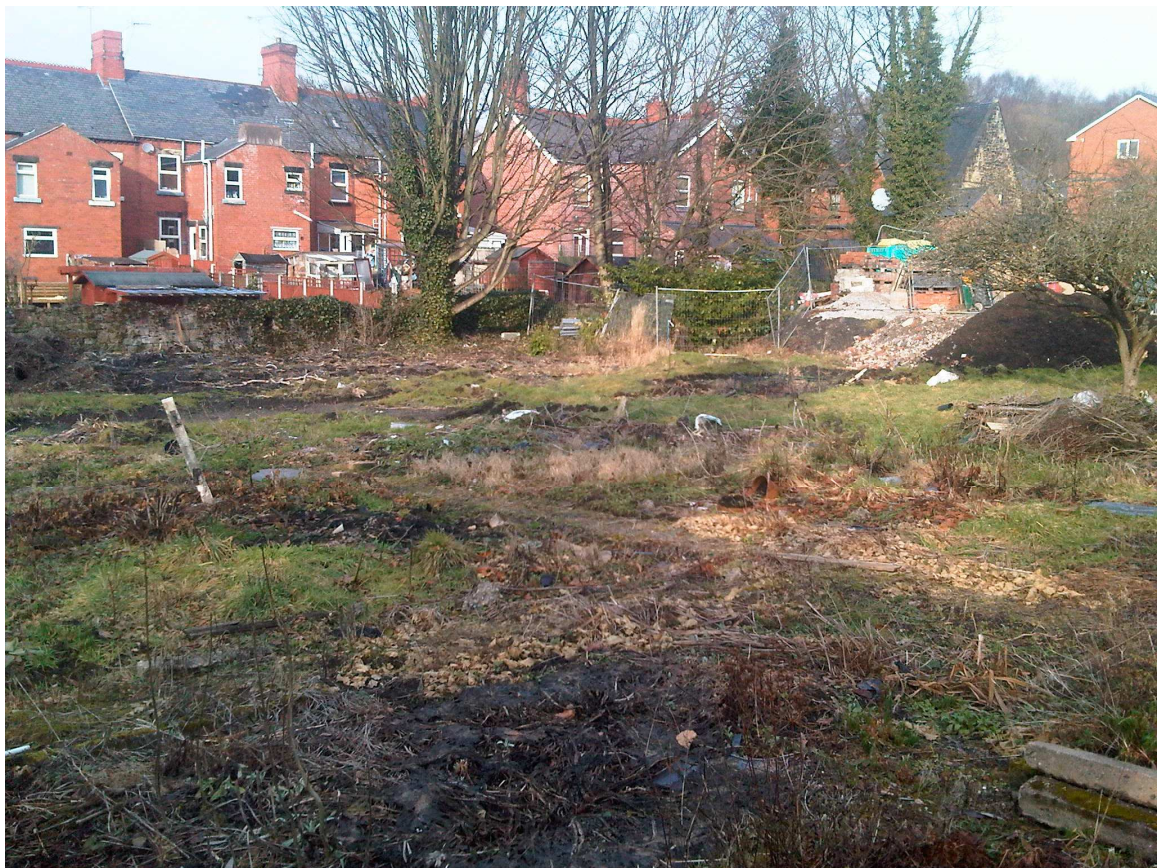
View to the north east showing the proposed access on to site from Meredith Close.
