**GREEN PLAN ENERGY LTD  
KINGMOOR PARK, WREXHAM INDUSTRIAL ESTATE  
ARBORICULTURAL IMPLICATIONS ASSESSMENT  
(Report Ref: TEP.2264.002 Revision C)**

**GREEN PLAN ENERGY LTD, KINGMOOR PARK, WREXHAM INDUSTRIAL ESTATE  
ARBORICULTURAL IMPLICATIONS ASSESSMENT**

Drawing 1: Tree Implications and Protection Plan: D2264.003B

Drawing 2: Recommended Tree Protection Fencing: TEP.HERAS.003A

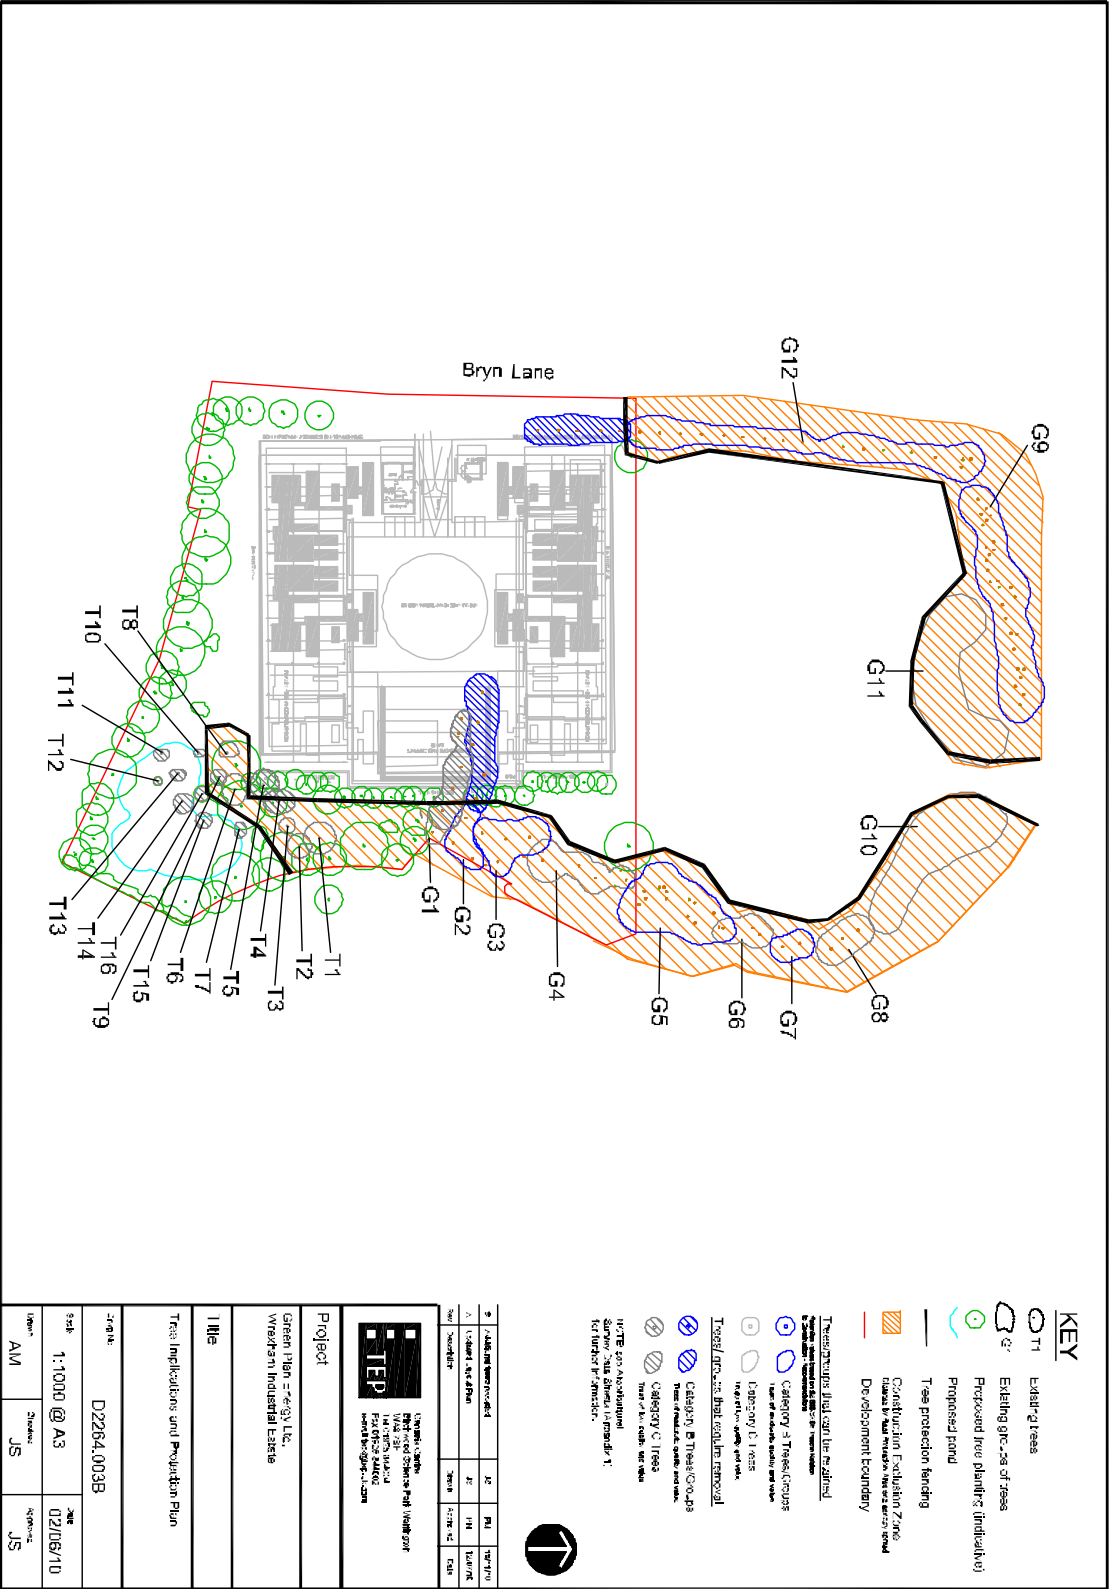
**DRAWING 1**

- 1.4 16 trees (T1-T16) and 12 groups of trees (G1-G12) were surveyed and mapped (Drawing 1). All arboricultural information recorded during the survey is presented at Appendix 1.

- 4.6 Tree and group locations, their quality categories and canopy spreads are shown on Drawing 1.

- 5.4 The **RPA** for trees on site has been used to inform the **Construction Exclusion Zone (CEZ)** shown on Drawing 1. Where deemed appropriate this has included an extension of the **RPA** to include the canopy to prevent it being damaged by construction machinery.

**TREE IMPLICATIONS AND PROTECTION PLAN**

- 6.5 It is the recommendation of this report that the proposed tree loss can be adequately mitigated for through a replacement planting scheme similar to that indicated on Drawing 1, provided that trees of a suitable size, quality and species are selected. This should include species of varied ultimate size and height, incorporating where possible the larger tree species with the potential to provide benefit beyond their immediate environment and to a more diverse range of ecology (for example oak, lime, beech, ash etc.).

- 7.6 An **Arboricultural Method Statement (AMS)** will be required where construction activities cannot be avoided within the **CEZs** shown on Drawing 1. The **AMS** will detail 'special mitigation construction and procedure' that will minimise damage to tree roots and the surrounding soil.

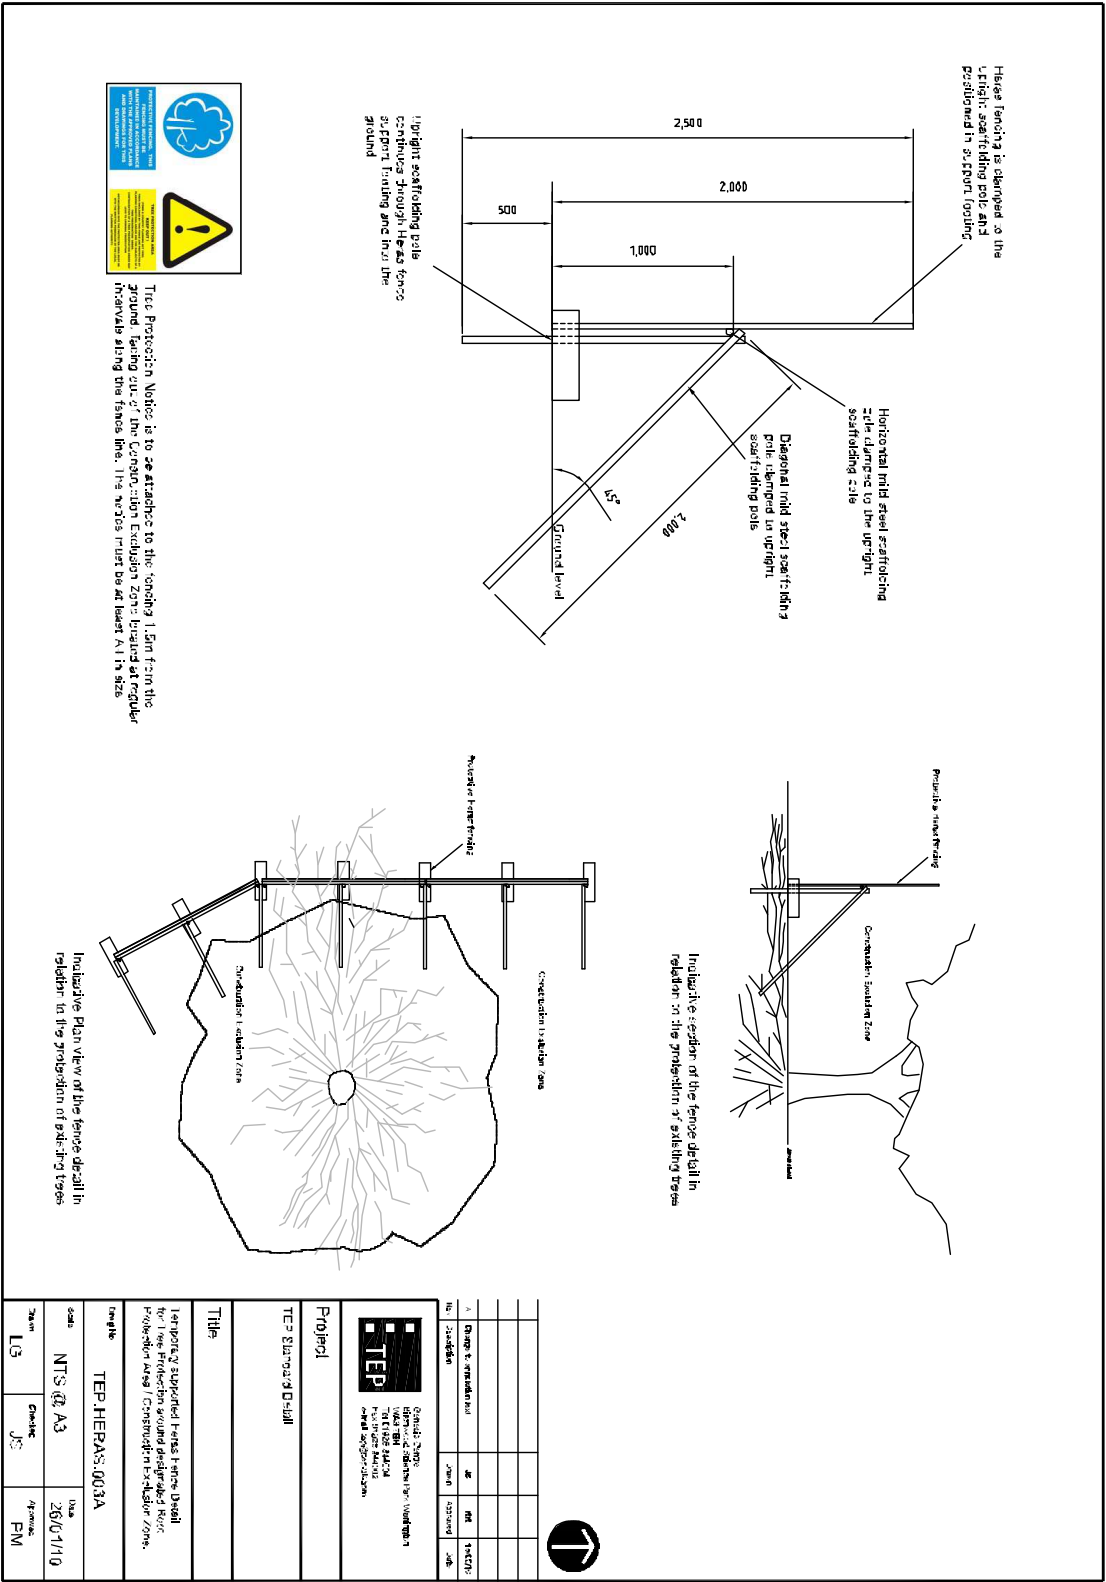
**DRAWING 2**

- 5.6 The fencing must be fixed into the ground to withstand accidental impact from machinery and to ensure that a sufficient protective area is maintained. Details of the recommended Heras protective fencing are shown in Drawing 2.

**RECOMMENDED TREE PROTECTION FENCING**

- 7.4 Groups G3 and G4 were found to have features of a size and condition desirable to bats.
- 7.5 Protective barrier fencing will be required to demarcate a **Construction Exclusion Zone (CEZ)** around retained trees prior to the commencement of development. Fencing alignment is shown on Drawing 1 and details of the recommended Heras fencing are shown on Drawing 2.
