## **PROTECTED SPECIES SURVEY**

**BRYN RHUG FARM**

**THE WERBOL, WREXHAM**

**18<sup>th</sup> August 2010**

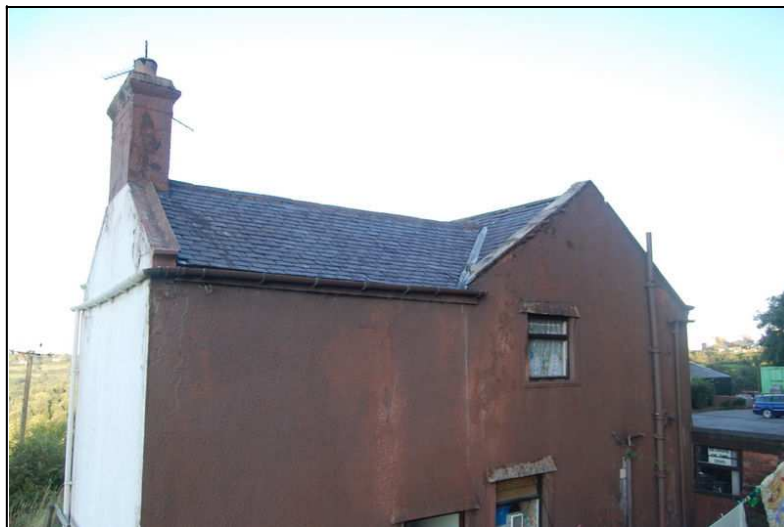
4. West elevation

No evidence of bats was found anywhere inside or outside of the house. No droppings were apparent on any of the cobwebbed areas in the loft and there were no signs of feeding perches. The external walls are fully rendered and do not support any gaps which could be used by bats.

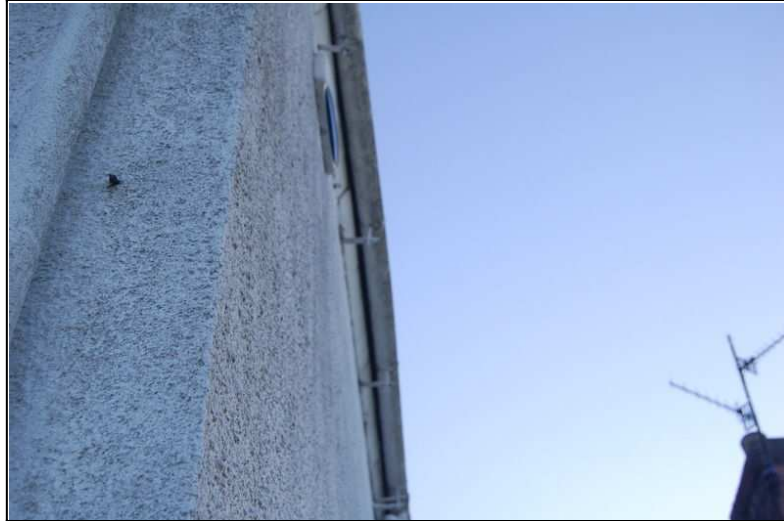
The serious cobweb infestation within the loft space would act as a deterrent to roosting bats. The cobwebs would also have the advantage of catching any droppings left by bats. In this situation any droppings would remain for a long period of time enabling any evidence of previous roosts by bats to be identified. The general absence of soffits and fascia boxes will further reduce the roosting potential of this building because these features can often provide a refuge for certain species of crevice dwelling bat.

**5. Tight fitting barge boards**

- ☐ The roof tiles should be removed by hand to ensure that no torpid or hibernating bats are injured during the proposed works.
- ☐ Door and window frames should be removed with care to ensure that no torpid or hibernating bats are injured during the proposed works.
- ☐ Structural members, lintel bearings, purlins or wall plates should be removed with care to ensure that no torpid or hibernating bats are injured during the proposed works.
- ☐ In the event that bats were found during the conversion then all work should cease and CCW (Mold office) and/or a licensed bat worker should be contacted for further advice.
