**THE BRYN  
Nr PENLEY, WREXHAM**

**BAT, BIRD AND AMPHIBIAN ASSESSMENT**  
(Doc Ref: TEP 2278.001C)

**March 2010**

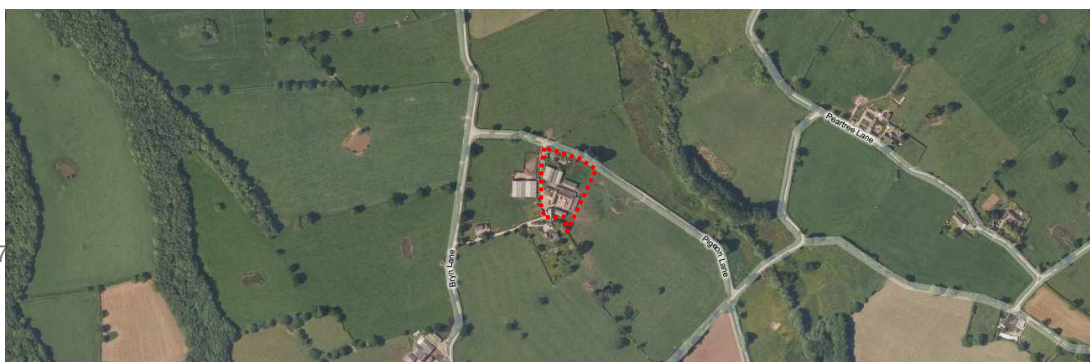
- 3.1 The Bryn is on Pigeon Lane, Hanmer, Whitchurch, Shropshire. The site is comprised of farm buildings, associated hardstanding and a small area of pasture land. The site is surrounded by pasture land as illustrated in Figure 1.

*Figure 1: Aerial photograph of the site and surrounding area*

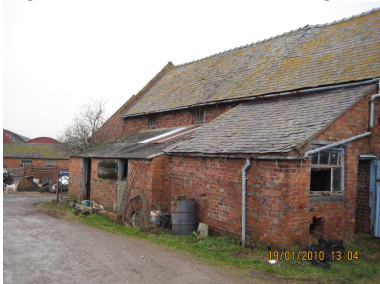
Figure 2: Exterior of building 1

- 5.2 Building 1 is a brick building with a pitched slate roof and gable ends (Figure 2, below). The ground floor is used as stables and the upper floor is a hay loft that is open to the roof (Figure 3, below).
- 5.3 There is an open hatch on one of the gable ends of the building. There are some slipped roof slates. The building has drain pipes at the eaves. There are a number of windows that have had the glass smashed. There are a number of holes in the bricks and mortar. The roof is constructed of wooden beams with no underlining (Figure 3, below).

- 7.3 Mitigation measures are to be built into the proposals which satisfy the need for suitable avoidance with confidence. Refurbishment of buildings 1 and 4 will provide roost enhancement through the creation of additional habitat roost crevices and ensuring multiple access points at ridge, eaves and gables. Roost crevices will be created through the provision of extra battens attached to purlins to create a gap of 20 – 25 mm between them. Roost boxes will be created by fixing boards (400 mm minimum height and width) across two or three purlins. Roof lining is to be replaced with traditional black bitumastic felt liners with small slits or flaps (30mm x 30mm) to ensure access into the roof.

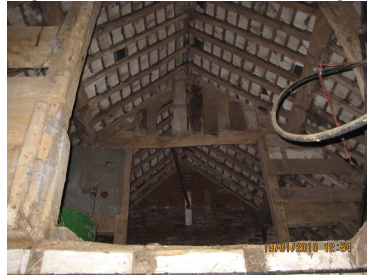
Figure 3: Loft void of building 1

- 5.4 No bats or evidence of bats such as droppings/ urine stains was found during external/internal inspection of this building. This building has potential to support roosting bats, associated with the open windows, slipped roof slates and gaps in brickwork which could allow bats to access the loft void or provide crevice roosting opportunities.
- 5.5 Building 2 is a brick building with a rounded corrugated metal roof (Figure 4, below). The building is open on one side and does not have any windows. The building is open to the roof and does not have any loft voids. The building is used for storage of farm materials. No bat field signs were identified and the building is considered to have low potential to support roosting bats.

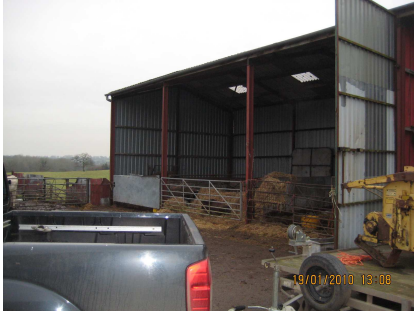
*Figure 5: Exterior of building 3*

- 5.6 Building 3 is a metal framed barn that is open on one side (Figure 5, below). The building is open to the roof and does not have any loft voids. No bat field signs were identified during the survey and its construction is such that it has very low potential to support roosting bats.

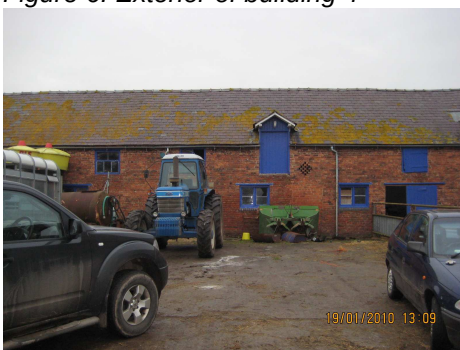
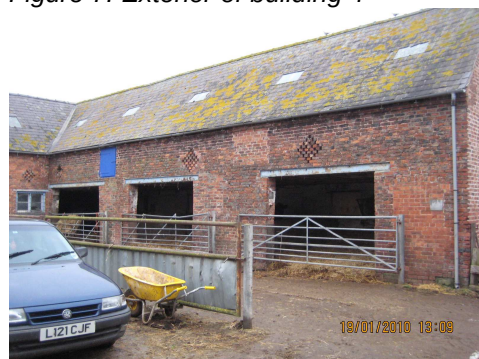
- 5.7 Building 4 is a 'C shaped' brick building with a pitched slate roof and gable ends, surrounding a hardstanding yard (Figures 6 and 7, below). The building has a single upper floor that is open to the roof (Figure 8, below). The ground floor is used as stables and the upper floor is used partly for storage and partly as a hay loft. There are some slipped roof slates. The building has drain pipes at the eaves. There are no other eaves features such as barge boards. There are a number of windows that have had the glass smashed. There are a number of holes in the bricks and mortar. The roof is constructed of wooden beams with felt underlining.

*Figure 6: Exterior of building 4*

*Figure 7: Exterior of building 4*

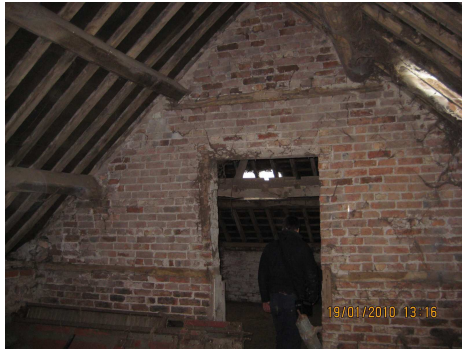
*Figure 8: Loft void of building 4*

5.8 No bats or evidence of bats such as droppings/ urine stains was found during external/internal inspection of Building 4. This building has potential for roosting bats associated with the open windows, slipped roof slates and gaps in brickwork which could allow bats to access the loft void or provide roosting opportunities.

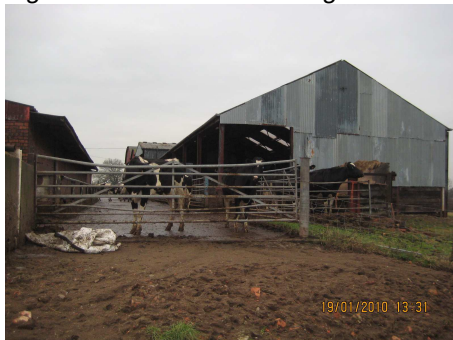
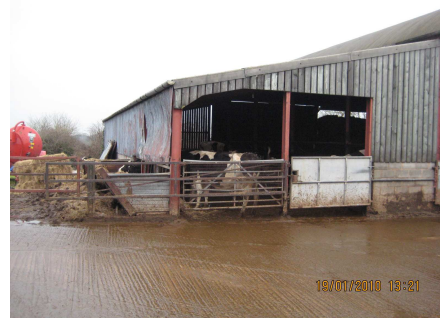
5.9 Building 5 is a metal framed barn that is open on one side (Figure 9, below). The other three walls of the barn are constructed of open-board vertical wooden panelling (Figure 10, below). There is no weatherboarding associated with the eaves of the barn and there are no crevices associated with the roof or eaves of the barn. The barn is open to the roof and does not have any loft voids. The open wooden panels would allow wind and, to a degree, rain to pass through the gaps between vertical planks. Internal inspections of this building could not be undertaken due to the presence of cattle. However due to the structure of the building it is considered to have very low potential to support roosting bats.

Figure 9: Exterior of building 5

Figure 10 Exterior of building 5

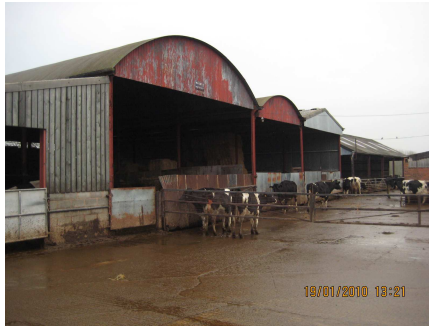
Figure 11: Exterior of building 5

5.10 Building 6 is a collection of consecutive barns that have asbestos roofs and wooden sides (Figure 11, below). The barns are open to the roof and do not have any loft voids. There is no weatherboarding associated with the eaves of the barns and no crevices associated with the roof or eaves of the barns. Internal inspections of this building could not be undertaken due to the presence of cattle. However due to the structure of the buildings they are considered to have very low potential to support roosting bats.

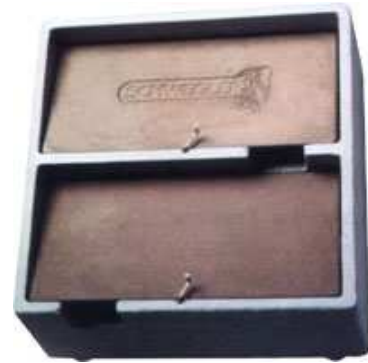
A02088 Schwegler No 16 IMF Swift Box, Double Chamber

Dimensions 460mm h x 430mm w x 225mm d

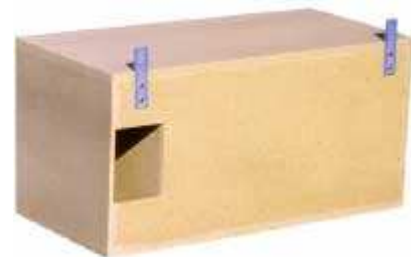
Ref: 002036D Schwegler No 23 Barn Owl Box

Entrance hole : 14 x 19 cm

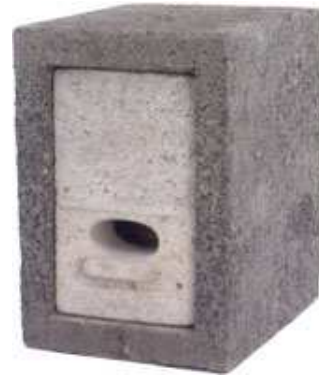
#### No 750/6 Bat tube

This long box can be installed within brick masonry, beneath plasterwork or wood panelling, or incorporated into concrete structures such as factory buildings or bridges. Inside it contains a woodcrete surface, a roughened wood board, and a metal mesh, providing a choice of roosting areas depending on the weather conditions and the bats' habits. This box is maintenance-free as the entrance slit is at the bottom, allowing for self cleaning. *No painting required, but if painting is necessary a natural breathable paint should be used*

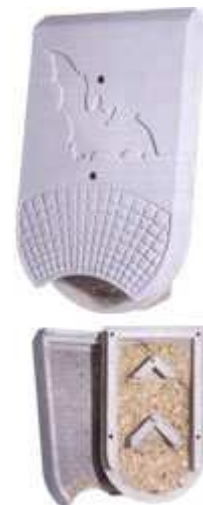
A02092 **Schwegler 1FQ Bat Box**  
£55.28 £64.95 inc VAT

Woodcrete (75% wood sawdust, concrete and clay mixture)  
Height 565mm; Width 350mm Depth 85mm Weight 13kg
