## **PROTECTED SPECIES SURVEY**

**ALTHREY FARM, BANGOR ON DEE**

**WREXHAM, LL13 0DA**

**17<sup>th</sup> September 2010**

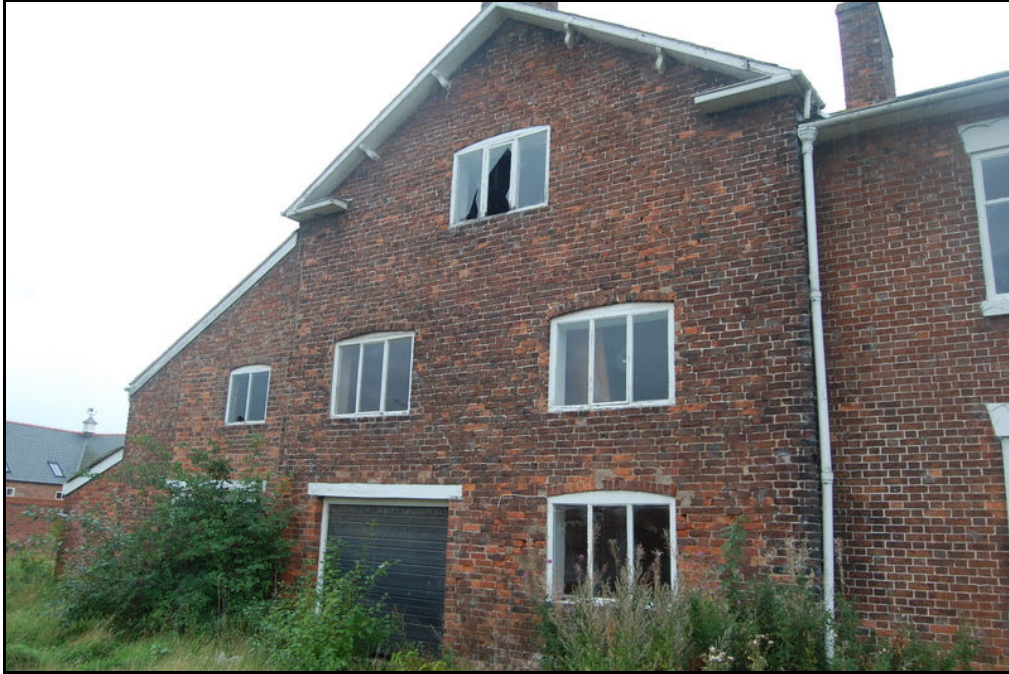
**1. Three storey section where the ceiling has collapsed – the roof void in this section will be converted**

There are two attic areas, one above each section of the house, both have exposed timbers. The attic above the two storey section is the largest and most intact while part of the other attic is now exposed where the ceiling has collapsed. The roof was apparently in a poor condition and had several holes where tiles had fallen off; these have only just been fixed to make the building more watertight. Even now the roof is quite airy with light coming in from underneath loose tiles and other gaps. Some of the timbers showed evidence of rain penetration and damp although generally the roof is quite dry.

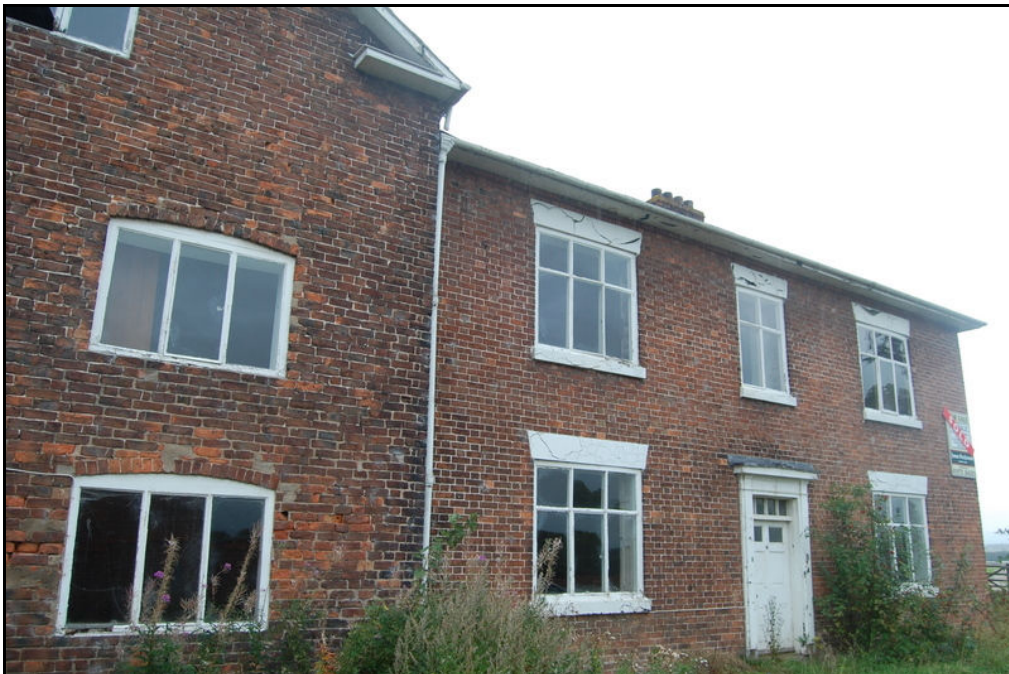
**2. Two storey section on the right where the roof void/attic will remain**

- If at some point the roof needs to be replaced use traditional bitumen roofing felt rather than plastic membrane which bats have difficulty gripping onto. This only needs to apply to the two storey section as the attics in the three storey section may be extended into accommodation/offices.

- Install 300mm of mineral insulation between the joists at ceiling level.
- Install three or four of the ridge tiles using option A or B in the attached example to allow bats access into the roof void (on the two storey section).

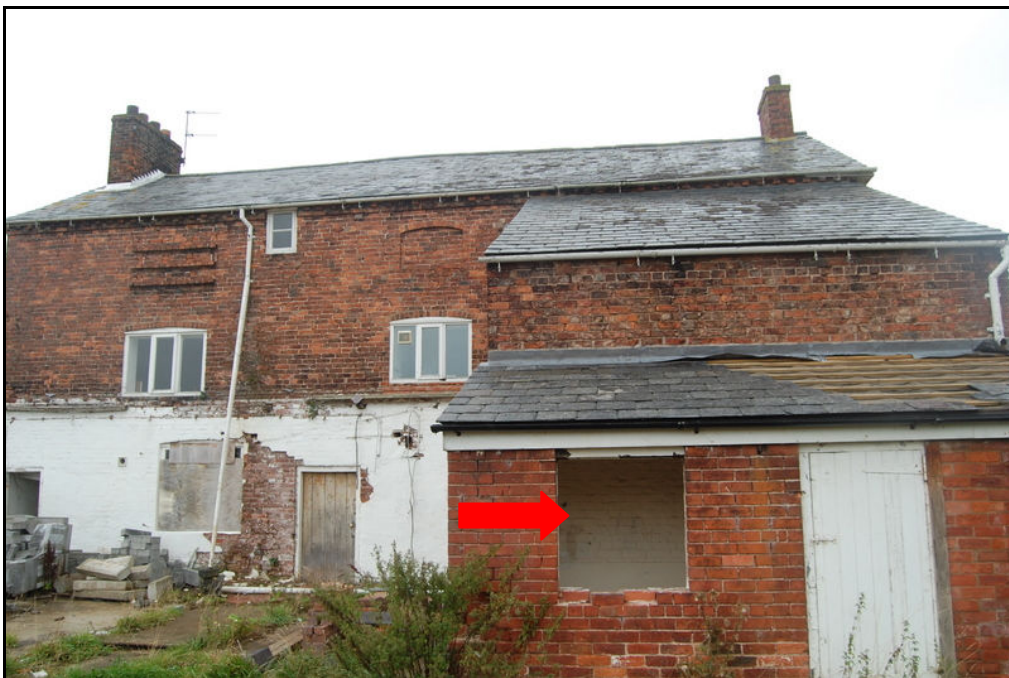
### 4. Rear elevation – swallows have used this former toilet

**Three swallow nests were noted within the small lean-to at the rear, also house martin nests under the roof overhang on the gable ends.**

**It will not really be possible to mitigate for the loss of swallow nest sites because of the nature and design of the property and there are no suitable outbuildings which can be used. In respect of house-martins they can still continue to use the overhangs on the gable ends.**

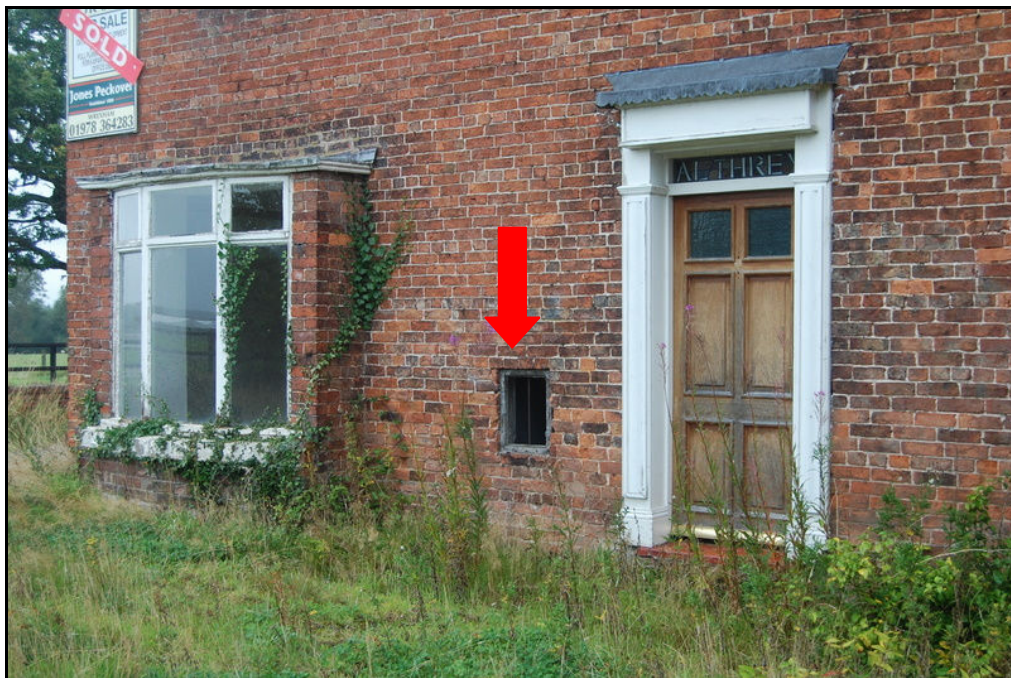
## 6. Hole next to the door leads into the cellar – ventilation panel is absent

The various fireplaces throughout the house were viewed and there did not appear to be any evidence such as piles of droppings or dead bats which are sometimes found in these locations. The cellar was inspected (which is actually quite small compared to the size of the house) but no evidence was found to suggest any use by hibernating bats. The cellar is actually quite damp and at present is not really suitable as a hibernacula.

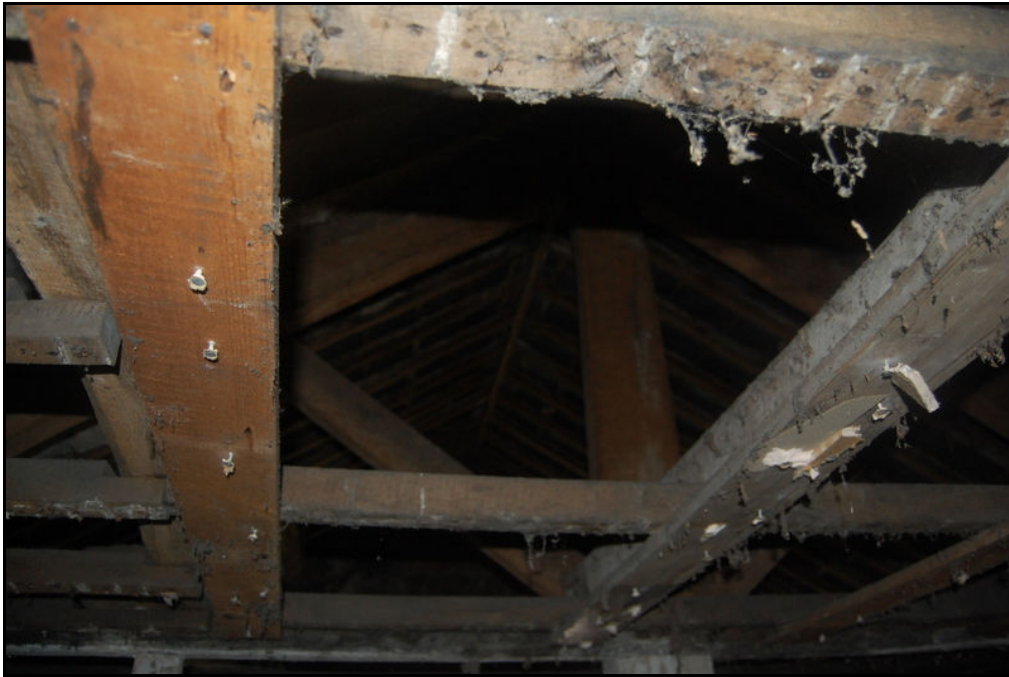
**7. Ceiling which has collapsed**

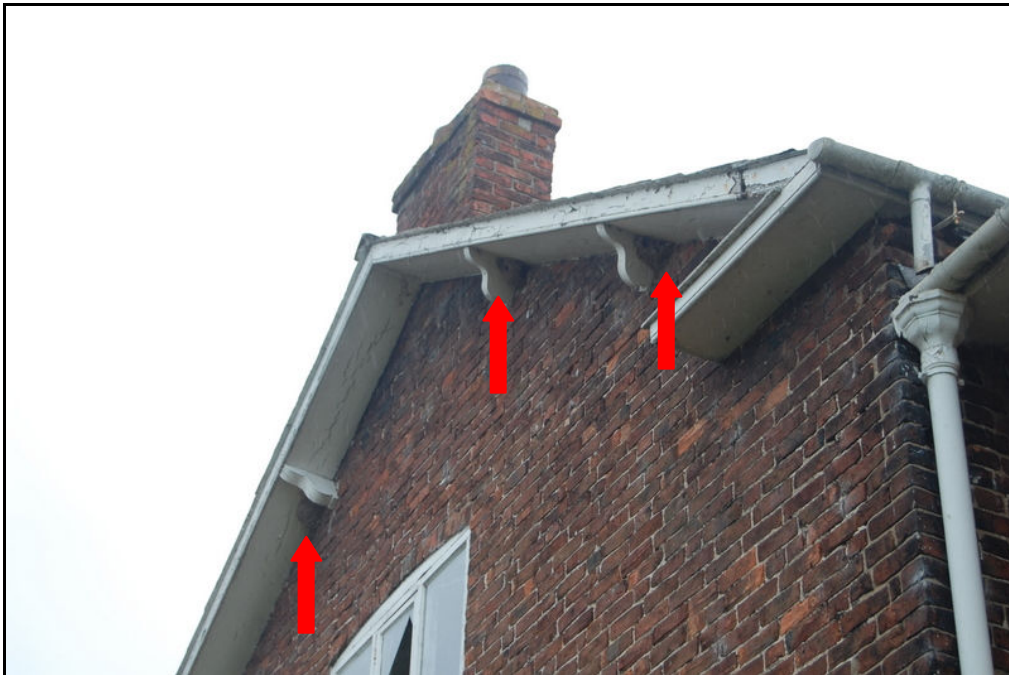
**8. Overhangs on gable ends which are used by house martins**
