**Bat assessment**  
**of a**  
**farm outbuilding at**  
**Blaen Cwm Llawernog**  
**Llanarmon Dyffryn Ceiriog**  
**Wrexham**  
**Grid reference SJ 1338 3420**  
**Visited on 20/7/09**

# **Bat assessment**

## **Farm outbuilding at Blaen Cwm, Llanarmon Dyffryn Ceiriog, Wrexham**

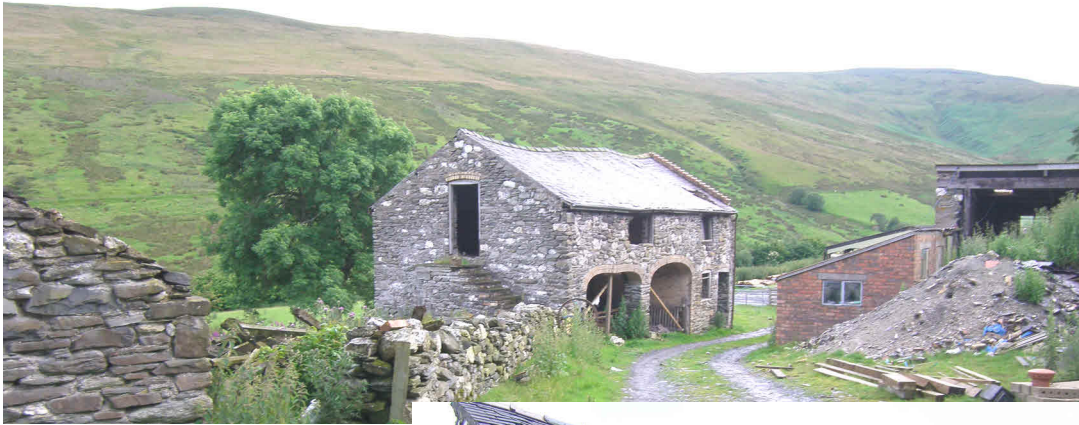
Looking west  
towards the  
implement shed

Inspection of  
the implement  
shed

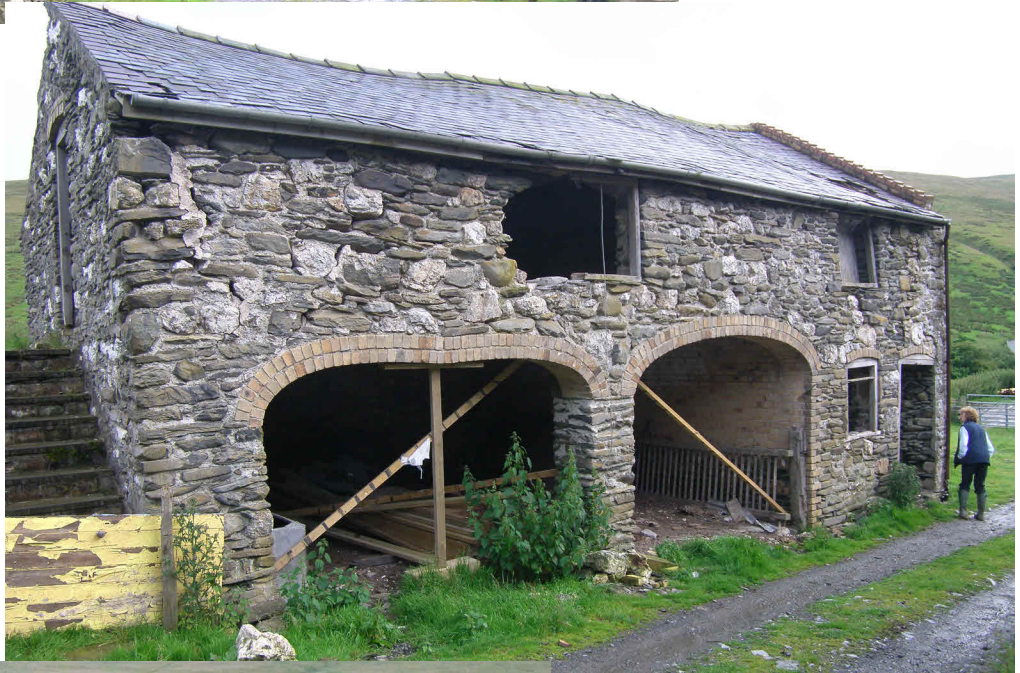
The building in question is a stone-built implement shed with a loft over, to the south of the farmhouse. Most of the ground floor is open to the north. The floor of the loft was in poor condition, and partially collapsed, and the loft was not entered. There was a large gap in the slate roof, which was in a state of collapse at its west end.

The roof is  
badly holed

However, it is not possible to be certain that bats will not hibernate or roost in crevices in the structures. Therefore, no crevices or gaps which cannot easily be seen to be empty should be filled between October and March, inclusive.

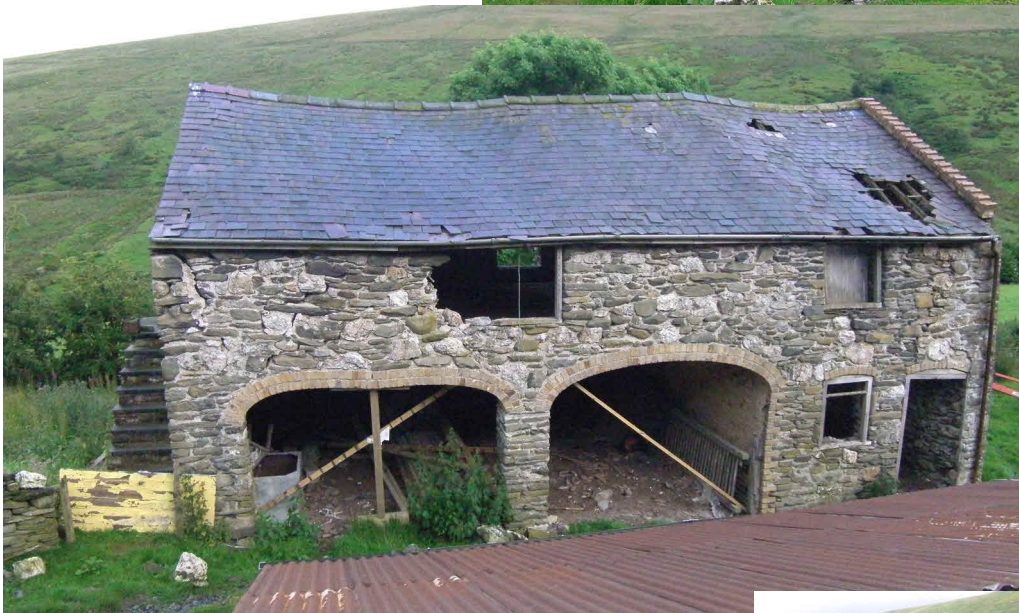
West end from the northwest.  
Main house with implement shed  
behind (arrowed)
