**LAND AT ROYAL BRITISH LEGION, LLAY,  
WREXHAM**

**BAT SURVEY**

**2021**

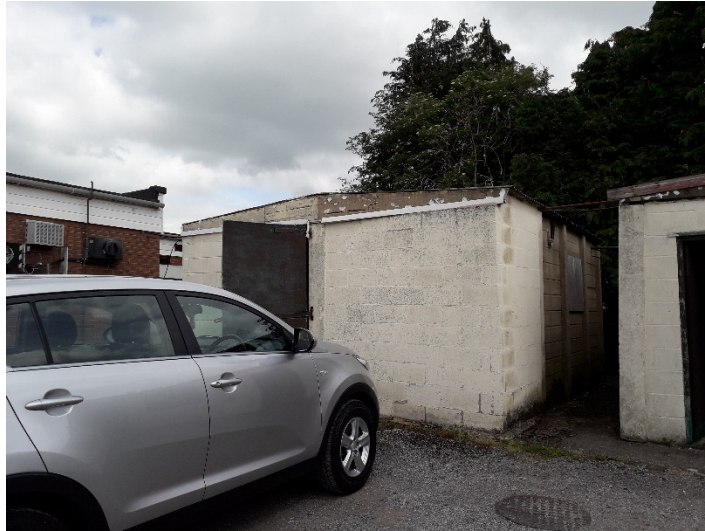
- 4.2 Building 1 was a single storey building with a gently pitched roof of corrugated material which could have been asbestos. The roof was unlined internally, with the corrugated sheets set on top of a steel frame. The walls were predominantly of single skin concrete slabs. There were several access points inside the building at eaves level but potential roost features (PRFs) were lacking and there was no evidence of bats within the building.
- 4.3 Building 1 has Negligible bat roost potential and is due to be demolished.

**Plate 1: View of Building 1**

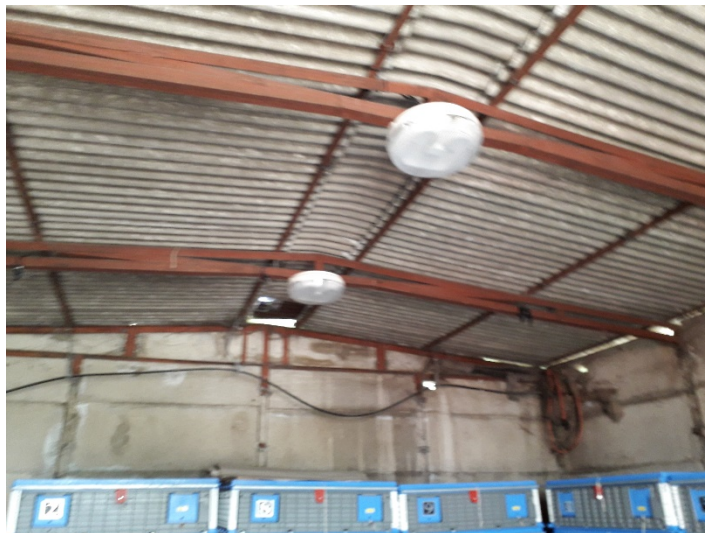
**Plate 2: Internal view of Building 1**

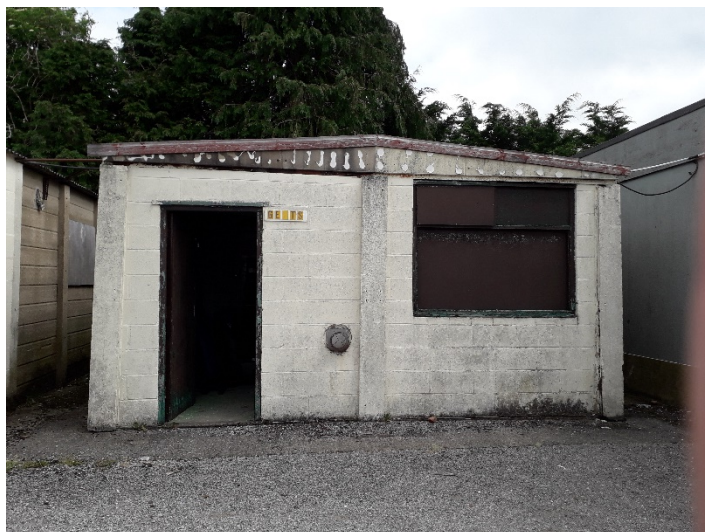
- 4.4 Building 2 was of a similar construction to Building 1, being single storey with a gently pitched roof of single skin corrugated material. There were windows on both the south-western and south-eastern aspects.

- 4.5 The south-western window was boarded on the inside and there was no glass or PRFs (bats are known to roost between boarding and glass windows). The window on the south-eastern aspect was also missing but blocked up with blockwork. There was a wide gap between the window and a single skin blockwork wall which was inspected. It was full of cobwebs and was well lit and not considered to offer a suitable roost feature. The blockwork was sealed at the top with a single row of bricks.

**Plate 3: View of Building 2**

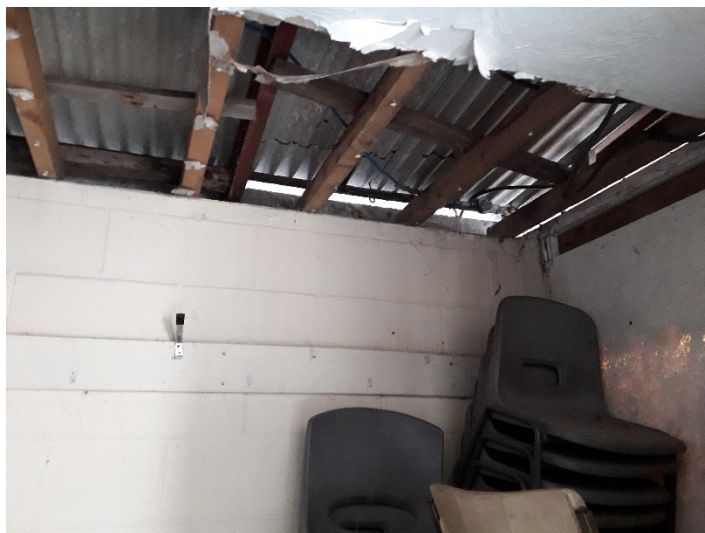
- 4.6 Internally the ceiling was boarded, though with large areas of missing boarding. No evidence of bats was recorded.
- 4.7 Building 2 has Negligible bat roost potential and is due to be demolished.

**Plate 4: Internal view of Building 2**

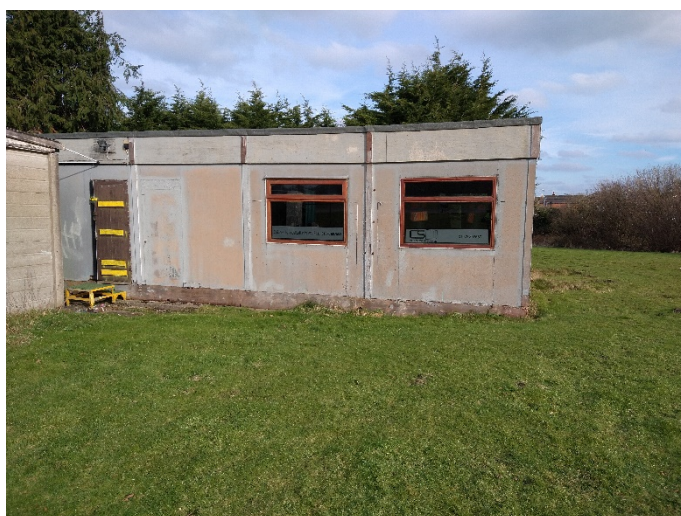
- 4.8 Building 3 was a flat roofed, single storey building currently used as a boxing club. It had a felt roof and several external windows which were well sealed.
- 4.9 There was wooden fascia boarding along the entire roofline of the building, which the roof felt lapped over. The boarding was warped in places, but for the most part was in good condition. Along both the north-eastern and south-western aspects there were numerous vents/holes at the base of the boarding, allowing access into the gap between the boarding and the external wall of the building. These gaps were approximately 6cm long by 1-2cm wide. Some of the vents were covered with cobwebs but others were clear and inspection with an endoscope did not find any evidence of bats but did confirm access into a potentially suitable cavity for roosting.

**Plate 5: View of Building 3**

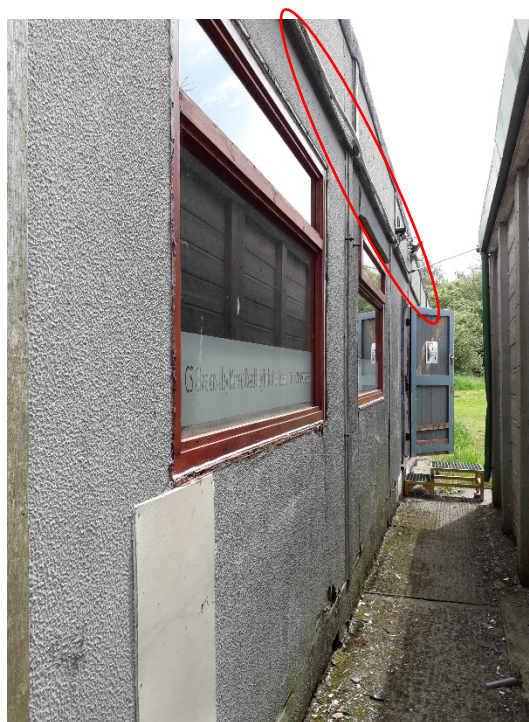
**Plate 6: View of Building 3 (L) and location of several PRFs.**

- 6.5 If demolition or the moving of Building 3 has not taken place within one year from the date of this survey, then the building should be reassessed for its potential to support roosting bats prior to disturbing works taking place.

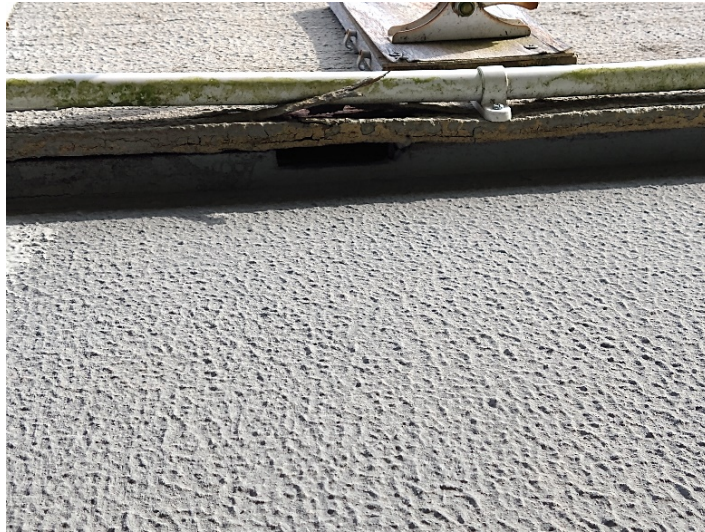
- 5.3 Building 1, 2 and 4 are of Negligible suitability for roosting bats, and the loss of these buildings will not impact upon bats.
- 5.4 Building 3 has Low suitability for roosting bats with potential roosting features found beneath bargeboards. A roosting status of 'likely absent' has been concluded following the findings of the dusk emergence survey.

**Plate 7: View of one of several potential roost features beneath barge boarding (Building 3)**

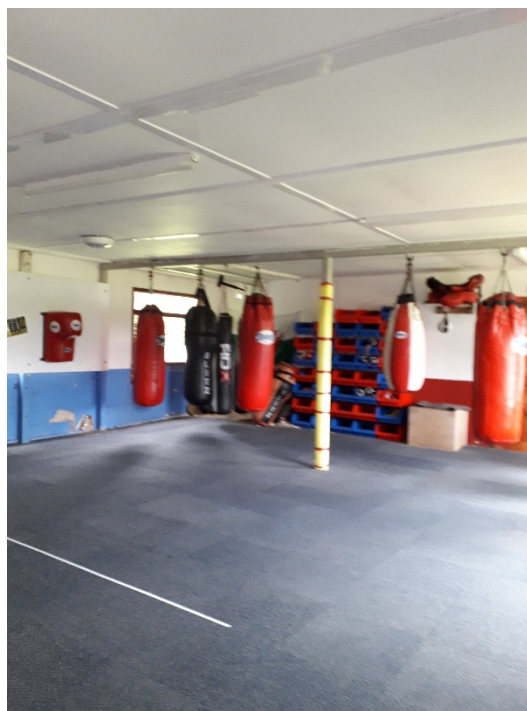
- 4.10 Internally the ceiling was boarded, but there was a hole in the boarding revealing wool insulation lining the gap between the roof and internal boarding.
- 4.11 Building 3 has Low bat roost potential and is due to be moved to another area of the site. The building was subsequently subject to a dusk emergence survey.

**Plate 8: Internal view of Building 3**

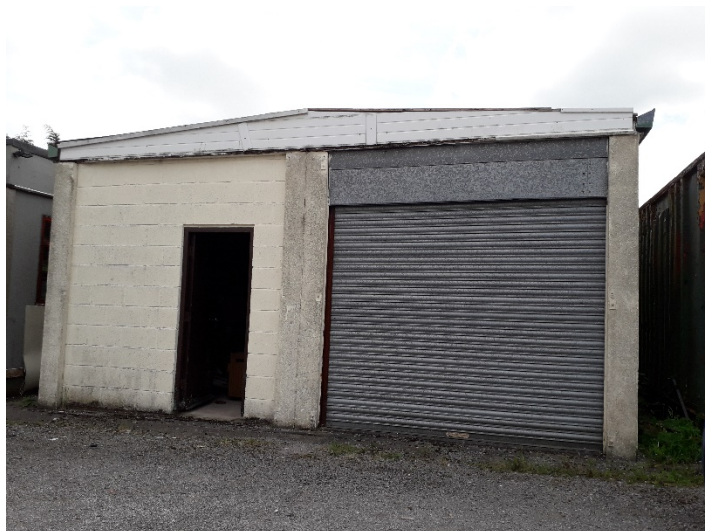
- 4.12 Building 4 was of a similar construction to Buildings 1 and 2. It has a gently pitched corrugated roof which was unlined and had sky lights, making the interior well lit. Walls were of a single concrete slab construction overlaid on a steel frame.
- 4.13 No evidence of bats was recorded.
- 4.14 Building 4 has Negligible bat roost potential and is due to be demolished.

**Plate 9: View of Building 4**

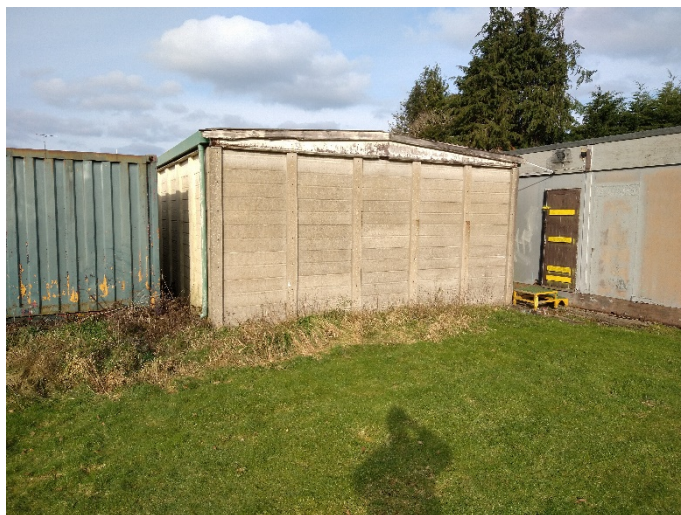
**Plate 10: View of Building 4**

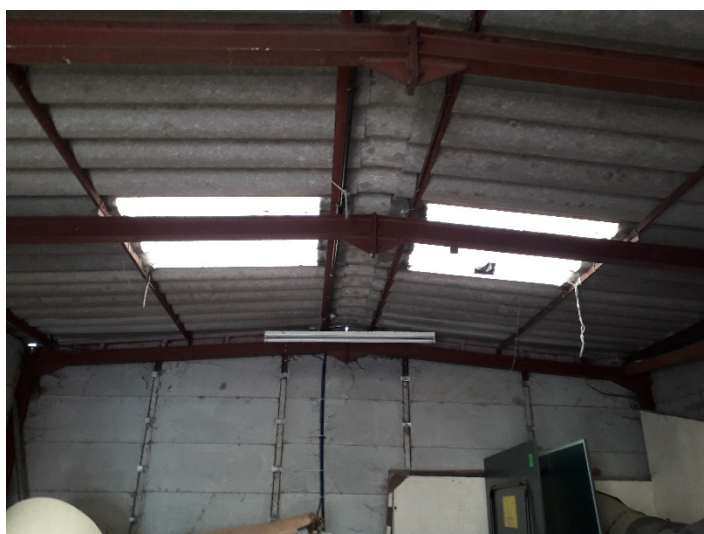
**Plate 11: Internal view of Building 4**

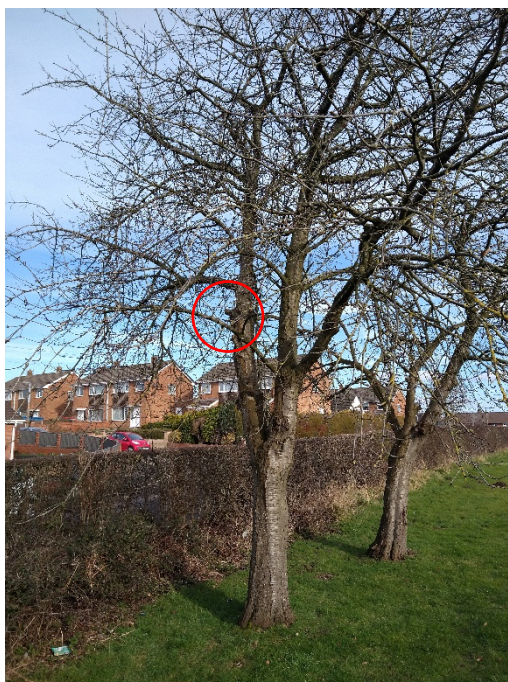
- 4.16 A single cherry tree present along the sites northern boundary had a lifted area of bark on the south-western elevation at approximately 4m high. Close inspection via ladder revealed a smooth sided cavity, open on one side. The entry point was approximately 15cm long, and ranged from 1 to 3cm wide. The cavity was smooth and dry, travelling back to approximately 10cm. There was no evidence of bats recorded and the cavity was considered to be relatively exposed but may offer a transient roost site. It was fully inspected and no bats were found.
- 4.17 The cavity was considered to offer Low bat roost potential.

**Plate 12: View of cherry tree with potential roost feature highlighted**

- 6.4 Bat roosting in trees is often extremely transient and evidence of bat roosting in trees does not persist like it does within buildings due to environmental factors. It is therefore recommended that the cavity within the cherry tree be subject to a pre-start check by a licensed bat ecologist immediately prior to the tree being felled.

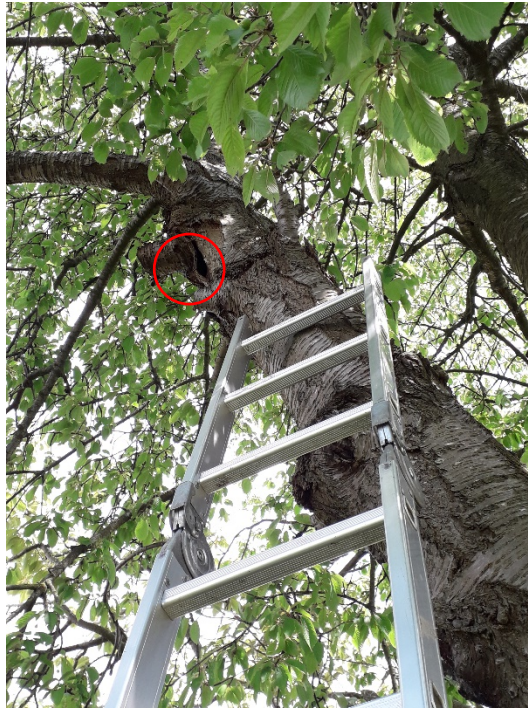
**Plates 13: View of PRF from ground**

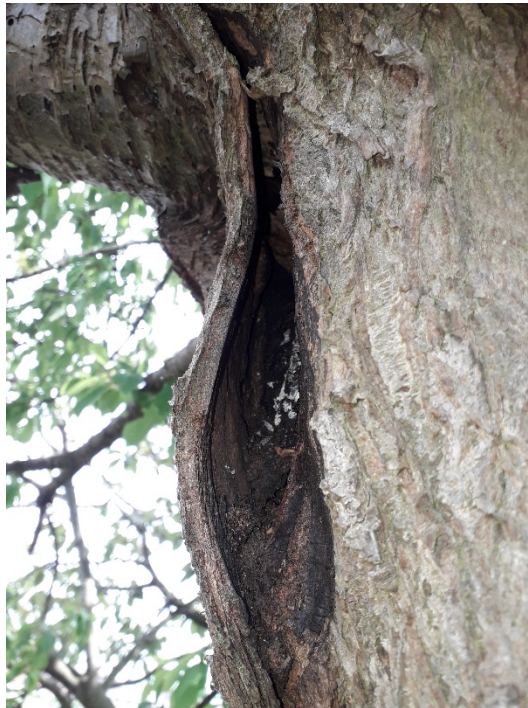
**Plate 14: Close up view of PRF with Low bat roost potential**
