## Template Method Statement to be used within a Bat Development Licence Application

| Method Statement Title: | Pigeon House |
| Site Address: | Pigeon House, Hanmer |

Part of a redundant barn range will be renovated into residential accommodation at Pigeon House, Hanmer.

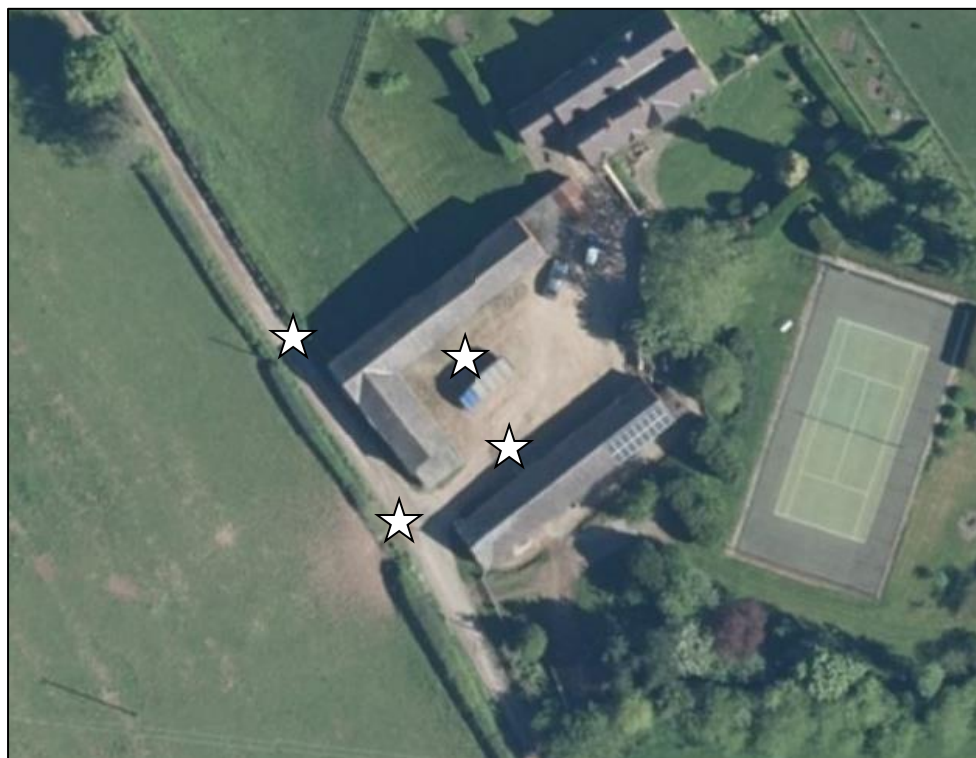
Vantage points used during dusk and dawn activity surveys.

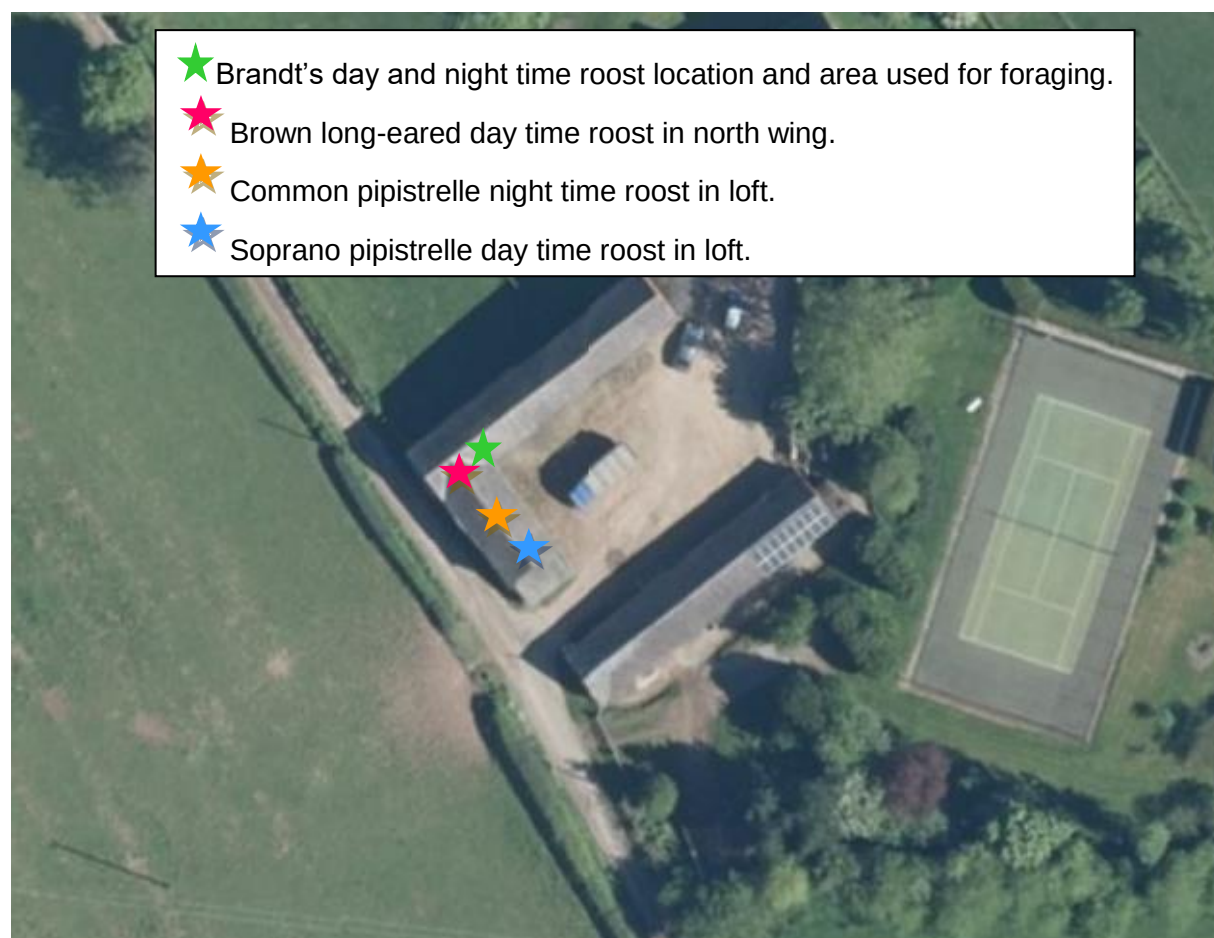
Approximate roost locations for individual species.

A maximum of three common pipistrelles are using the loft above the west wing as a night time roost. Common pipistrelle were found to be resting/sheltering at night time but were not suspected of roosting within the barn during the day time.

A maximum of three soprano pipistrelles are using the loft above the west wing as a day time roost. Internal detectors indicate that soprano pipistrelle were roosting within the barn throughout the day and emerged to feed at night time.

A maximum of one brown long-eared is using the west end of the north wing as a day time roost. A maximum of two Brandt's bats are using the hay loft of the north wing as a day and night time roost. This species was not recorded outside of the barn during the activity surveys. Two Brandt's bats were observed feeding and flying within the hay loft and internal detectors indicate that they were also roosting here during the day time.

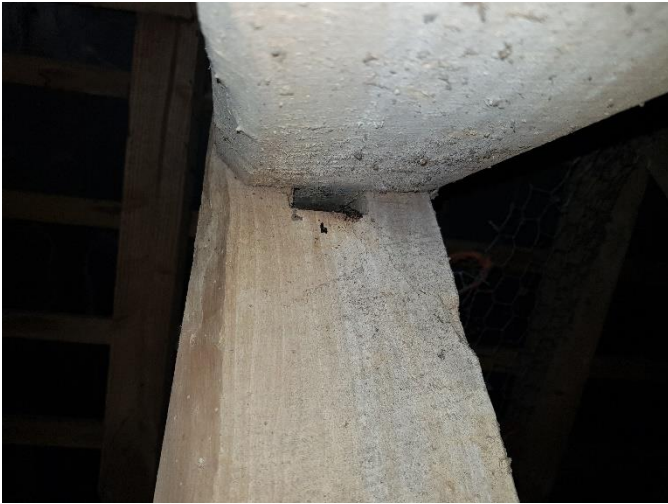
**One of the suspected roosting sites for soprano pipistrelle within the loft above the west wing.**

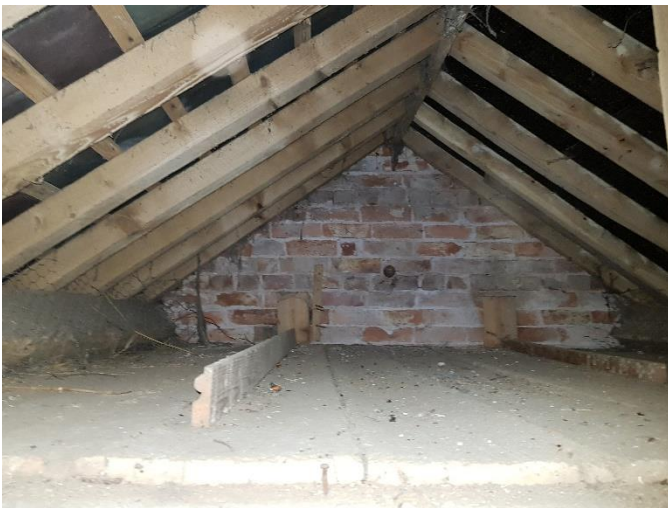
**Enclosed area within loft space above the west wing. Suspected common pipistrelle night time roosting area.**

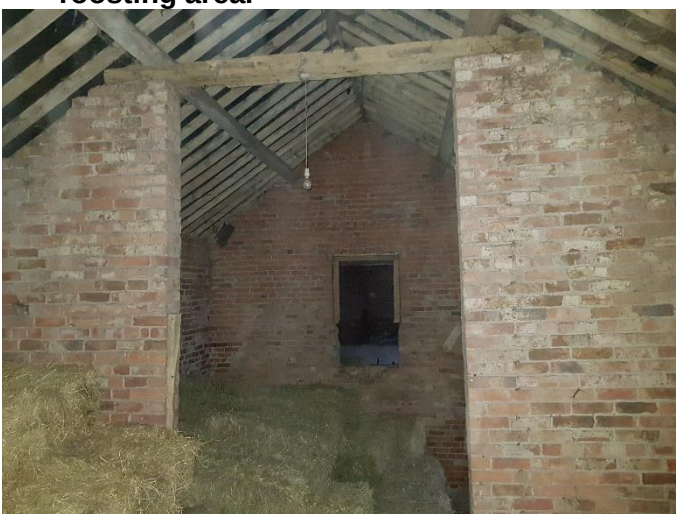
**Hay barn extending into north wing of the barn range. This area was in use by Brandt's bats for foraging and will remain undeveloped but will house the compensatory roost sites.**

A purpose-built bat loft will be constructed in the north wing of the barn range, adjacent to the renovated areas in order to replicate the enclosed loft space to be lost above the west wing. The bat loft will be ready by March 2022 in time for the return of bats from their hibernation sites. The remainder of the north wing will remain open to the rafters as a hay barn to provide vital indoor foraging areas for Brandt's.

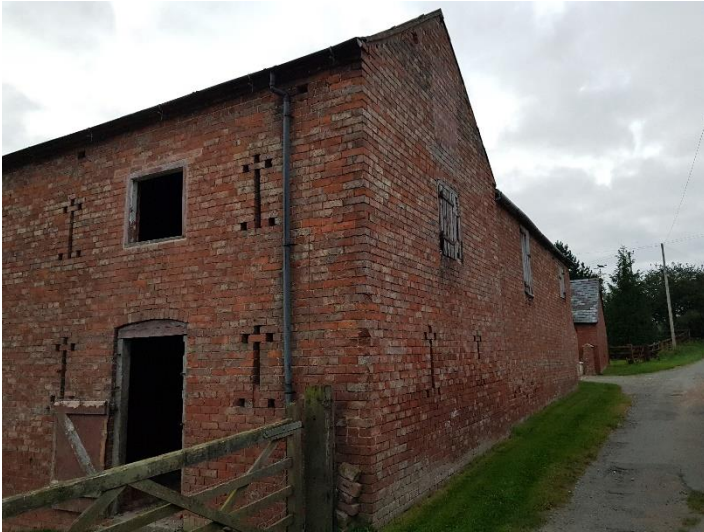
**Lower door used by brown long-eared to enter and leave roosting site. BLE observed flying around within the ground floor section. Common pipistrelle also observed emerging through ground floor door.**

Only the central stall within the ground floor of the barn will be renovated and therefore these areas will remain as potential roosting and foraging sites. Specifically, the ground floor area at the north facing gable where the majority of brown long-eared activity was observed.

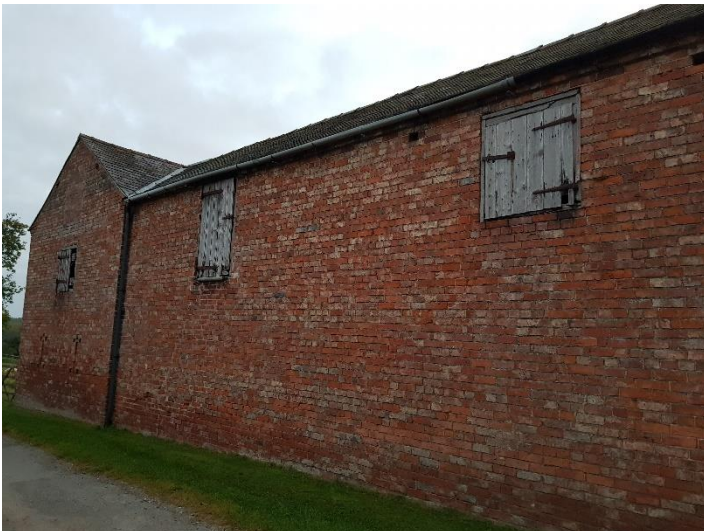
**Soprano and common pipistrelle observed emerging from gaps at the eaves of the barn and re-entering through aeration holes in the brickwork.**

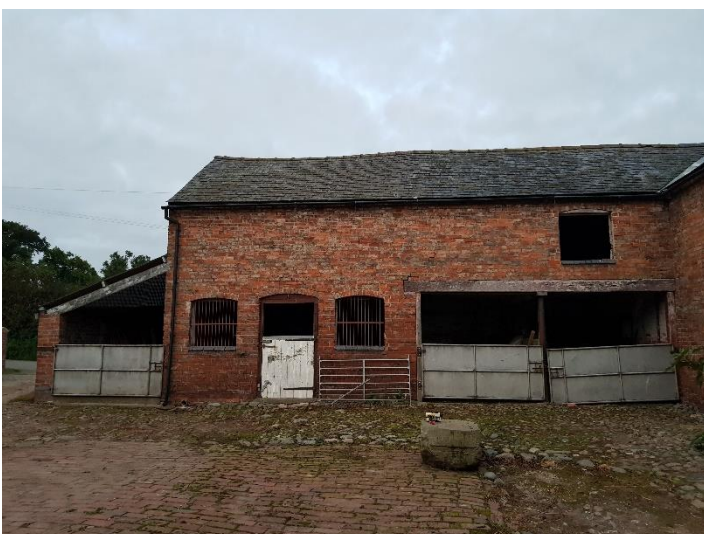
**Single storey lean-to to be removed. Soprano pipistrelle observed emerging from lean-to. Brown long-eared observed entering at top floor window.**

The existing roof of the barn will be repaired which may require partial removal. A single storey lean-to at the south-east facing gable end of the barn will be removed during works.
