Phase II Geoenvironmental Site Assessment  
Proposed Industrial Development,  
Pacific Park, Wrexham

Reference: 14-255-R2-1  
Date: May 2021

## PHASE II GEOENVIRONMENTAL SITE ASSESSMENT

Land to the South of Bridge Road North  
Pacific Park  
Wrexham  
LL13 9PN

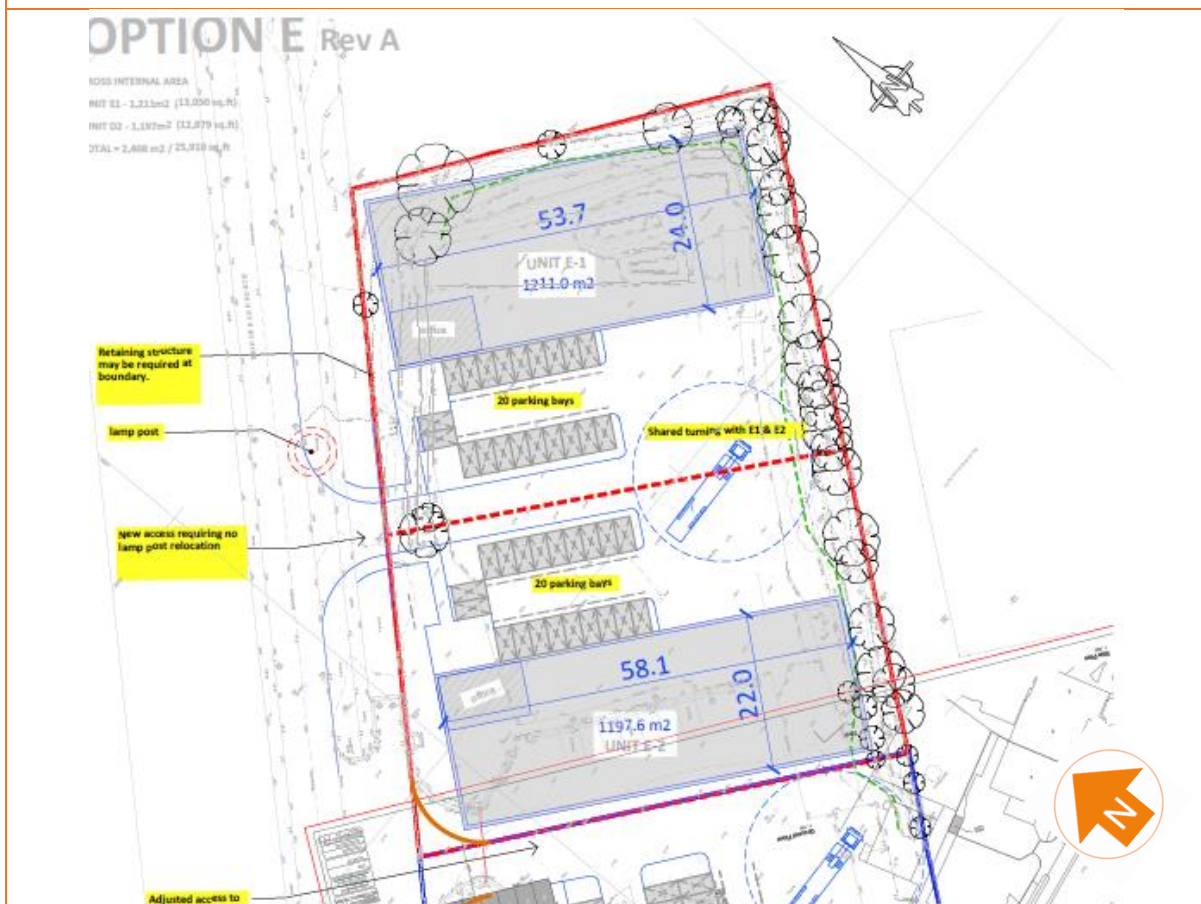
FIGURE 1.1 SNAPSHOT OF PROPOSED DEVELOPMENT

E3P understands that the proposed development will comprise of two industrial units with associated adopted estate roads and utility infrastructure. A snapshot of the proposed development layout is indicated in Figure 1.1.

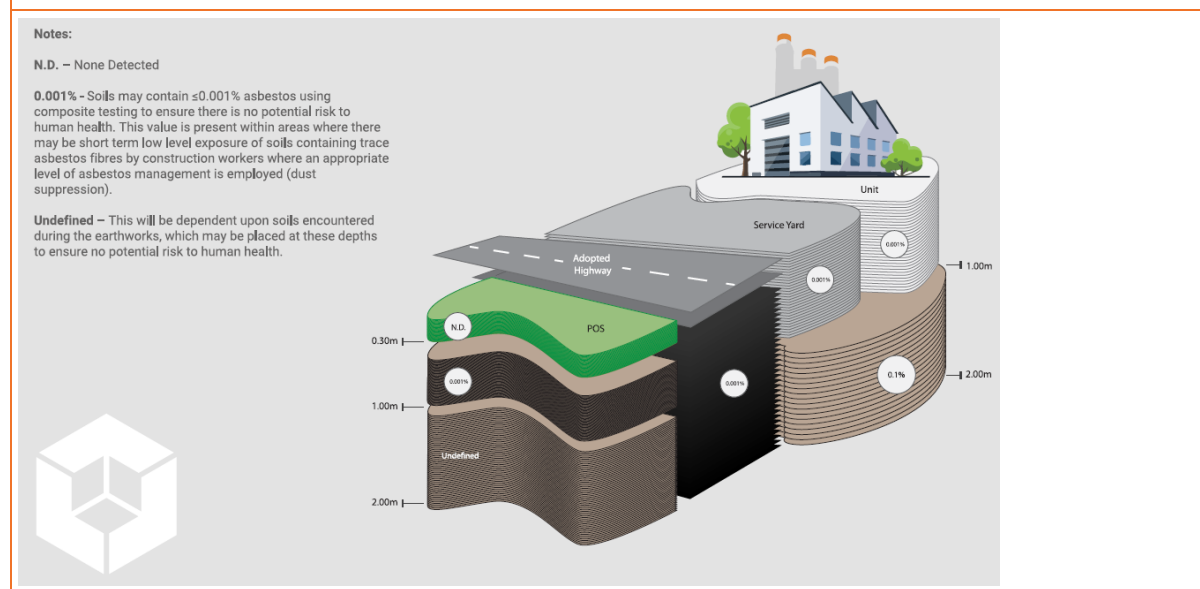
**FIGURE 4.1 ASBESTOS RISK MITIGATION CONCEPTUAL SITE MODEL**

Asbestos has been identified in WS101 and TP108 at a concentration of 0.002%. These areas should therefore be isolated and undergo a phase of delineation and hotspot removal with placement within an area of low sensitivity in line with the asbestos risk mitigation conceptual site model.

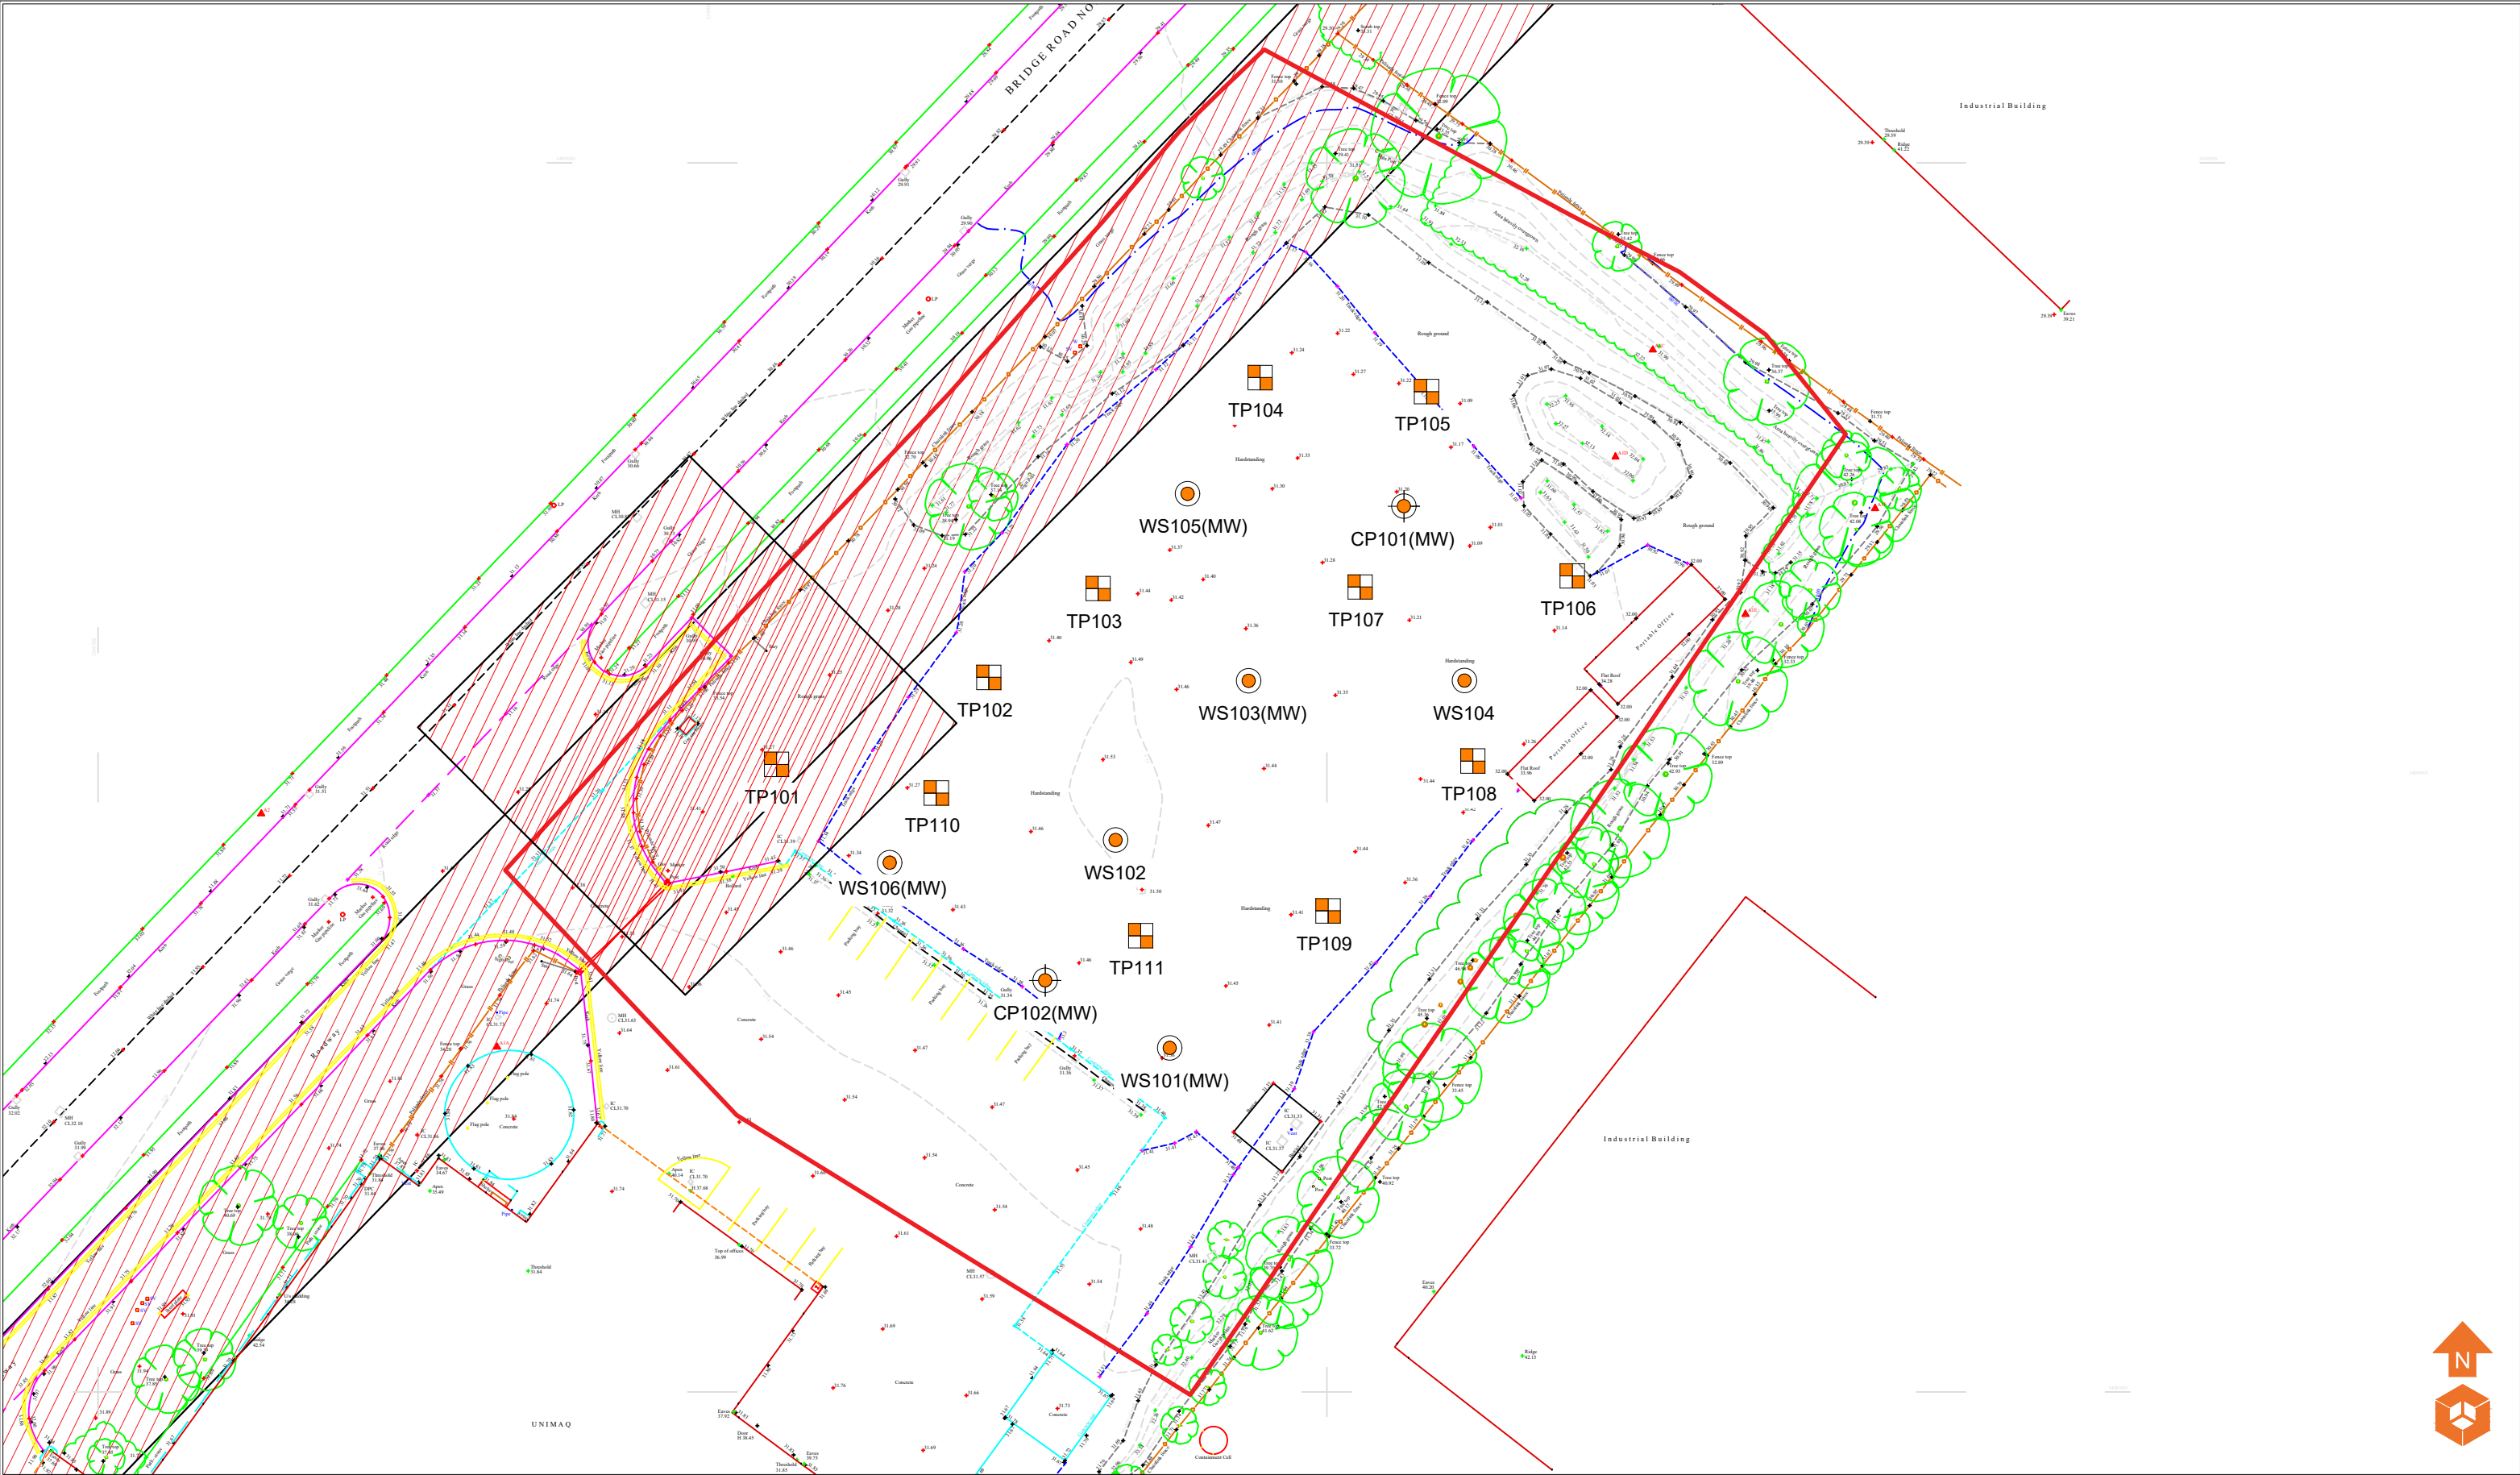
The sampling locations are illustrated in Drawing 14-255-005 (Appendix III). The ground conditions encountered are indicated on the logs, which are provided in Appendix V.

| HOLE | DEPTH TO STRATUM (m bgl) | | |
|---|---|---|---|
| TP111 | 0.00–1.30 | 1.30–2.00 | – |

Mechanically excavated trial pits were advanced to investigate ground conditions and to retrieve environmental samples, spatially distributed to offer the maximum site coverage whilst also being advanced to target specific contaminant sources.

Cable percussive boreholes were advanced to investigate deep ground conditions and undertake in-situ detailed geotechnical testing.

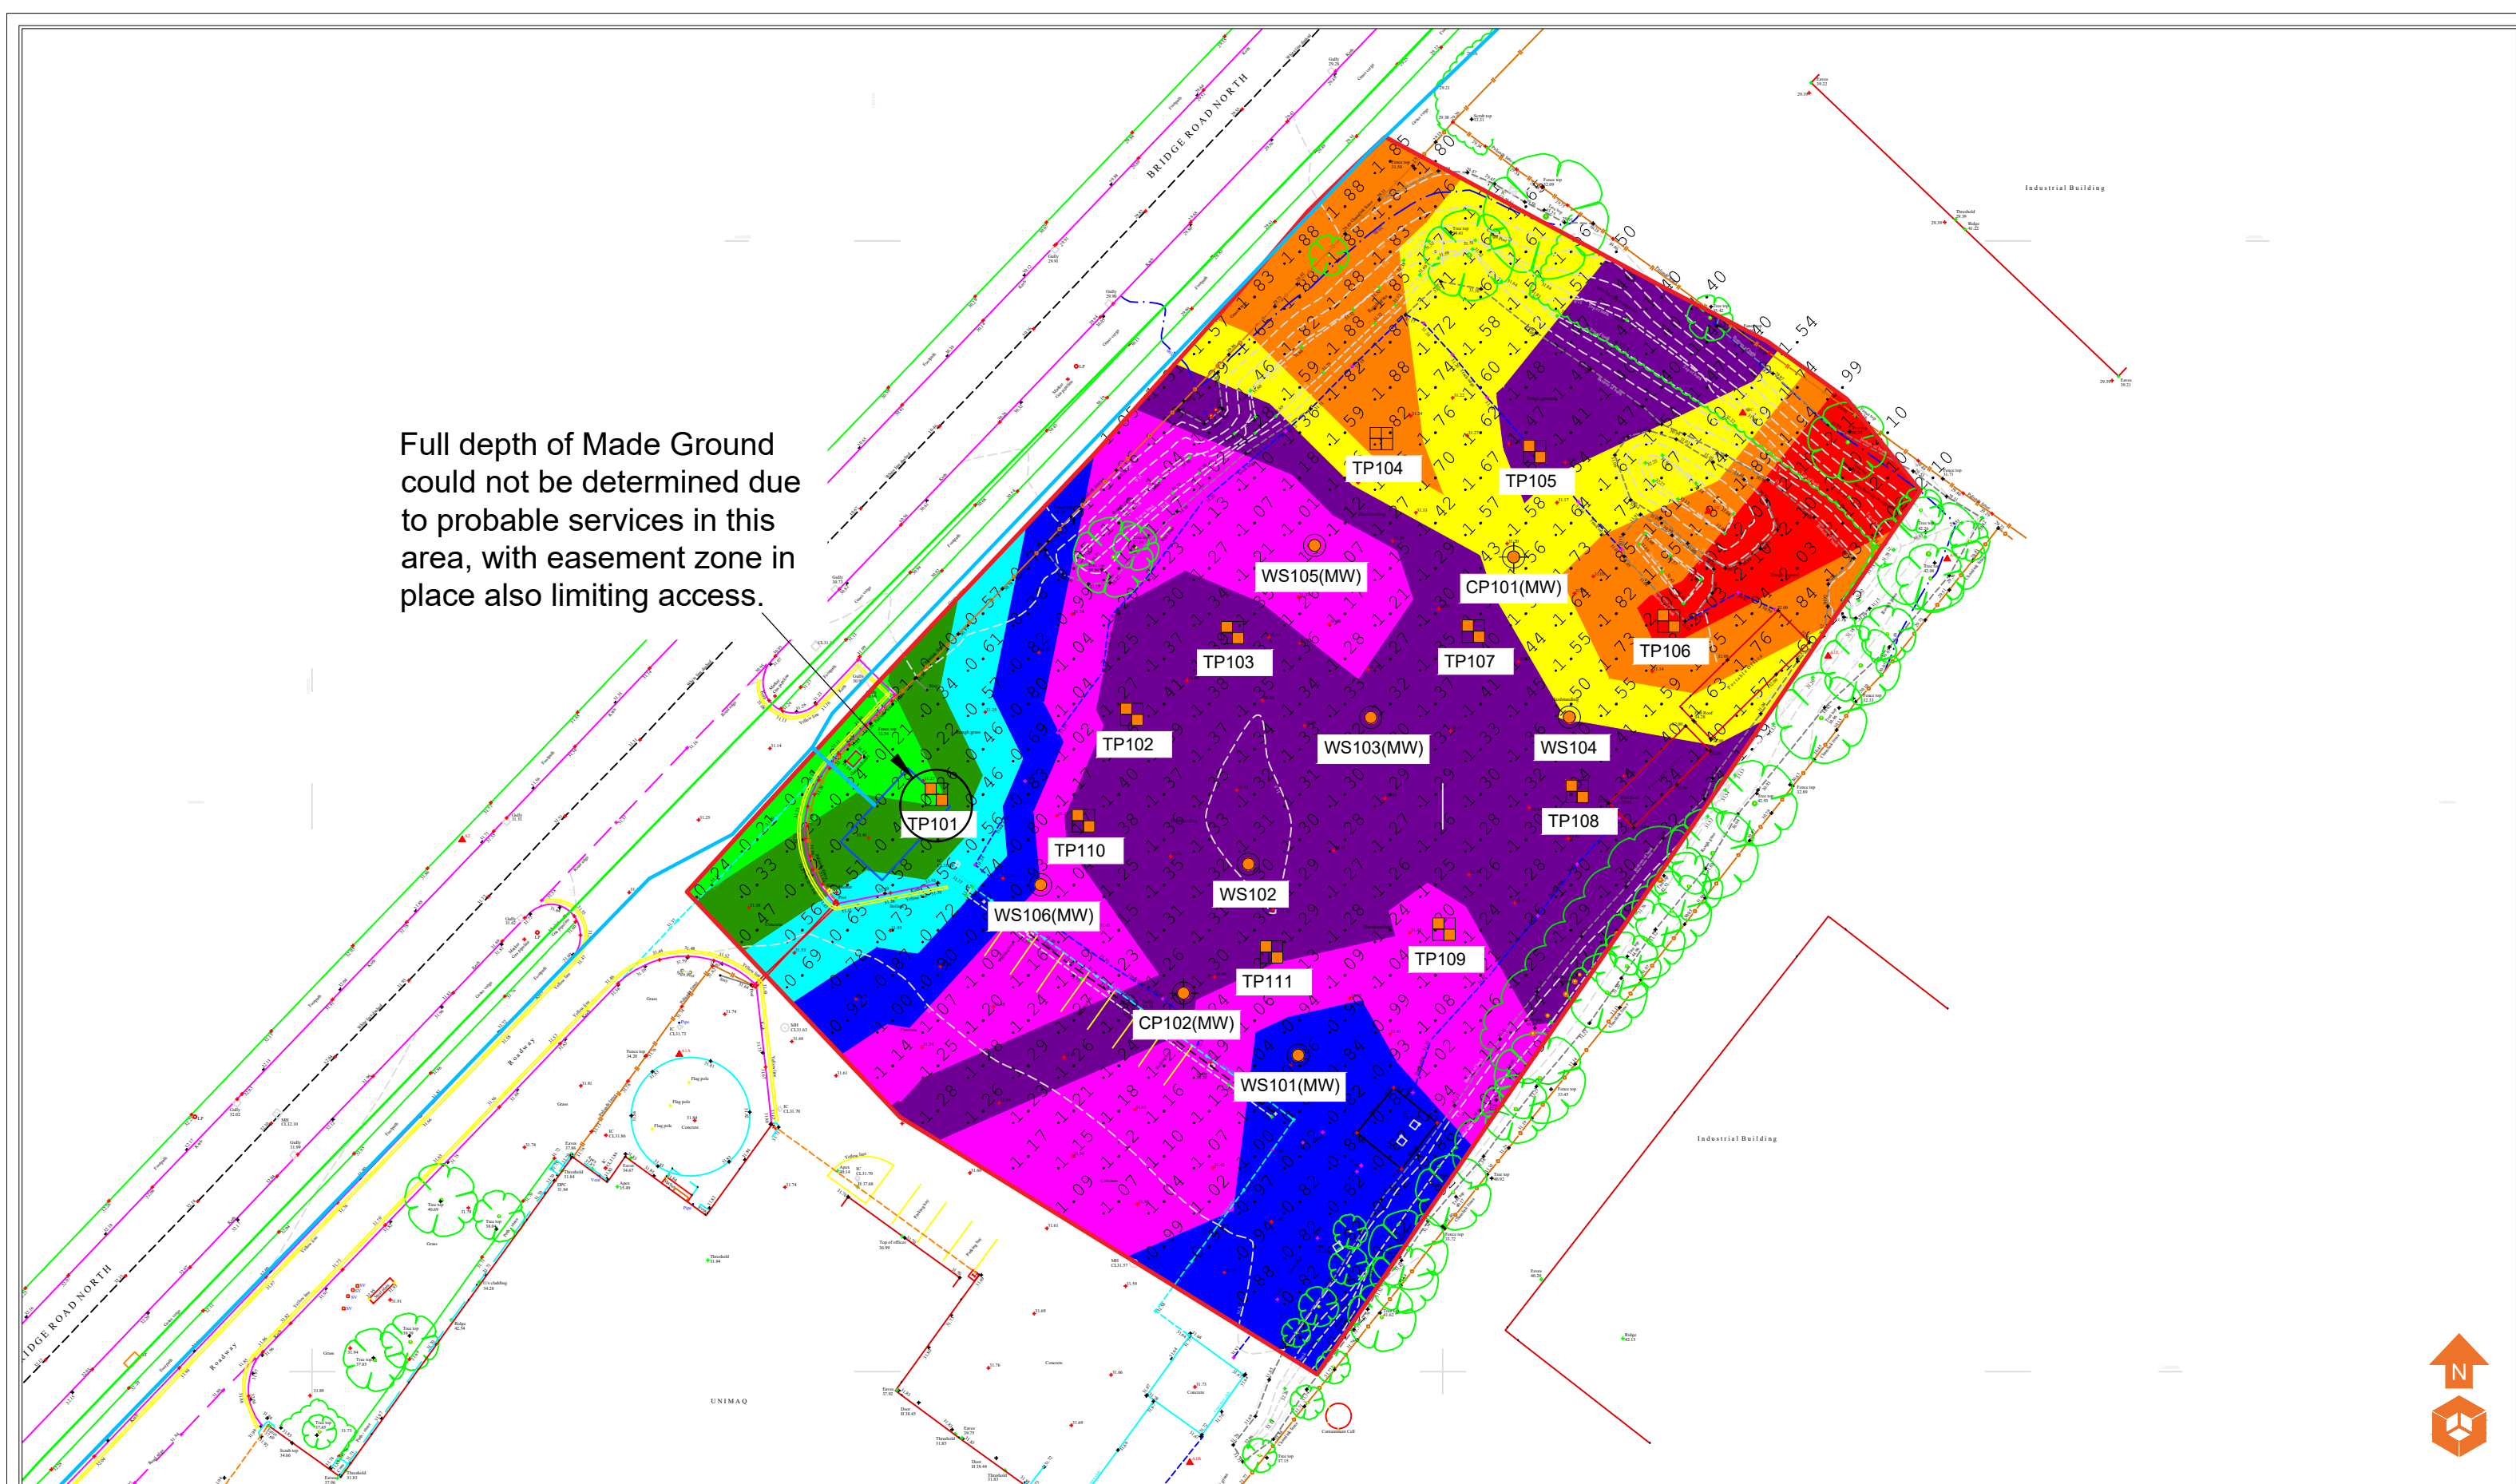
Full depth of Made Ground could not be determined due to probable services in this area, with easement zone in place also limiting access.

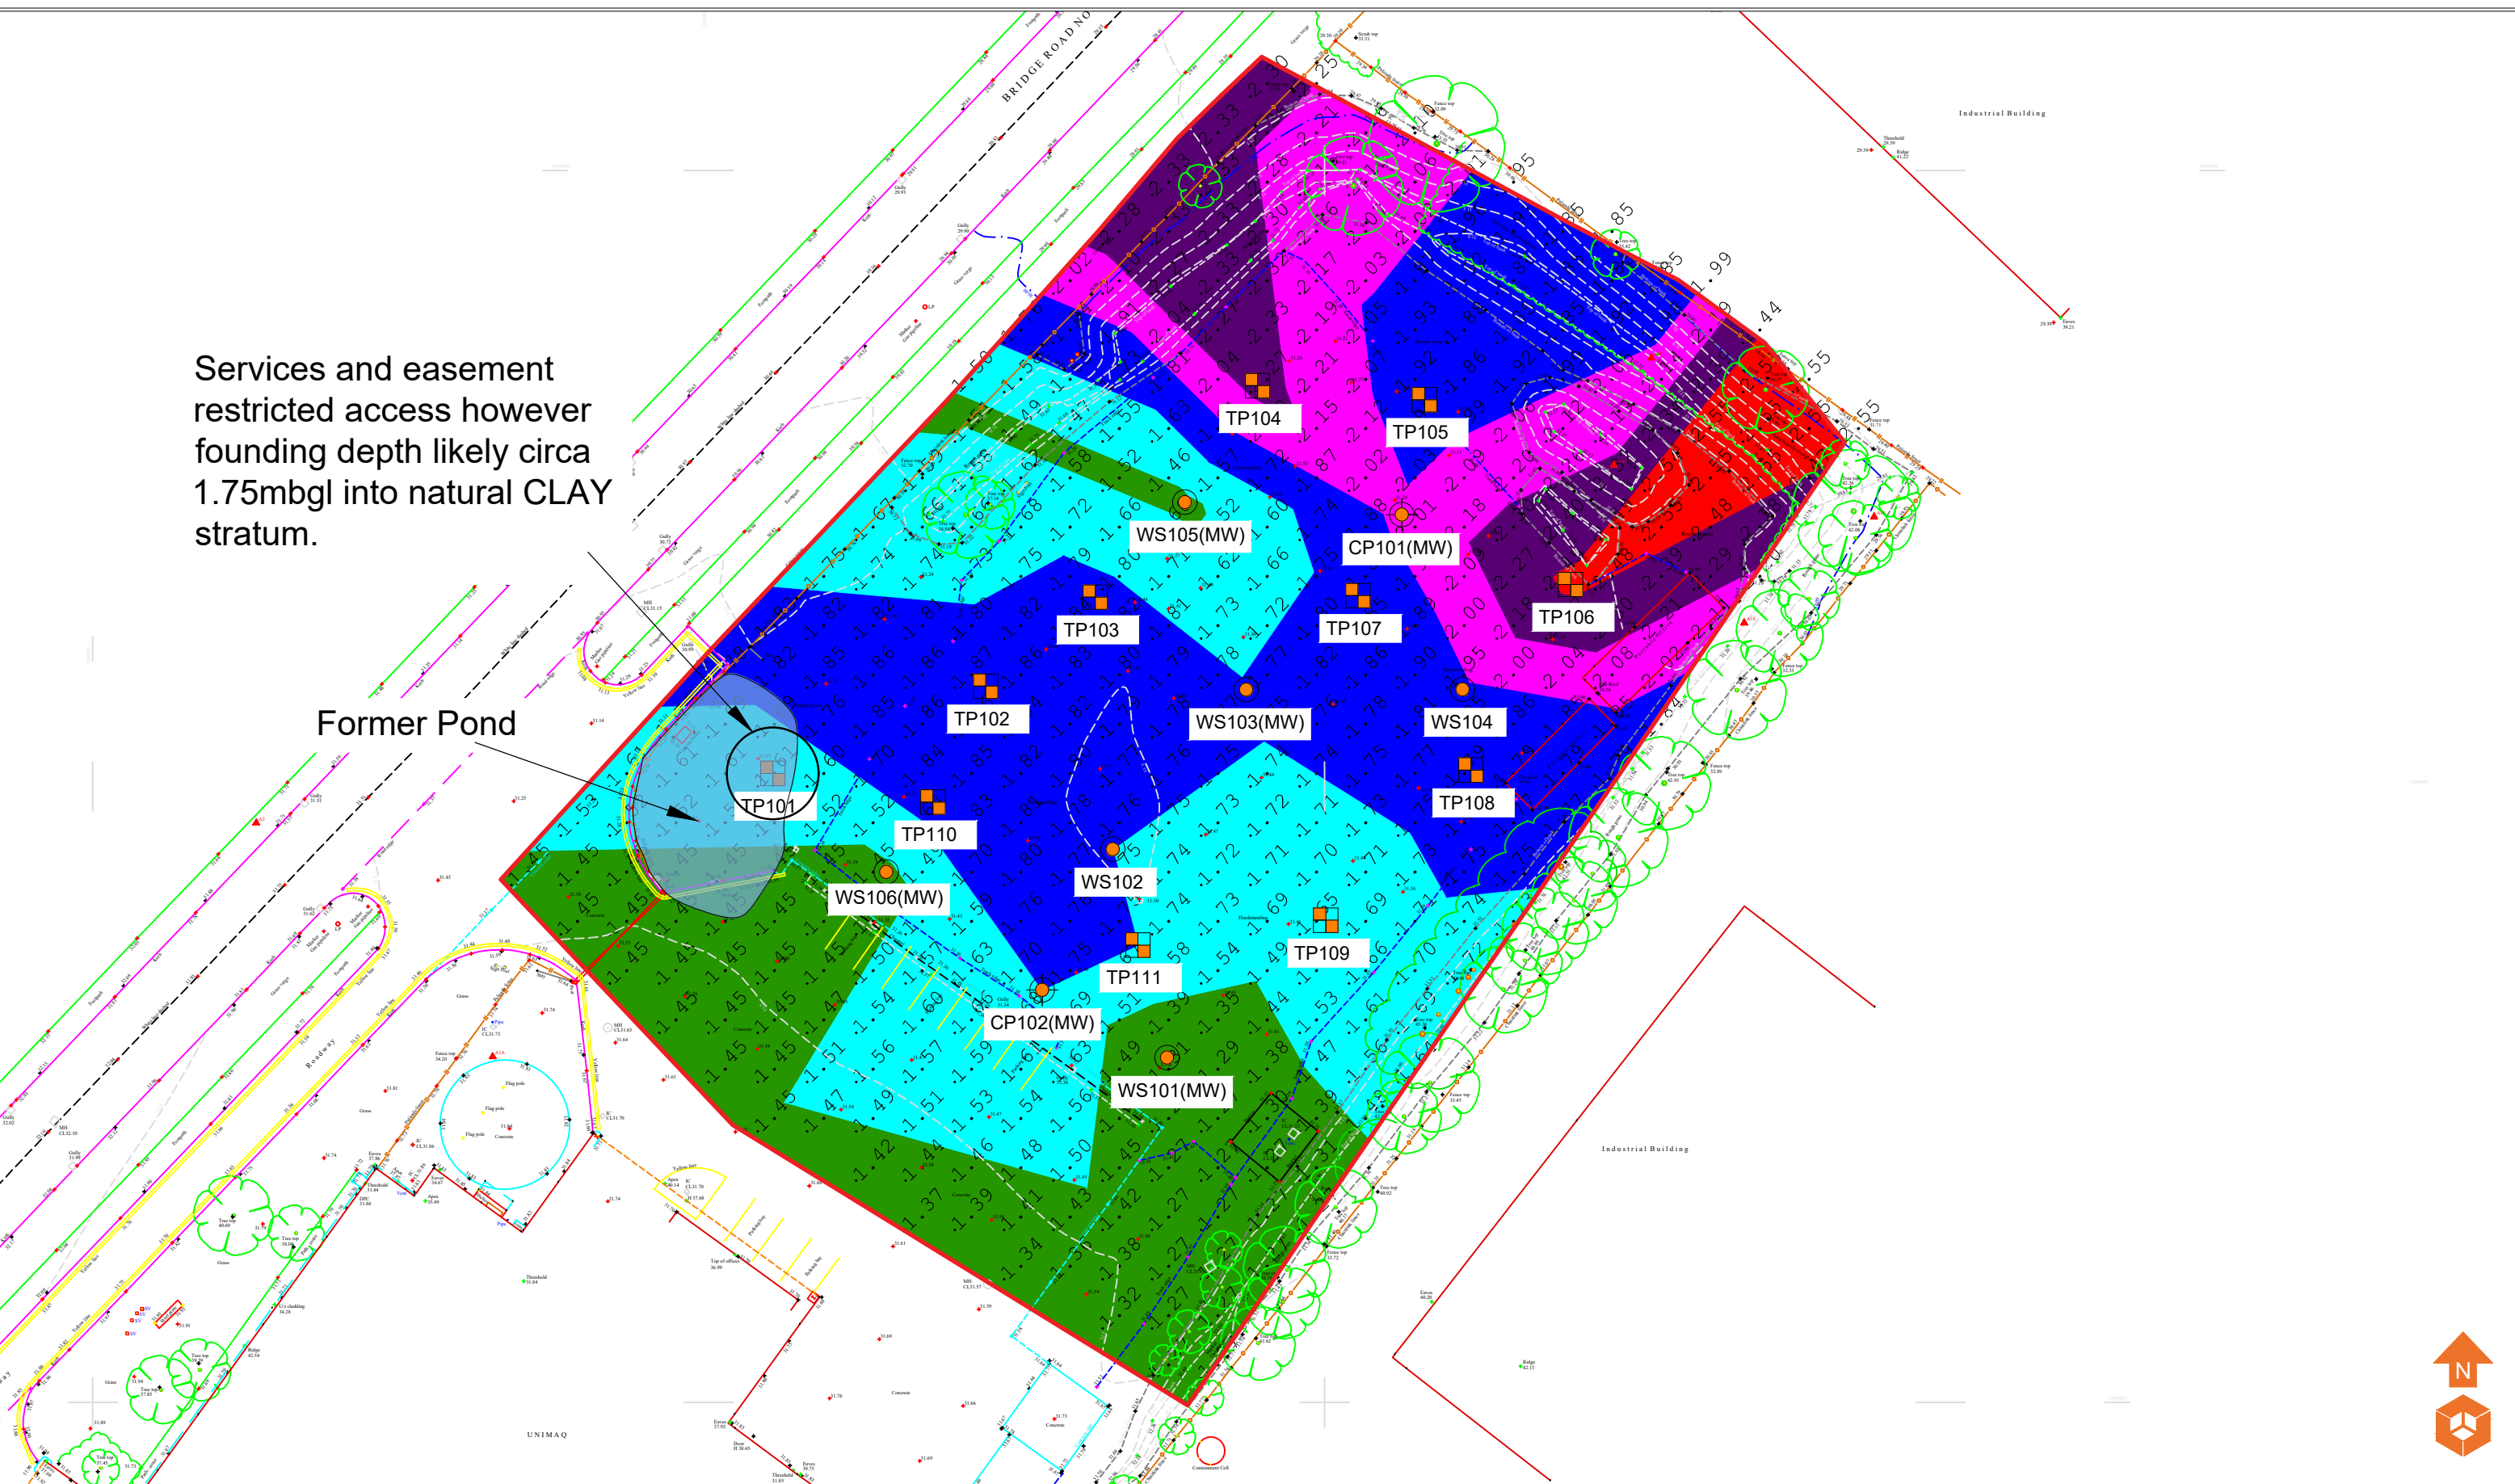
Services and easement  
restricted access however  
founding depth likely circa  
1.75mbgl into natural CLAY  
stratum.

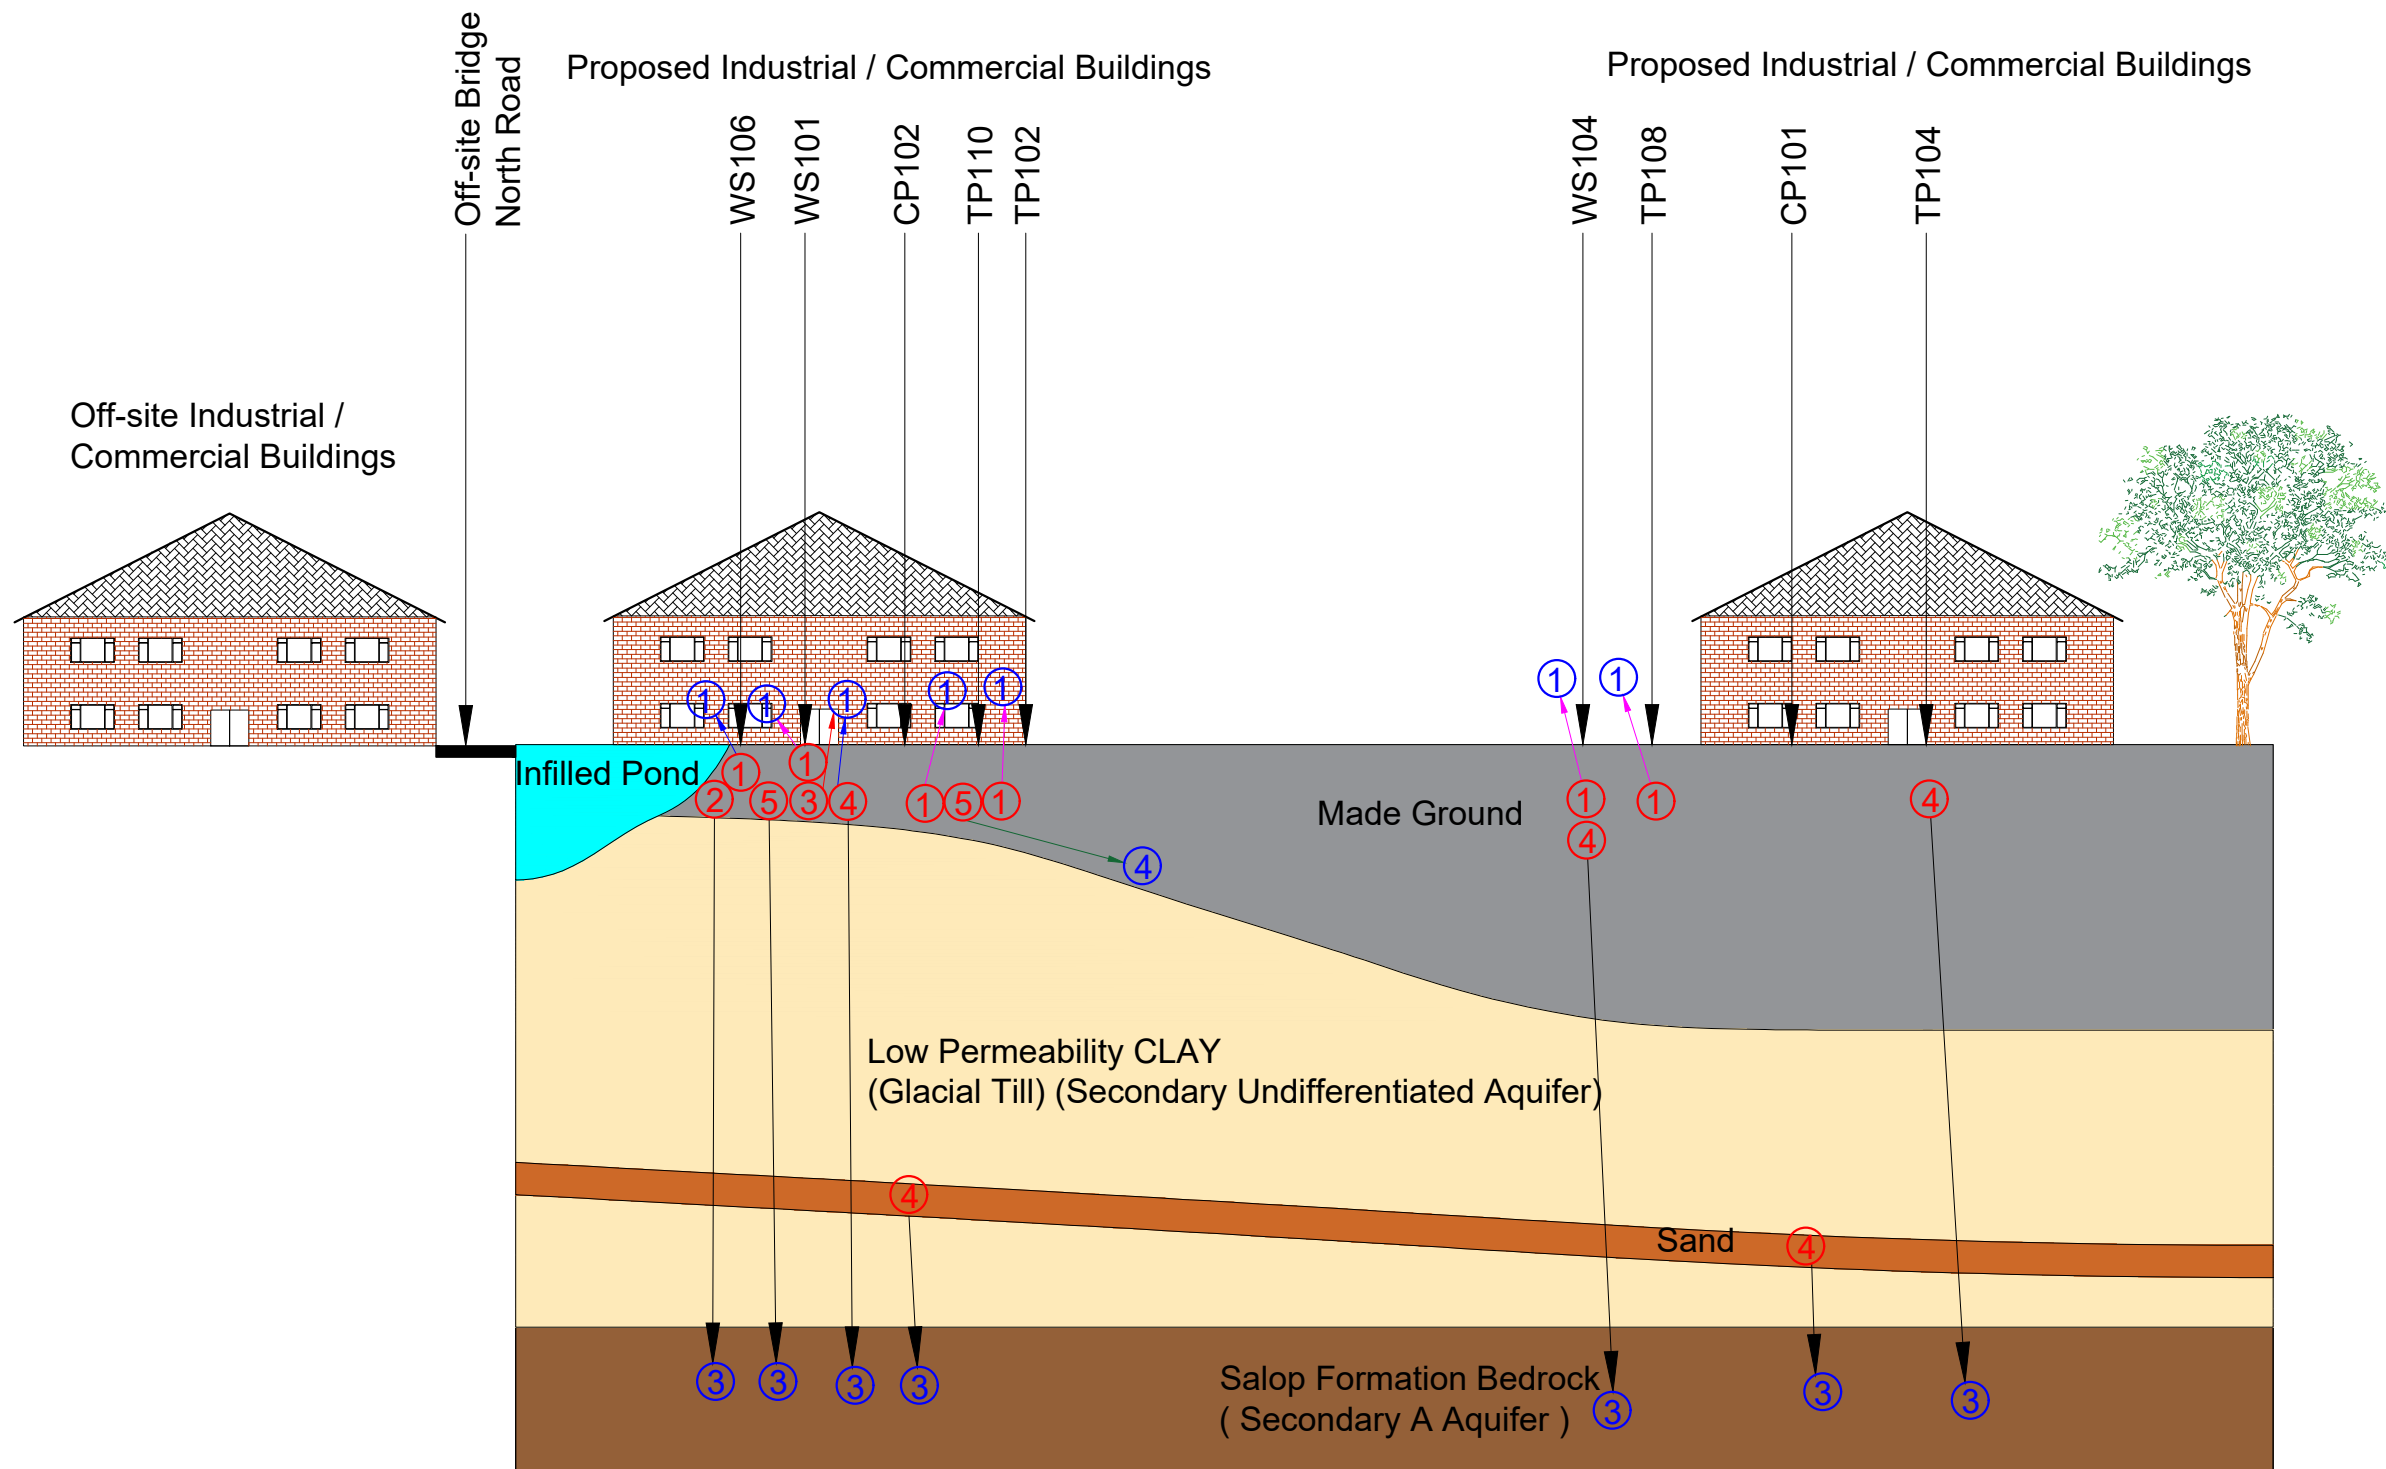
- Made Ground
- Clay
- Bedrock
- Infilled Pond
- Off-site Bridge
- Sand

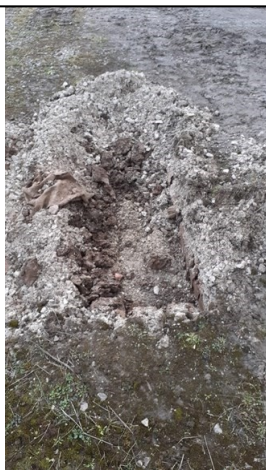
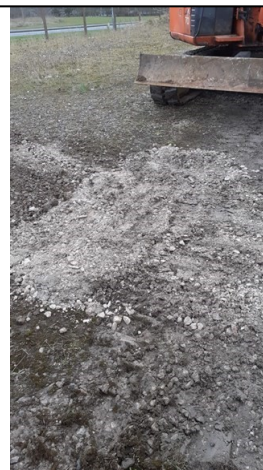
### Trial Pit 101

Within TP101 a layer of black reworked clay (0.09–0.20m bgl) was observed overlying a layer of limestone gravel. The trial pit was terminated due to the likely presence of underlying services.

Remarks: 1. Trial pit terminated at 0.21m bgl due to potential underlying services.

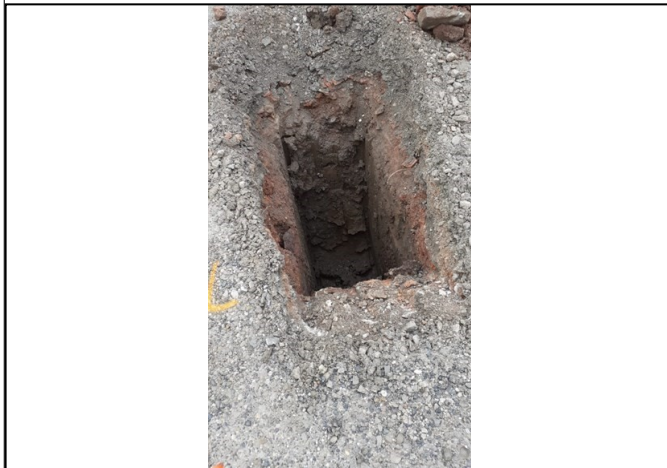
Trial Pit 102

Within TP102 a layer of asphalt (0.04-0.07m bgl) was observed to be overlying a layer of concrete (0.07-0.19m bgl) which was underlain with a layer of reddish brown sandy gravel (0.19-0.72m bgl), which was in turn underlain with a layer of reworked clay (0.72-1.42m bgl).

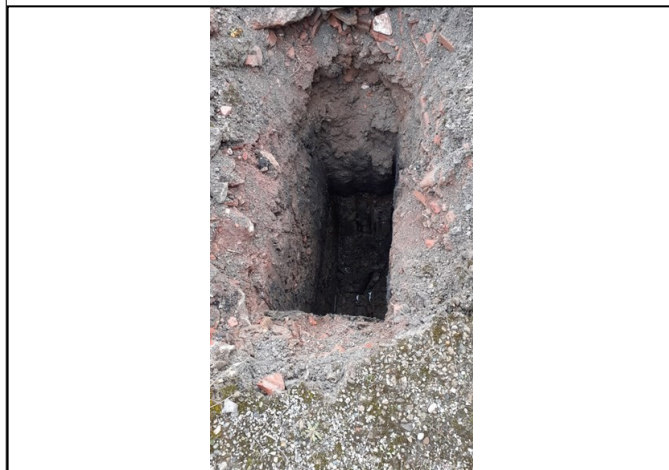
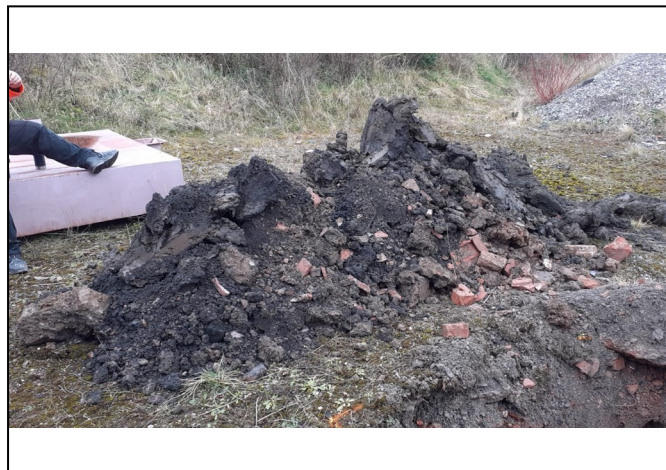
Trial Pit 104

In locations (WS102, WS103, TP104) a brownish black sandy gravel with pockets of clay were encountered where the gravel consisted of ash, clinker and mudstone at depths of between 0.33-1.88m bgl. In the case of TP104 a clay layer was observed overlying this layer. This strata is likely to be associated with the former railway tracks.

Remarks: 1.Complete. 2. Perched water encountered at 1.88m bgl

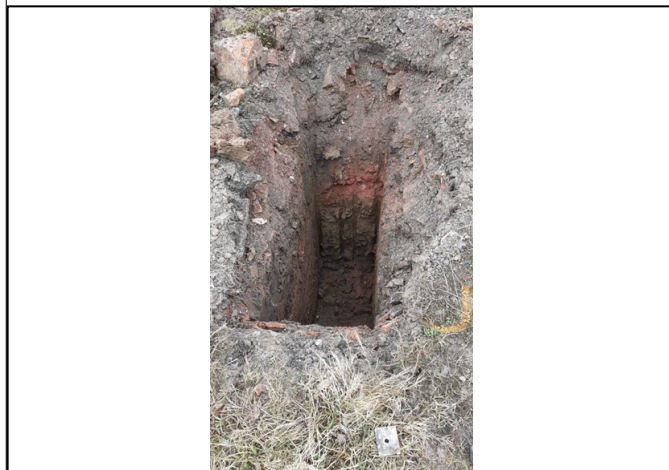
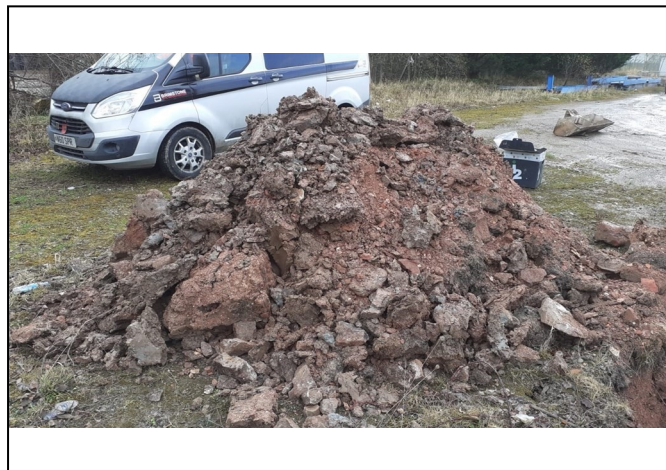
Trial Pit 106

In locations TP106 and TP108 a stiff blackish brown gravelly clay was observed overlying the reddish brown gravel at depth of between 0.60-1.00 mbgl and 0.50-1.20mbgl respectively.

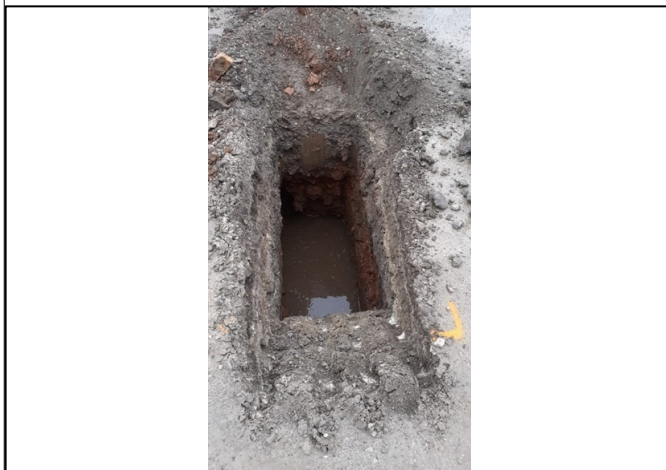
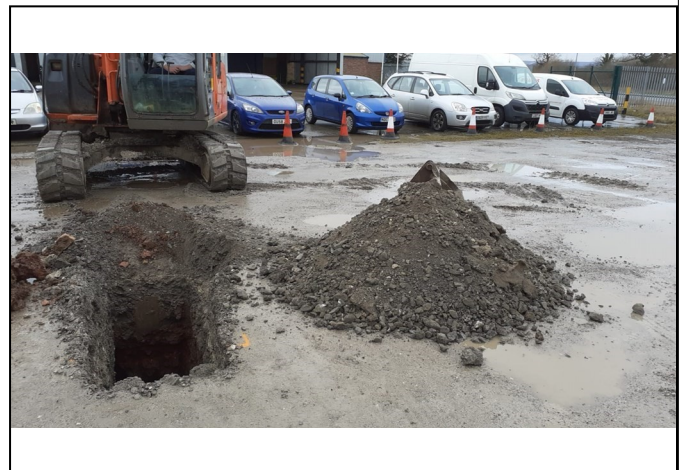
Trial Pit 111

Remarks: 1. Complete. 2. Former land drain encountered at 0.60m bgl.

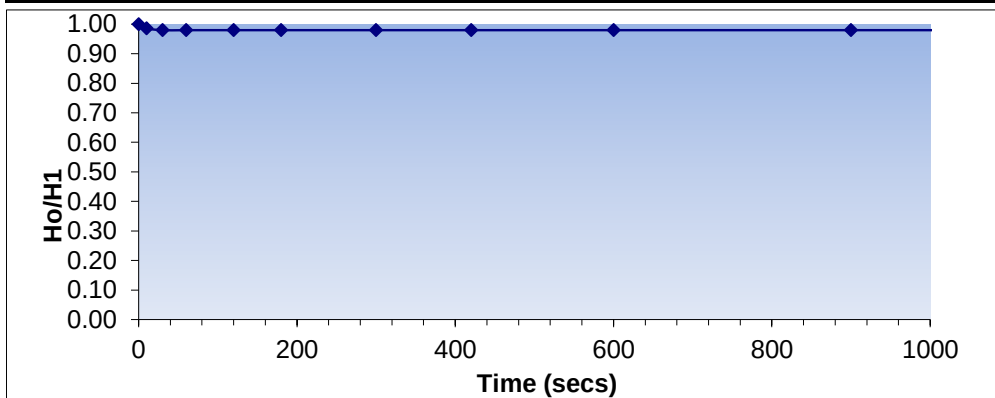
General Approach

$$k = \frac{A}{F(t_2 - t_1)} \log_e \frac{H_1}{H_2}$$

Soil infiltration was taken over the wetted area from between 75% and 25% of the effective depth. All tests showed clay drift deposits to have a poor soakage potential.
