Ash Road North, Wrexham

Proposed New Building

Geo-environmental Report

Ipsen Ltd

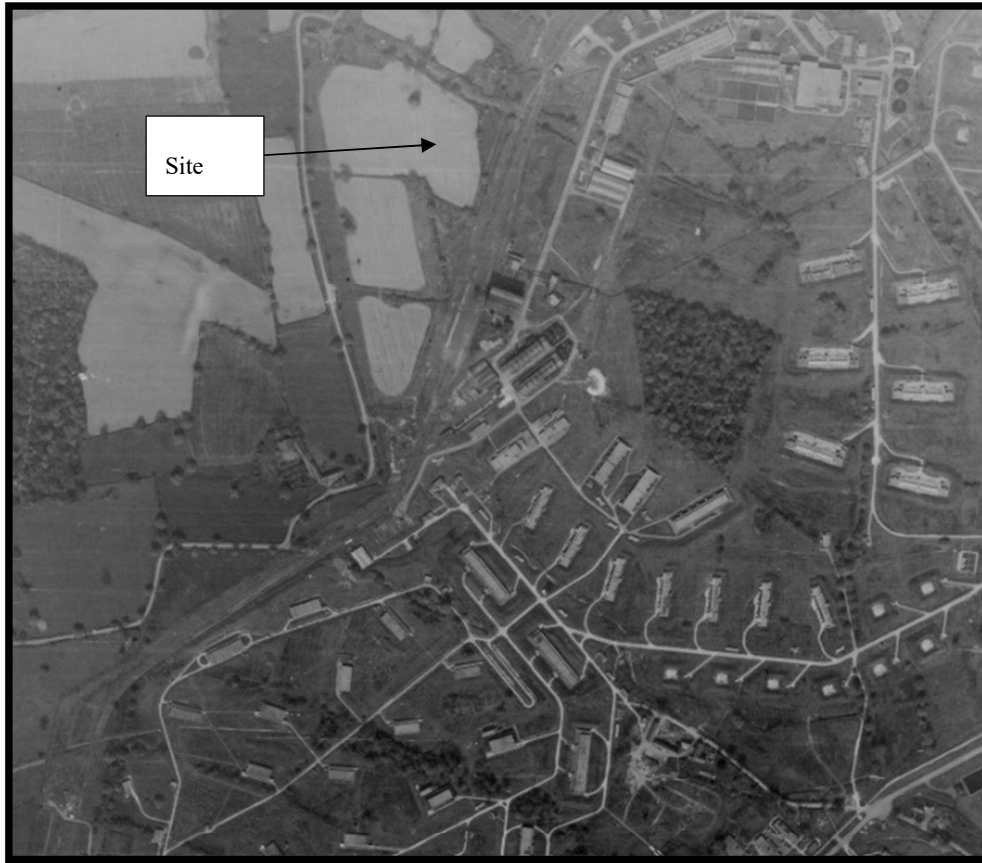
### **1946 Aerial Photograph**

This was confirmed by the 1946 aerial photograph from Reference 2, which is presented below.

The area was used for Cordite production during WWII, which was the propellant for shells. Production ceased in 1945, and the Welsh Development Agency started construction of Wrexham Industrial estate in the 1960's.

The 1954 OS plan (1:10,560 scale) shows no development within the site boundary, although the road crossing the site is no longer shown, and a new road had been constructed to the east of the site, see Figure 3c. However, numerous buildings and access roads are evident across the land to the east and south of the site. These are the remains of buildings from the area's use during WWII as an Ordnance Factory. Development from the Ordnance Factory

extended up to the site's eastern and southern boundaries, with the site area itself remained undeveloped.
